**ENGINEERING ANALYSIS OF
TEN SIDE SCAN SONAR TARGETS
BETWEEN THE NORFOLK HARBOR CHANNEL
AND THIMBLE SHOAL CHANNEL
HAMPTON ROADS, VIRGINIA**

Waterway Surveys & Engineering, Ltd.
321 Cleveland Place
Virginia Beach, Virginia 23462

December 1984

Final Report

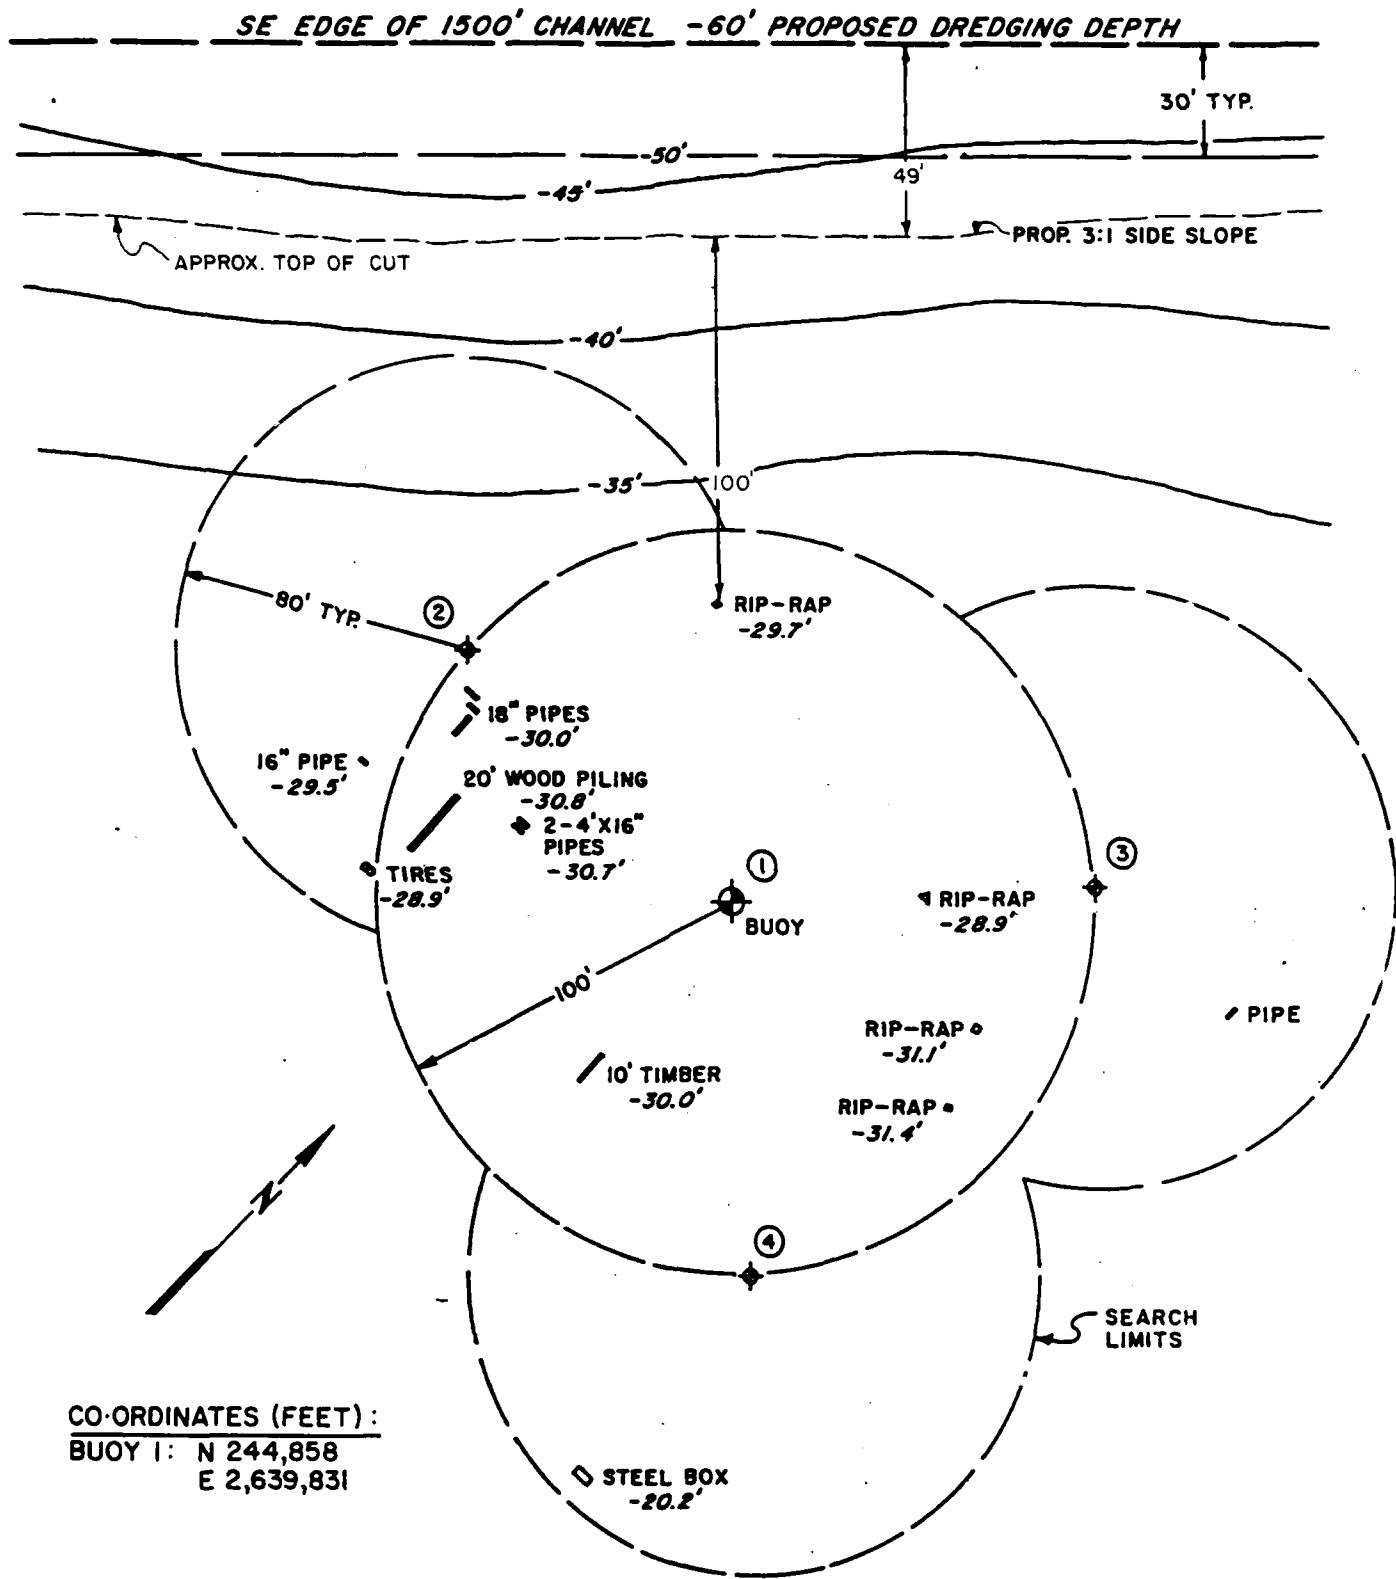
FIGURE 2
DISTRIBUTION OF OBJECTS FOUND AT NH # 1
 SCALE: 1"=50'

Interpretation of side scan sonar records showed a large area of small scattered objects, extending 2 feet above bottom level (A.B.L.), in 36 feet of water. The Corps recommended searching a 400-foot diameter area, so a search pattern was set up using a 100-foot tag-line swinging around anchor buoys set in 4 locations (see Figure 2).

Most of the objects were within 100 feet of buoy 1 and range from small sections of 16-inch steel pipe to single pieces of 2-foot diameter rip-rap. As shown in Figure 2, the target area is well south of the southeast edge of the 1,500-foot wide Norfolk Harbor Entrance Reach; the closest object being more than 100 feet from any dredging activity. Even if dredging did take place in this area, none of these objects would be considered anything other than routine obstructions for a large hydraulic dredge.

These objects pose no threat to the shipping industry using Hampton Roads because of their small size and distance outside of the channel. The bottom depth in this area is more of a threat to ships than the objects investigated. No removal or further investigation will be necessary at this target.

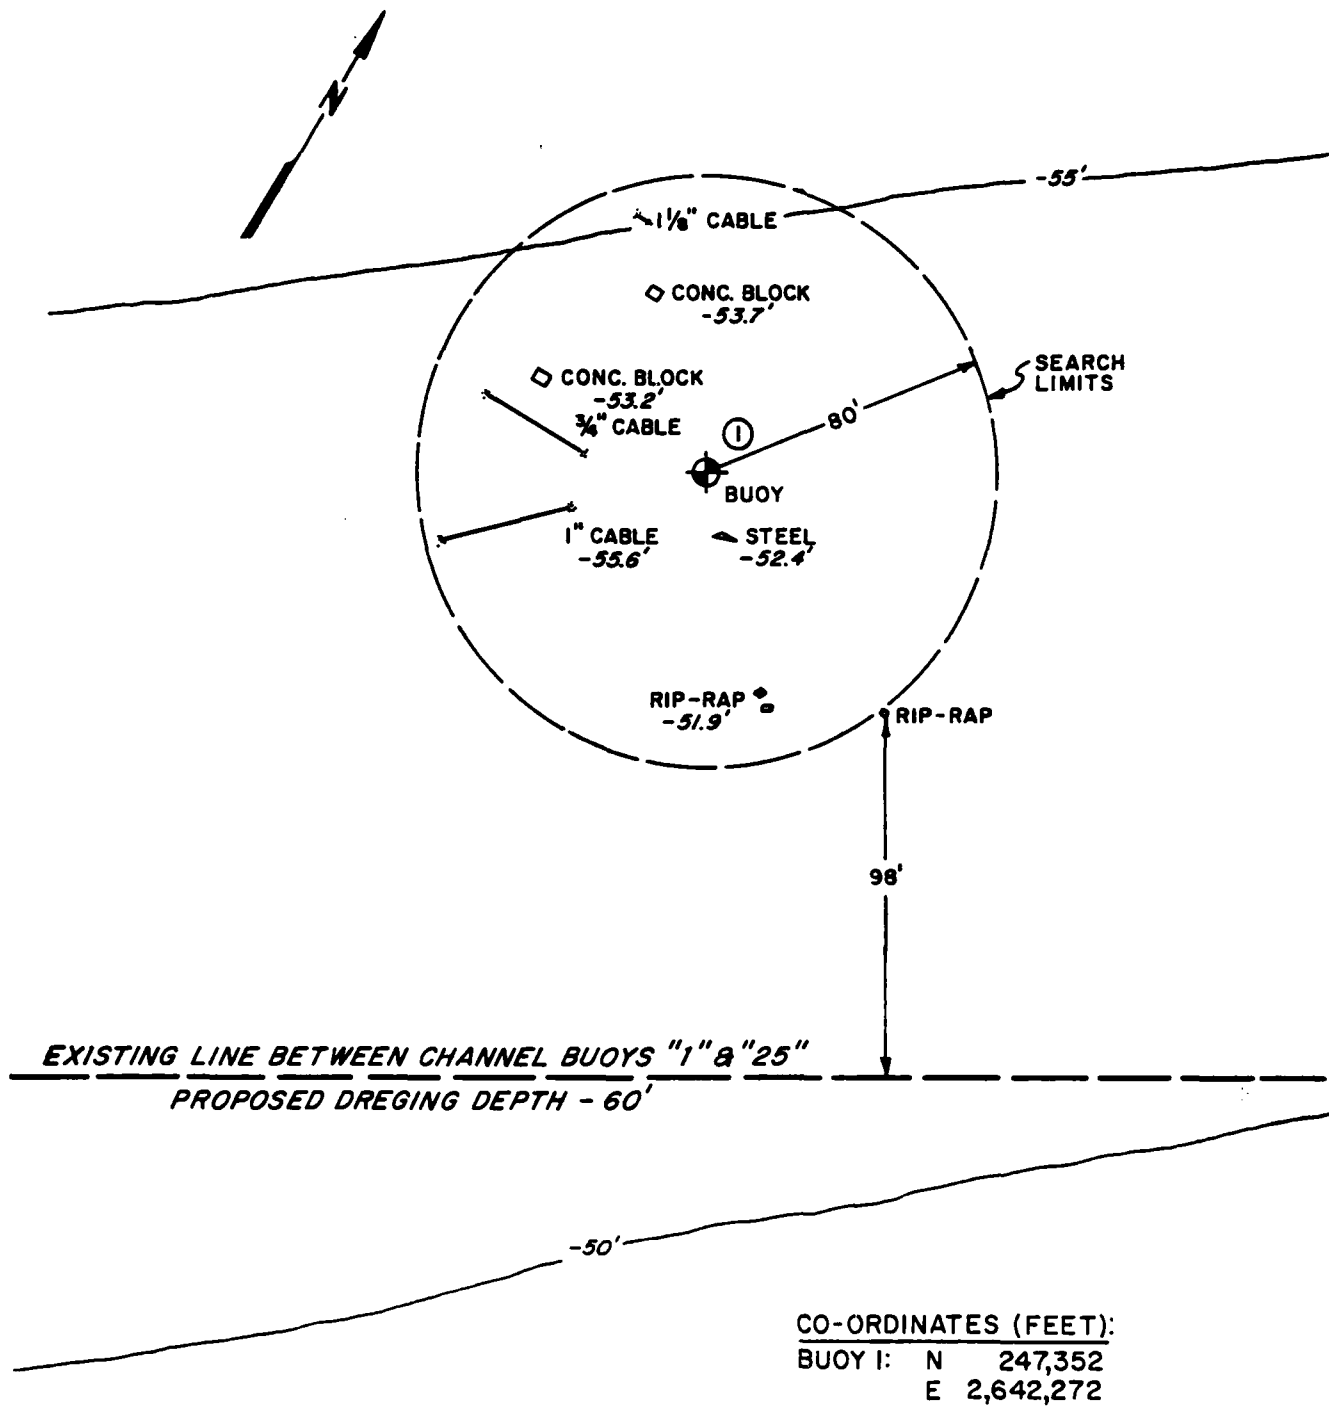
FIGURE 3
 DISTRIBUTION OF OBJECTS FOUND AT NH # 3
 SCALE: 1"=50'

Interpretation of side scan records showed an area of small scattered objects, extending 3 feet A.B.L. in 56 feet of water. A tag-line search of the bottom was made out to a radius of 80 feet from buoy 1 (see Figure 3).

The target area is approximately 100 feet northwest of a straight line between channel buoys "1" and "25". These buoys currently mark the southern limit of the natural channel at approximately the 50-foot contour. With the proposed dredging depth at -60.0' MLW, all the objects found in this area will effect the dredging activity.

Two 4' x 4' concrete blocks were observed with 2.5' exposed above the bottom. These blocks are probably 4' tall, but there is no way of knowing without further investigation. Cables were found in the same situation with the ends disappearing into the mud. These cables could be connected to the concrete blocks, to another object underneath the existing bottom level, or could run an undetermined distance under the bottom. A piece of 1/2-inch thick steel plate 4 feet long and 1 foot A.B.L. was found encrusted with marine growth.

All these objects have the potential of having greater dimensions beneath the bottom. If dredging is necessary in this area, these objects should be described with co-ordinates in the plans and specifications for dredging and/or be investigated further for removal prior to dredging.

There is a natural channel 2,200 feet wide below -60.0' MLW beginning 200 feet to the northwest of this target area. If this channel is adequate for shipping and channel buoys "1" & "25" can be moved closer to the 60-foot contour, then these objects will not intimidate shipping and will not require any further investigation.

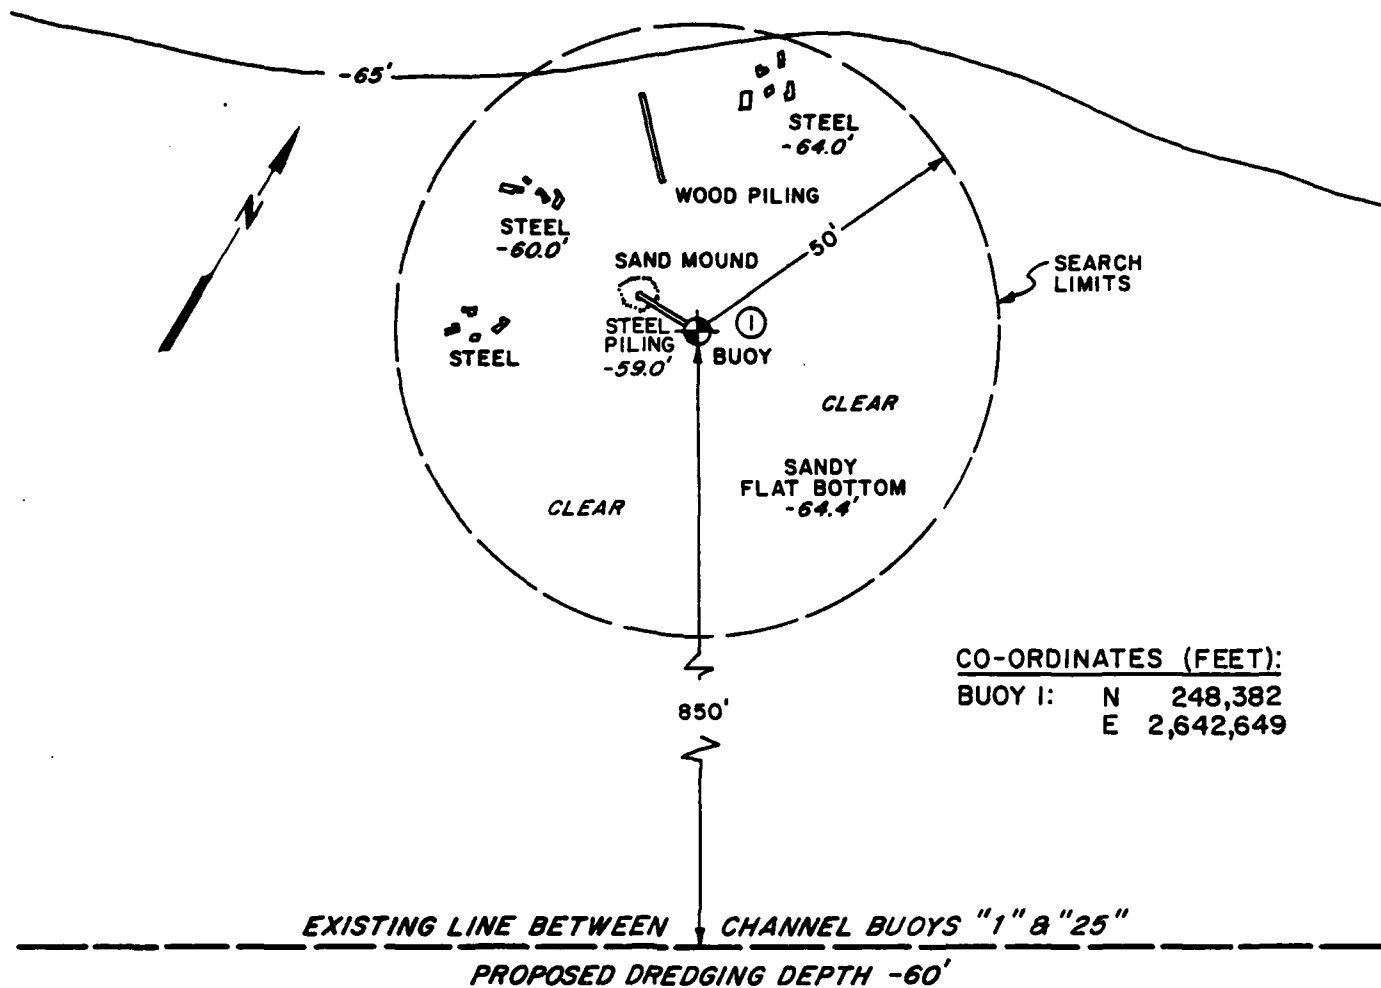
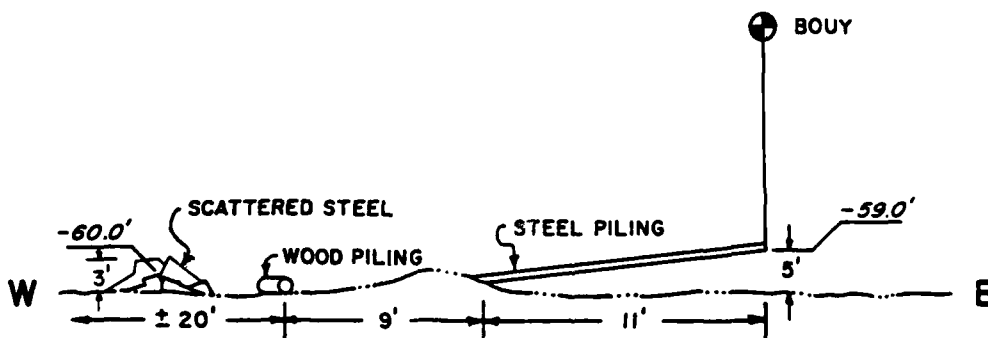
DISTRIBUTION OF OBJECTS FOUND AT NH # 4

Interpretation of this side scan sonar record showed an area 30 feet wide by 60 feet long in 65 feet of water with objects extending up to 3 feet A.B.L. A 50-foot radial sweep of the bottom was made pivoting around the east end of a steel pile located at buoy 1 (Figure 4).

The average depth at this target area is 64 feet below MLW. The most significant object found is a 12-inch wide, 3/8 inch thick steel sheet pile with 11 feet exposed above the sand. The buoy was tied to the east end of the pile having a least depth of -59.0 feet MLW which is cantilevered 5 feet above the bottom. (See Profile View, Figure 4). Several small groups of scattered irregular-shaped steel plates were found to the west of the buoy. This thin steel is heavy with marine growth on exposed surfaces. It extends from 0 - 3 feet above the bottom with a least depth of -60.0 feet MLW.

The target area is well into the existing natural channel, being 850 feet northwest of the line between channel buoys "1" & "25". The total width of the natural channel at this point, below -60 feet MLW, is approximately 2,500 feet. Since the average depth at this target is 64 feet below MLW, dredging will not be necessary. The steel sheet pile, having a least depth of 59.0 feet below MLW, should be removed because it is in direct line with any outgoing ship traffic. It is recommended that the area to the west with the scattered steel plates be investigated further if, in fact, the channels are dredged to a depth of -60 feet MLW.

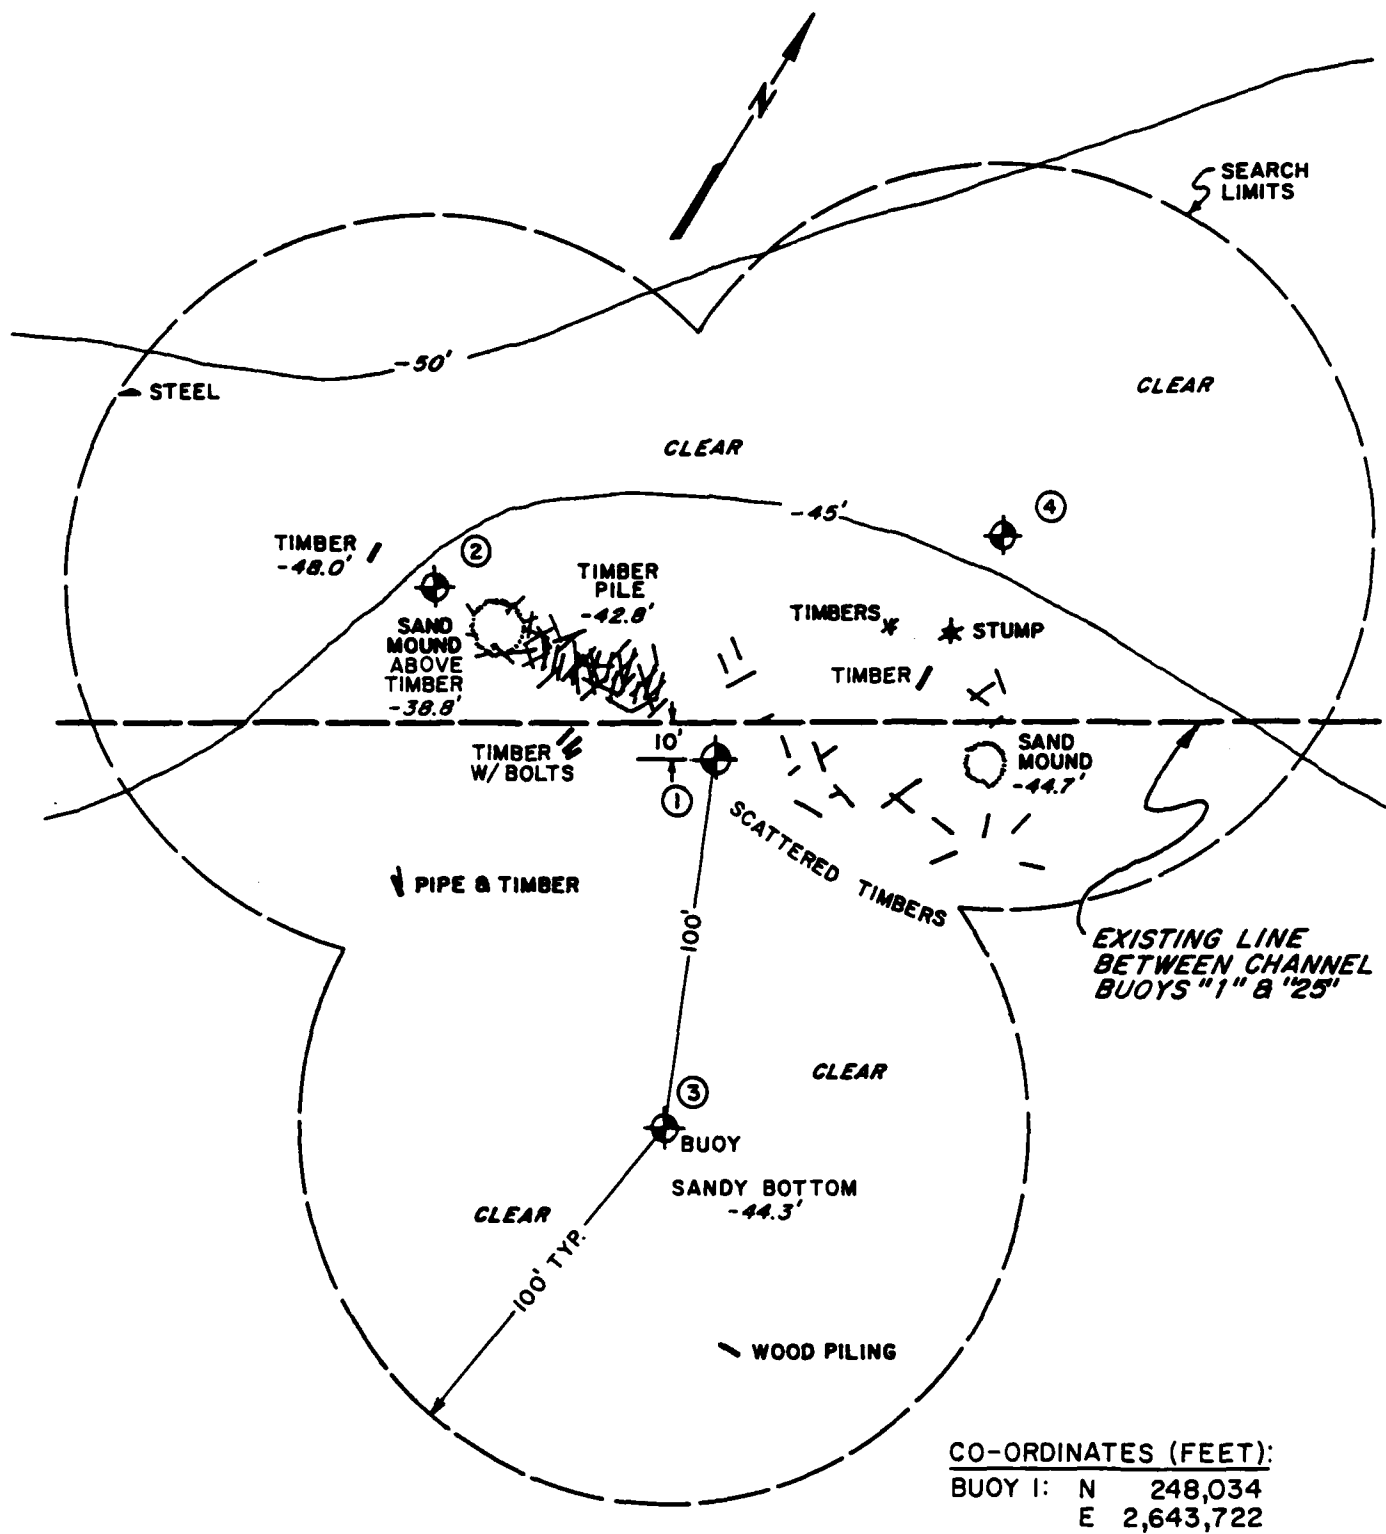
FIGURE 5
 DISTRIBUTION OF OBJECTS FOUND AT NH # 5

Interpretation of side scan sonar records showed a 15-foot by 20-foot object in 46 feet of water extending 10 feet above the bottom. The Corps of Engineers recommended a 400-foot diameter search area to be covered at this target. A search pattern, similar to that used at NH #1, was set up with buoy 1 dropped at the given co-ordinates and 3 additional buoys set at 100 feet in radials from buoy 1 in order to achieve maximum coverage (see Figure 5).

The average depth at this target is -45 feet below MLW. Most of the objects found are timbers, 2 x 10's and 2 x 12's of various lengths, scattered about the bottom, partially to totally exposed. The largest concentration occurs between buoy 1 and buoy 2. This large pile of timbers, 70 feet long and 15 feet wide, runs east-west with a large sand mound, 15 feet in diameter and 6 feet high, at its western-most end. The least depth occurs on this mound at -38.8 feet MLW. Most of these timbers are rotten and deteriorated.

The target area falls right on the line between channel buoys "1" and "25" marking the south side of the natural channel. The existing channel width is already adequate northwest of this point, with over 2,000 feet deeper than -60 feet MLW, therefore dredging will not be necessary at the target site. If additional widening was found to be necessary along the south side, these rotten timbers should not create a problem for a large hydraulic dredge, but a description of this area with co-ordinates should be included in the plans and specifications for dredging. No further investigation will be required at this target.

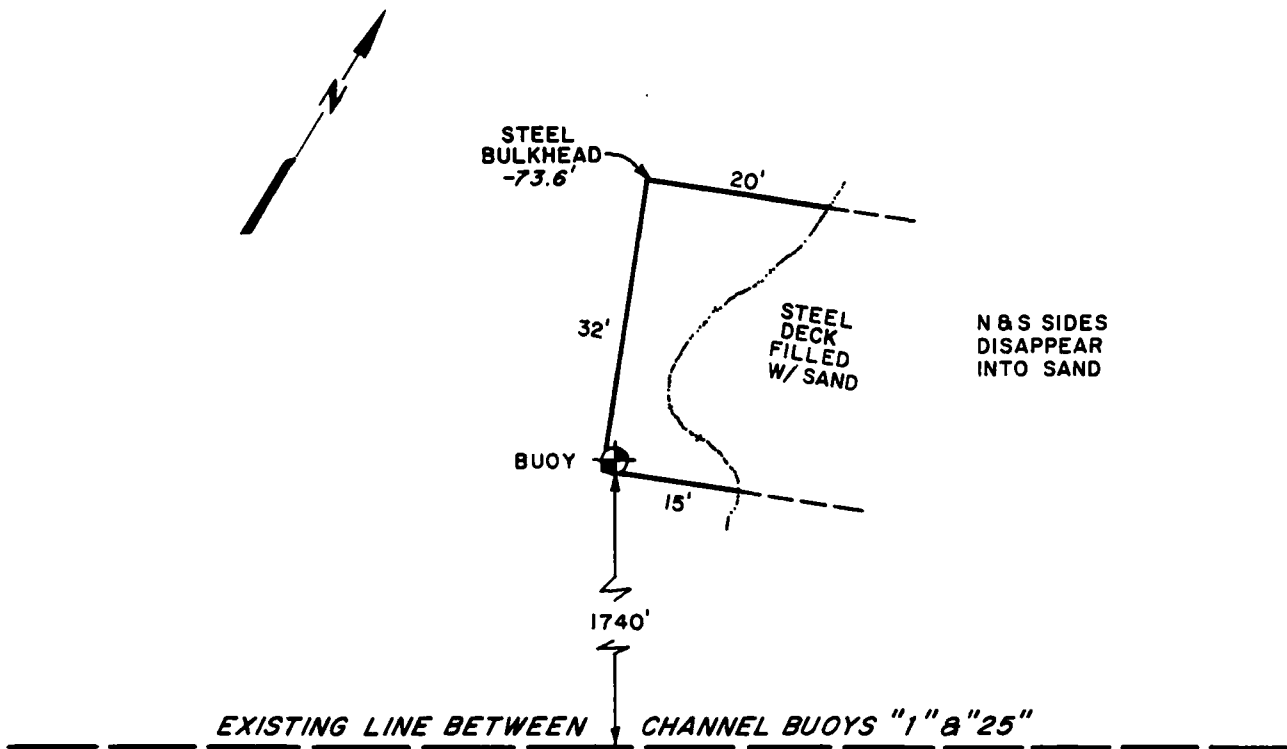
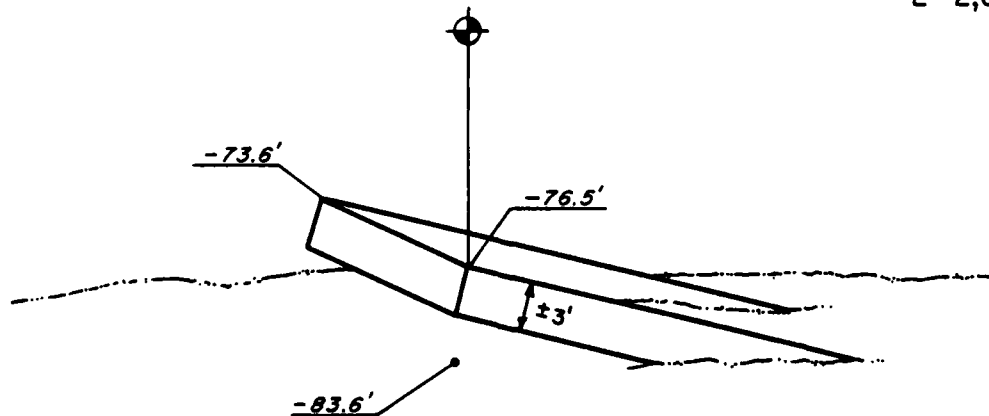
LOCATION OF OBJECT FOUND AT NH # 6

Interpretation of side scan sonar records showed a target 60 feet by 100 feet in 75 feet of water rising 5.5 feet above the bottom. The buoy anchor was dropped directly onto the object, therefore, a sweep of this area was not necessary.

The object can be described as a large steel box 32 feet across (north-south) with 15-20 feet exposed above the sand on the west end (see Figure 6). The box has a steel deck with a steel bulkhead approximately 3 feet high around the perimeter. The west end of the box is cantilevered out of the sand with sand filling the inside of the box from the east. The northwest corner is highest, with a least depth of -73.6 feet MLW.

The object is located in deep water in the center of the natural channel. This object is much too deep to intimidate ships navigating a 55-foot project channel. The side scan sonar records show more than one of these objects, but because of the bottom depth throughout this area, the object would have to be over 20 feet above the bottom to intimidate shipping. Since the records indicate a maximum height of 5.5 feet, no further investigation or removal of this target is necessary.

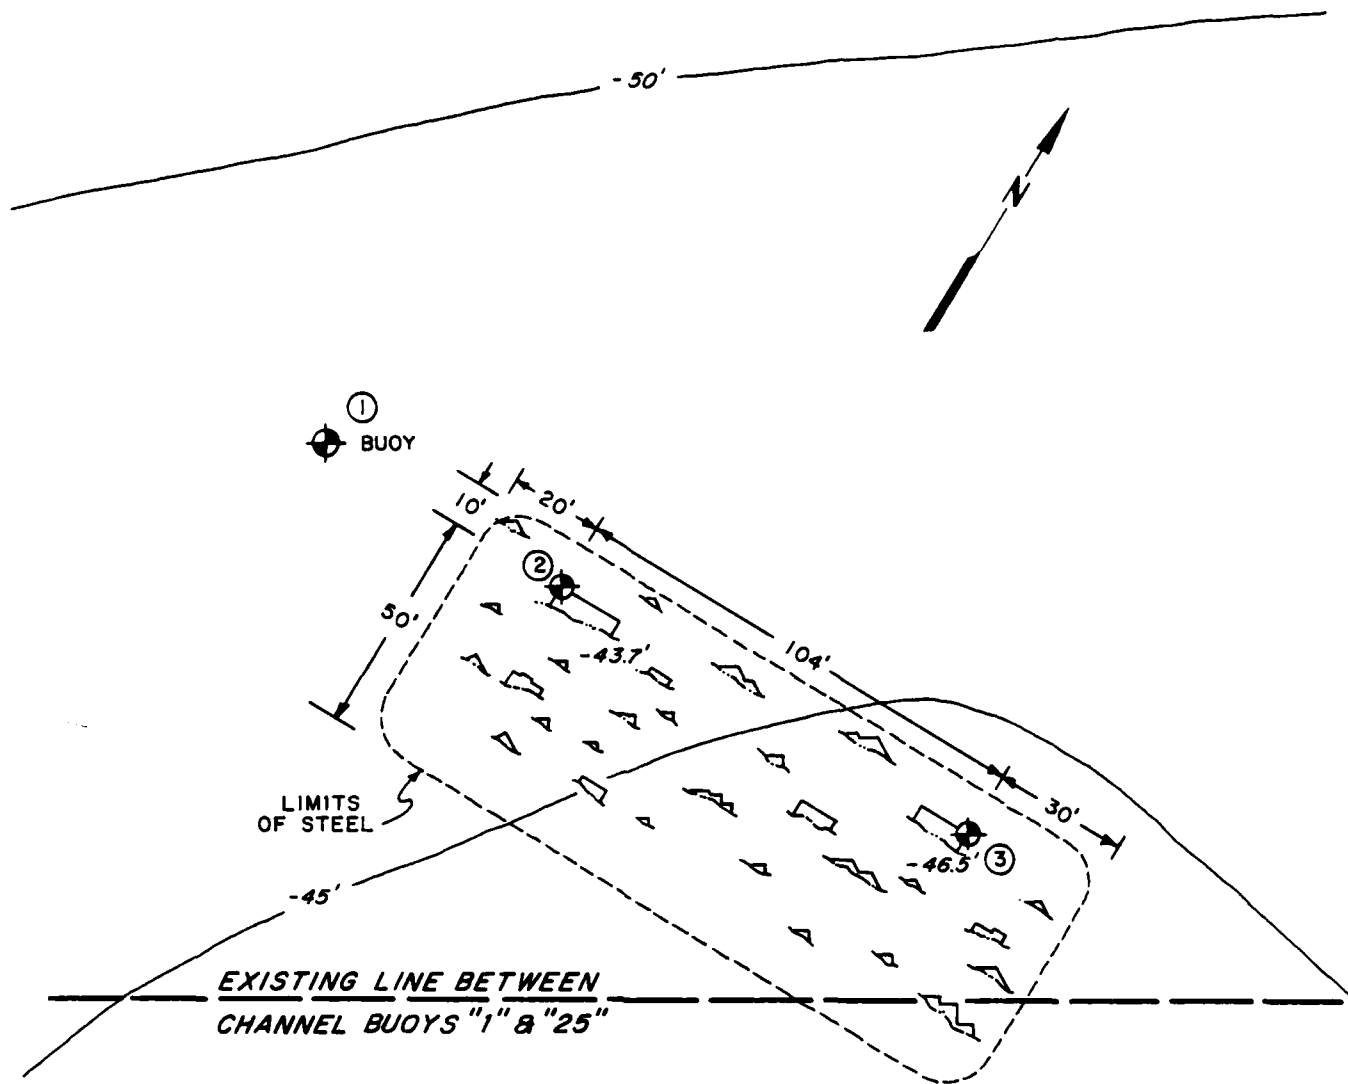
FIGURE 7
 DISTRIBUTION OF OBJECTS FOUND AT NH # 7
 SCALE: 1" = 50'

Interpretation of side scan sonar records showed that this target would cover an area 225 feet by 55 feet in 44 feet of water and extend 4 feet above the bottom. Buoy 1 was dropped using the given co-ordinates. A radial sweep revealed the west edge of the target, 60 feet east of buoy 1. A second buoy was then set and the investigation continued to the east where a third buoy was placed near the eastern limit. Buoy 2 and buoy 3 were positioned and the entire target area was then related to these two buoys (see Figure 7).

Buoy 2 was tied to the NW corner of a large piece of 1/2 inch thick steel plate covered with marine growth. It is 15 feet long running east-west and 5 feet wide, with the north side elevated, sloping down to the south and disappearing into the sand. The least depth is at the northeast corner, -46.1 feet MLW. Buoy 3 was tied to a 4-foot wide piece of 1/2 inch thick steel, again sloping out of the sand to the north. Sand was built up at the south side and scouring occurred to the north - this being typical around all the steel. The least depth was -46.5 feet MLW. These were the largest pieces of steel, but the shallowest object was a piece of steel plate, 10 feet east-southeast of buoy 2 with a least depth of -43.7 feet MLW. The entire target area, approximately 154 feet long by 60 feet wide, is made up of irregular, scattered pieces of partially exposed steel plate with extensive mounding, which suggests additional steel beneath the bottom.

The target area extends from the line between channel buoys "1" & "25" to 100 feet northwest, with an average bottom depth of -48 feet MLW. A cross-section of the natural channel at this point would show 2,000 feet of width below -60 feet MLW. Therefore, if the channel buoys are moved northwest to the 60-foot contour, this area would pose no threat to ships and no further investigation would be required.

If dredging is determined necessary to deepen the area northwest of the existing channel buoys to -60 feet MLW, then this area of steel will be a problem for the dredge. Further investigation will be necessary prior to removal of the steel. A suggestion would be to move buoy "25" to the northwest to avoid this obstructed area.

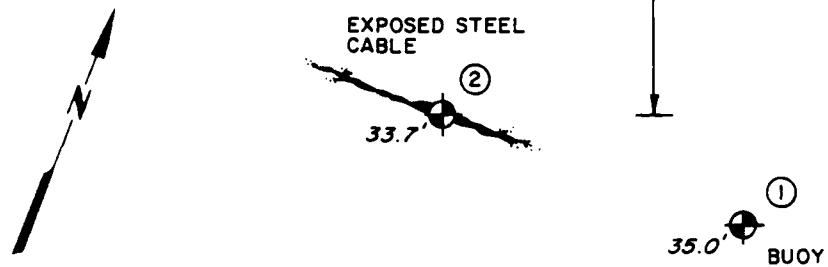
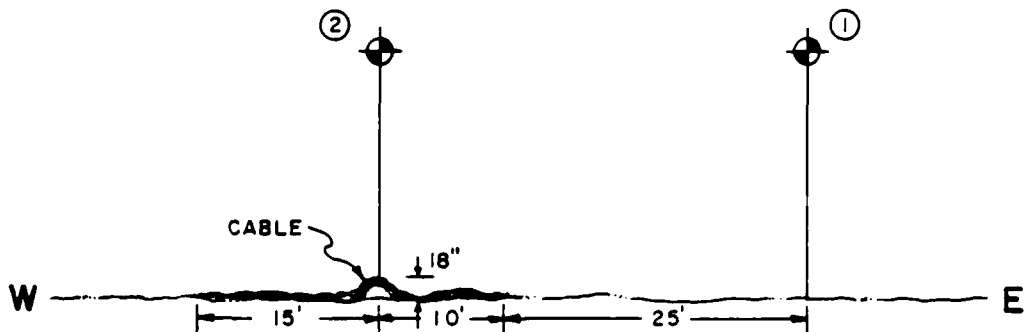
LOCATION OF OBJECT FOUND AT NH #10

Interpretation of side scan sonar records showed this target to be 5 feet by 30 feet in 26 feet of water and extending 1 foot above the bottom. Buoy 1 was dropped in 35 feet of water at the given co-ordinates and a 50-foot radial sweep was performed (see Figure 8).

The bottom was consistently flat and sandy. At 35 feet west of the pivot point, a bundle of steel cable was found. The cable is approximately 1/2-inch to 3/4-inch in diameter, with up to 12 lays bundled together, shaped like a coil lying on its side. Only the top of this coil is exposed, being 18 inches above the bottom with a least depth of -33.7 feet MLW. Buoy 2 was tied off to this point and co-ordinates were obtained from the surface. The exposed cable extends 10 feet to the east and 15 feet to the west of this high point before disappearing into the sand.

The steel cable is located 970 feet south of the line between channel buoys "25" and "23" (see Figure 1). This area is too far outside the existing channel to intimidate the ships using the channels. No dredging will occur in this area, therefore, no further investigation of this target will be necessary.

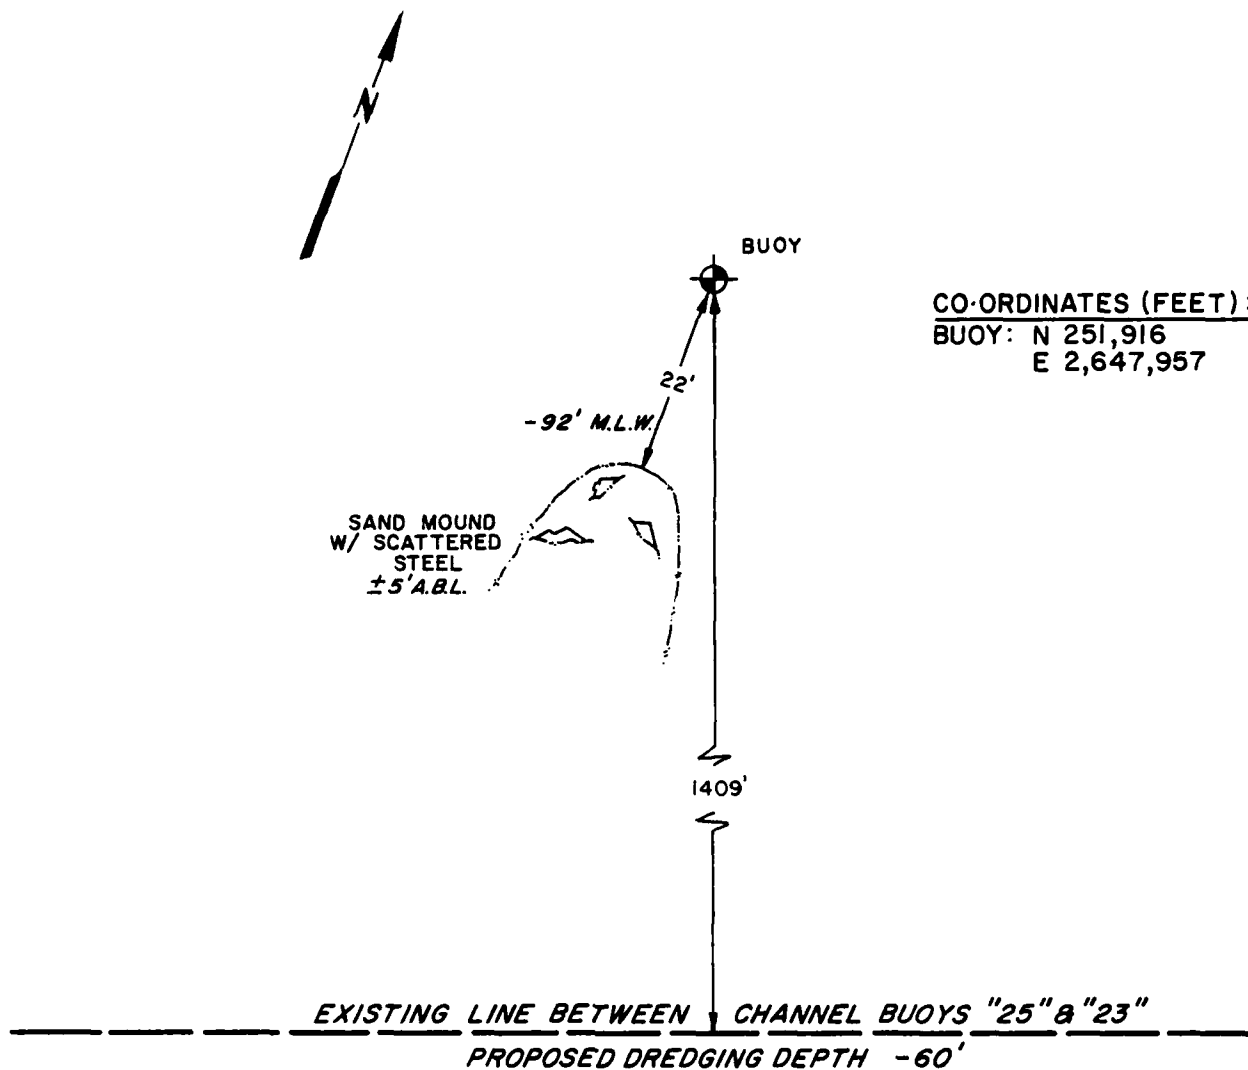
FIGURE 9
 LOCATION OF OBJECT FOUND AT NH # 11
 SCALE: 1" = 20'

Interpretation of side scan sonar records showed this target to be 70 feet by 70 feet in 65 feet of water rising 6 feet above the bottom. The actual depth of the bottom by fathometer at the given co-ordinates is -92 feet MLW. This agrees with the depths shown on the nautical chart in this area (see Figure 1).

A sweep was made of the bottom even though the depth of the water exceeded 90 feet. The north end of a large mound of sand was found 22 feet south of the buoy anchor (see Figure 9). The bottom depth at this point is -92.4 feet MLW. The sand mound rises gradually to 5 feet above the average bottom depth and levels off 40 feet south of the buoy. At this point the mound is approximately 15 feet wide. Small pieces of jagged steel plate were found extending 6 inches out of the mounded sand. The search was stopped at this point because of strong currents and lack of bottom time.

The target area is located in very deep water on the north side of the natural channel. Soundings in the vicinity of the target verified the depths. These depths were consistent and showed no local shoaling. No further investigation of this target will be necessary because of its extreme depth.

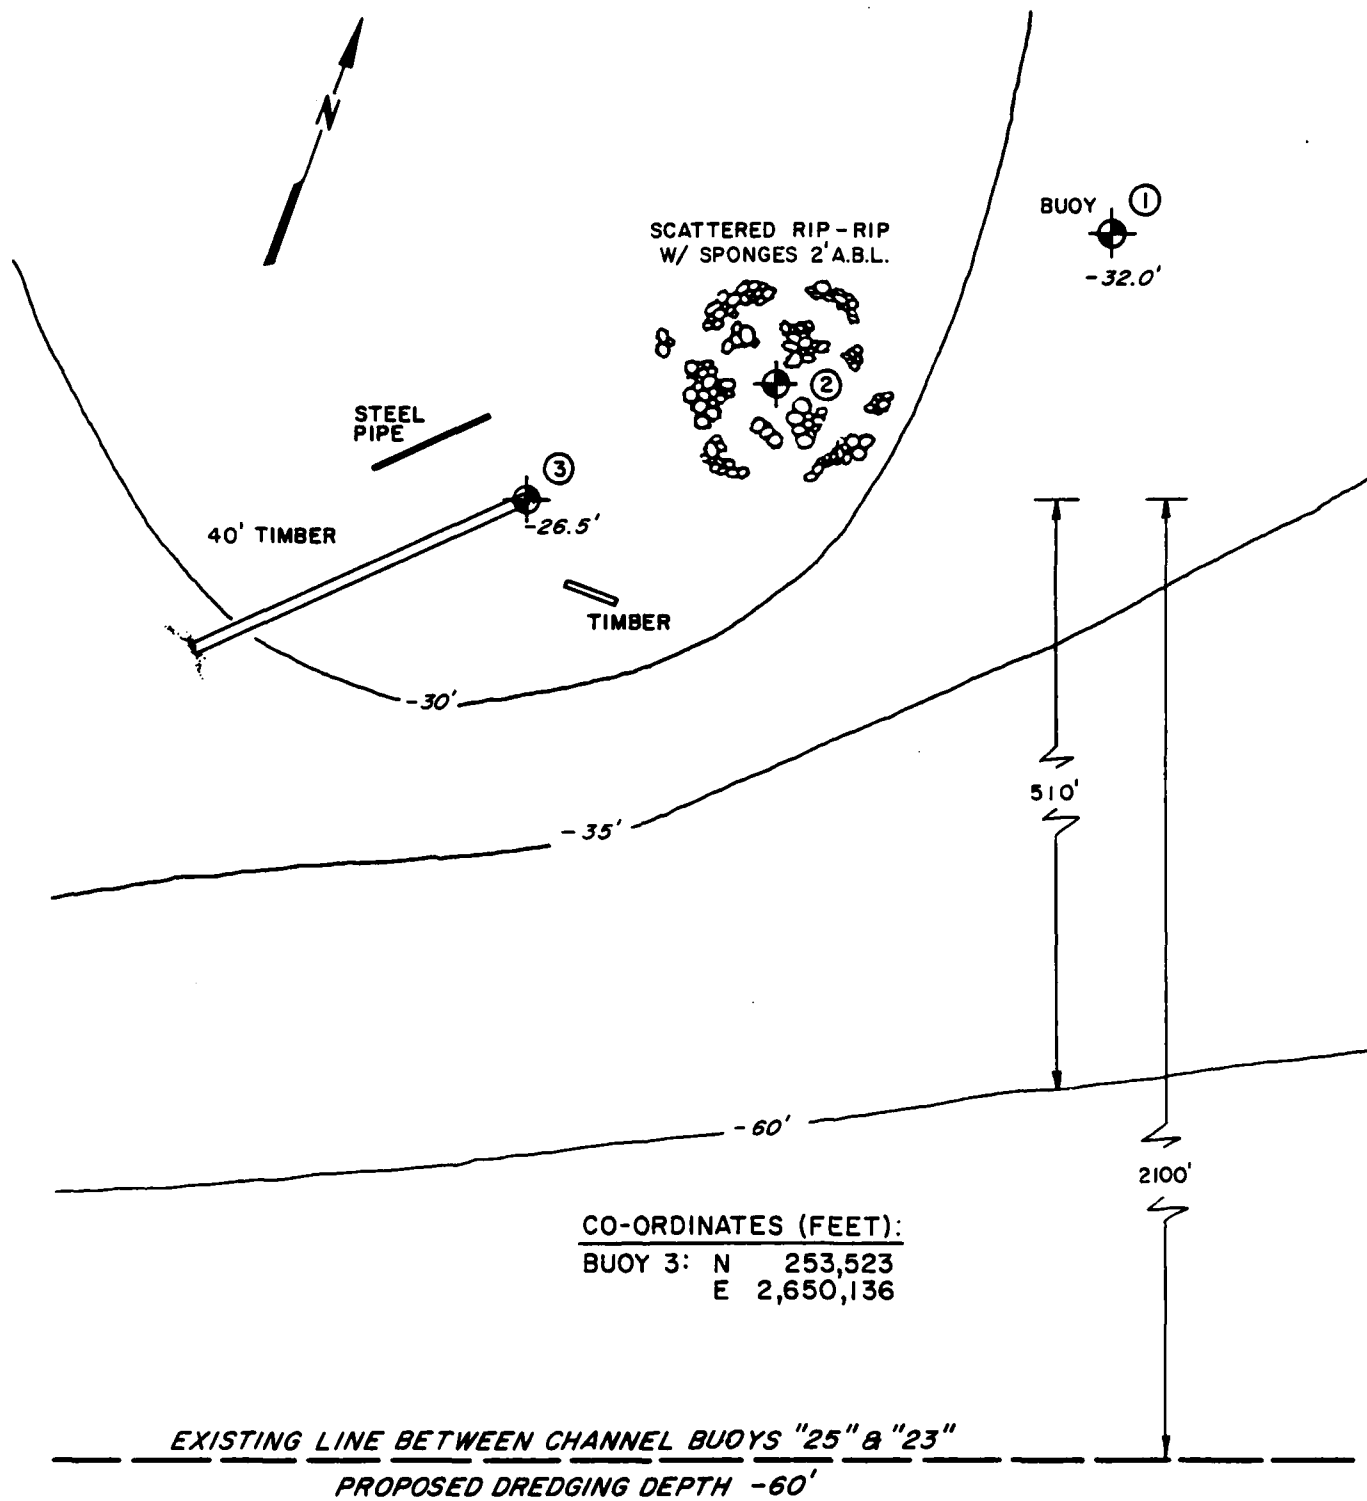
FIGURE 10
 DISTRIBUTION OF OBJECTS FOUND AT NH # 12
 SCALE: 1" = 20'

Interpretation of side scan sonar records showed an area 50 feet by 60 feet in 30 feet of water extending 2 feet above the bottom. Buoy 1 was set at the given co-ordinates and a radial search of the bottom was performed about this point. (See Figure 10).

The average bottom depth at this target is -30 feet MLW. A small group of 1 foot diameter rip-rap with sponges growing on top was found 40 feet southwest of buoy 1. The maximum height of the sponges is 2 feet above the bottom. This area was marked with buoy 2. The most significant object found was a 40-foot long, 6-inch by 12-inch timber, oriented northeast-southwest, with its southwest end disappearing into the sand. Buoy 3 was tied to the northeast end, and positioned. A least depth of -26.5 feet MLW was recorded.

This target area is located on the north side of the natural navigation channel, 510 feet north of the existing 60-foot contour. It is 2,100 feet north of the line between channel buoys "25" and "23". The total width on the natural channel at this point, with depths greater than 60 feet, is 1,350 feet. This target is already shown on the nautical chart as a 29 foot obstruction between the 30-foot and 36-foot contours (see Figure 1).

The target does not intimidate ships using the channel to Hampton Roads because the shoal water surrounding it to the south is a threat in itself. It is unlikely that dredging will occur this far north of the channel because shoal waters extending east and west would have to be removed on the outside of the turn. Therefore, no further investigation of this target will be necessary.

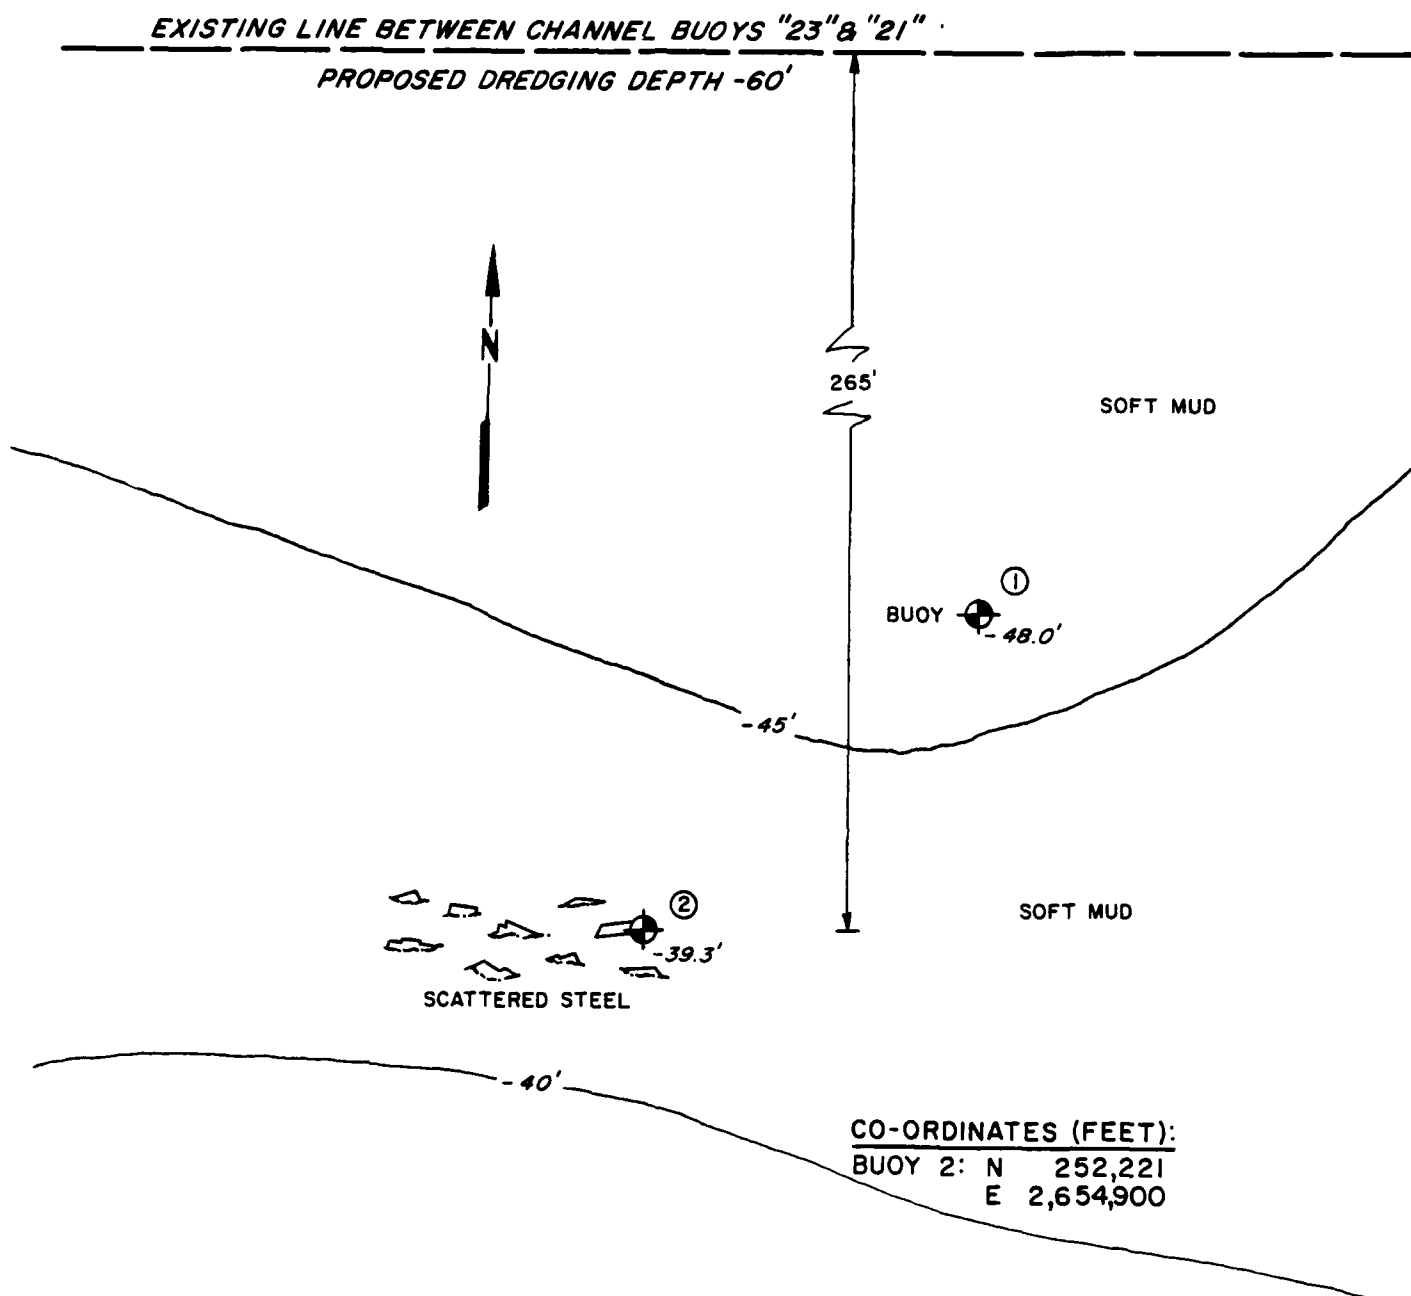
FIGURE II
 DISTRIBUTION OF OBJECTS FOUND AT NH # 14
 SCALE: 1" = 20'

Interpretation of side scan sonar records showed an area 30 feet by 50 feet in 36 feet of water, with a maximum height of 3 feet above the bottom. A 100-foot radial sweep of the bottom around buoy 1 revealed a consistent, soft, muddy bottom, with the only objects found being 50 feet to the southwest (see Figure 11).

Further investigation found 3/8-inch to 1/2-inch thick steel plates varying in size, extending out of the bottom up to 3 feet. This steel is scattered about with no uniformity, covering an area of 30 feet east-west by 10 feet north-south. Buoy 2 was attached to the largest piece of steel at the eastern edge and its least-depth was determined to be -39.3 feet MLW.

This target lies 265 feet to the south of the line between channel buoys "23" and "21", with an average bottom depth of 42 feet. A cross-section of the natural channel at this point shows only 1,000 feet of width below -60 feet MLW. It is very likely that the Thimble Shoal Channel will be extended to the west to channel buoy "23". Assuming it is dredged to -60 feet along the line between buoys "23" and "21", the top of the side-slope will be over 200 feet to the north of any steel. Therefore, this target will not intimidate any ships using the deepened port of Hampton Roads and will not require any further investigation.
