**EVALUATION OF THE EFFECTS OF A PLASTIC BEAD  
PAINT REMOVAL PROCESS ON PROPERTIES OF  
AIRCRAFT STRUCTURAL MATERIALS**

Materials Integrity Branch  
Systems Support Division

December 1985

Final Report for Period October 1984 to August 1985.

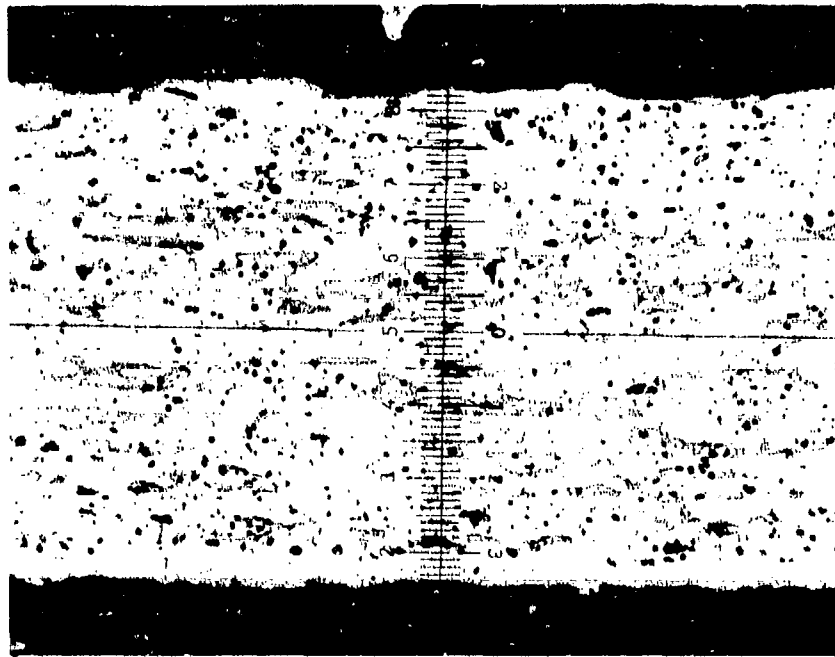
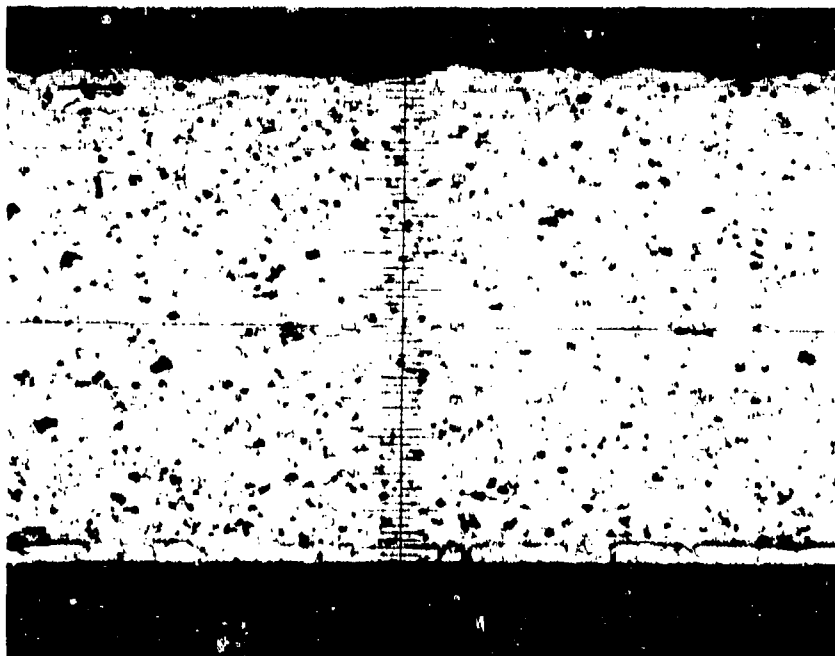
Figure 10. Alclad 7075-T6 After the First Paint Removal. (a) Specimen 17A, 38 psi nozzle pressure, (b) Specimen 13B, 60 psi nozzle pressure. MAG: 100X

several general observations were made about the effects of plastic bead paint removal. First, the cladding was severely damaged by the paint removal process. The cladding was thinned, cracked, and pitted by the paint removal process. Since the 7072 cladding is very soft, it was very easy for the paint removal process to damage the cladding. Second, the damage produced by the paint removal process was localized and nonuniform. In some areas the cladding was completely removed and in some areas it was not. This was probably due to the variability of the paint removal process. For instance, lower nozzle pressures required longer dwell times than the higher nozzle pressures to remove the same amount of paint. In so doing, the surface was exposed to plastic beads for a longer period of time and increased the likelihood of damaging the alclad. Third, although the thin skin honeycomb panels experienced four paint removal operations, systematic reductions of cladding could not be calculated. That is to say each paint removal operation did not result in a specific reduction of cladding thickness. This was partly due to the localized damage of the paint removal process and the probability of detecting the damage through metallographic analysis. In order to determine the incremental reduction of the cladding thickness for each paint removal operation, exhaustive metallographic and statistical analyses are required which were beyond the scope of this program.

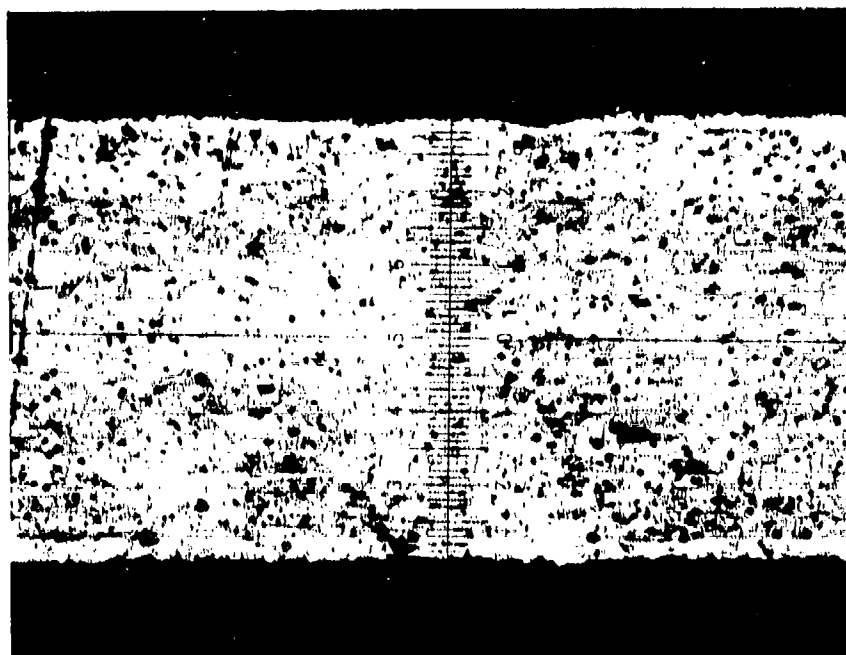
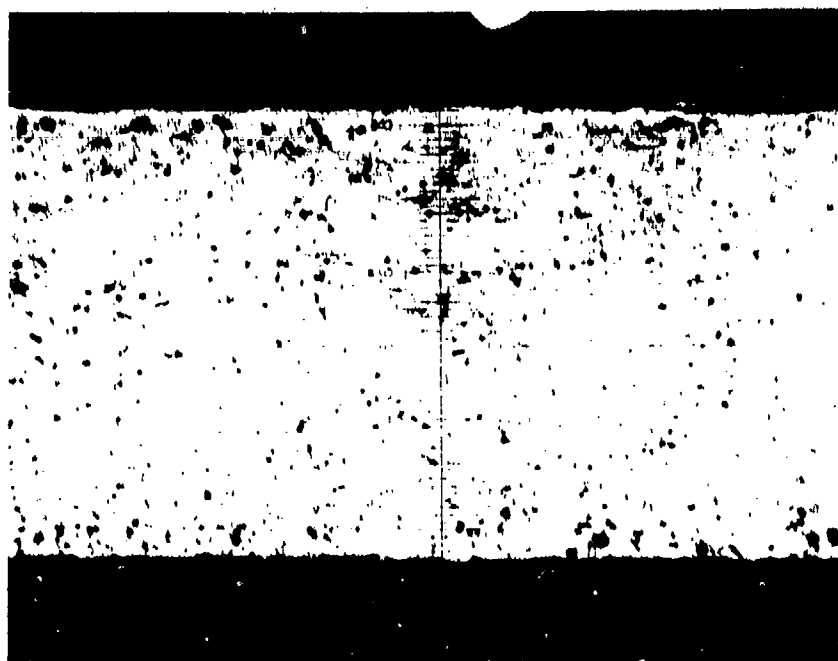
Figure 13. Alclad 7075-T6 After the Fourth Paint Removal. (a) Specimen 10A, 38 psi nozzle pressure, (b) Specimen 35A, 60 psi nozzle pressure. MAG: 160X

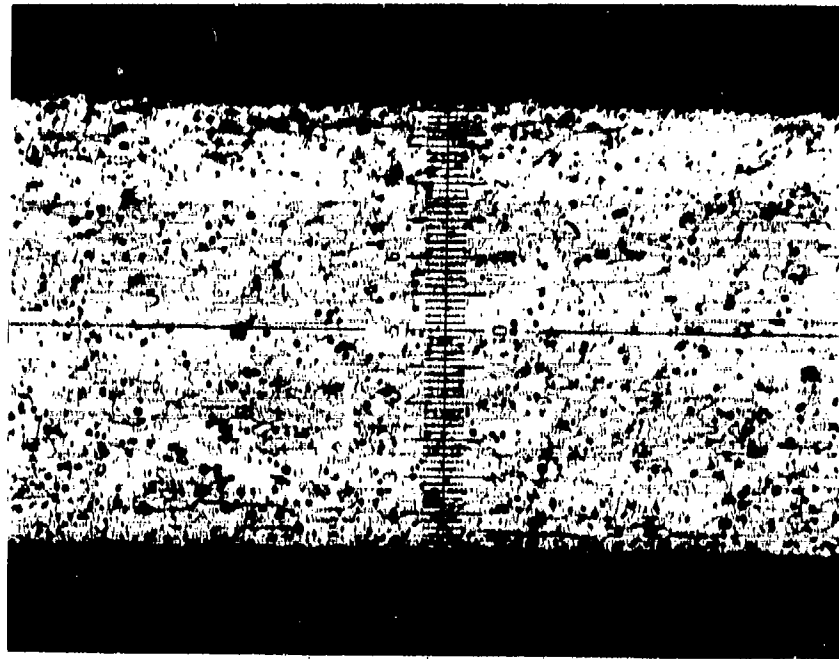
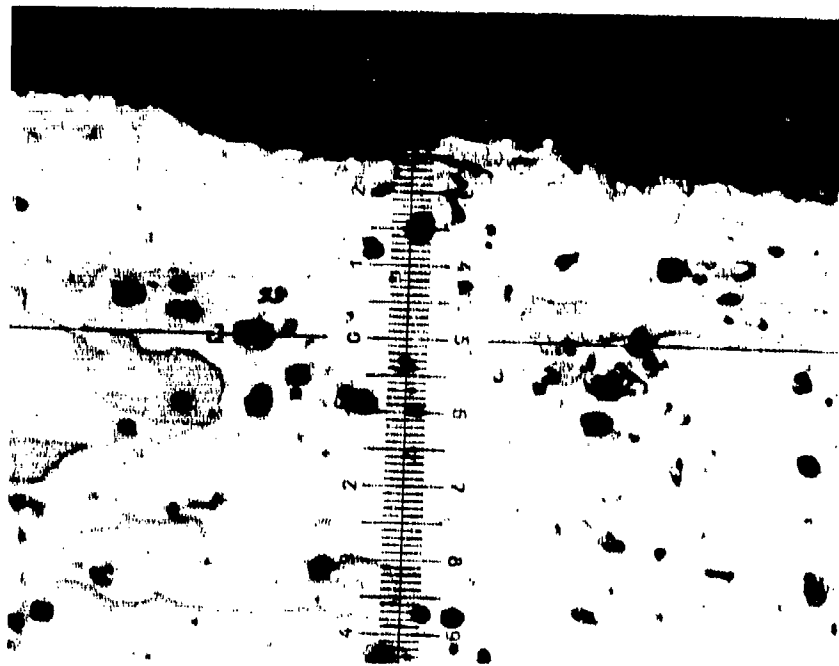
Figure 14. Alclad 7075-T6 Thin Skin Honeycomb with Five Coats of Paint After One Paint Removal at 38 psi (Specimen 36A). MAG: (a) 160X, (b) 800X

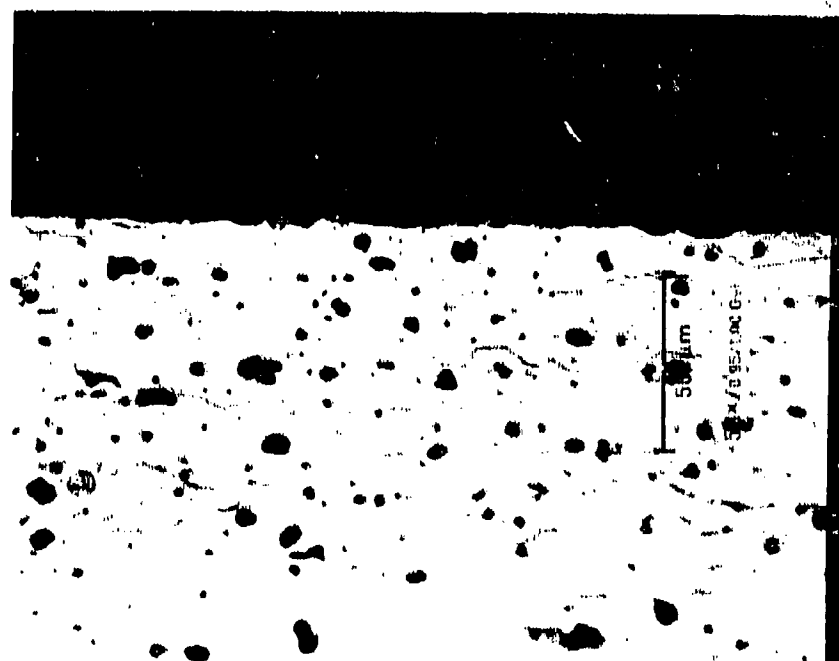
Metallographic analysis indicated that plastic bead paint removal damaged the surface of the sulfuric acid anodized 7075-T6 for either nozzle pressure (Figures 16-18). Some surface pits were detected which measured approximately 0.5 mils across and 0.08 mils deep (Figure 17). Since the unclad 7075-T6 is substantially harder than the alclad 7075-T6 surface, the unclad 7075-T6 was less susceptible to damage by plastic bead paint removal. If anything, it is believed that plastic bead blasting might improve the fatigue properties by peening, thus creating residual

Figure 18. Sulfuric Acid Anodized 7075-T6 Blasted with a Nozzle Pressure of 60 psi.  
MAG: (a) 100X, (b) 500X

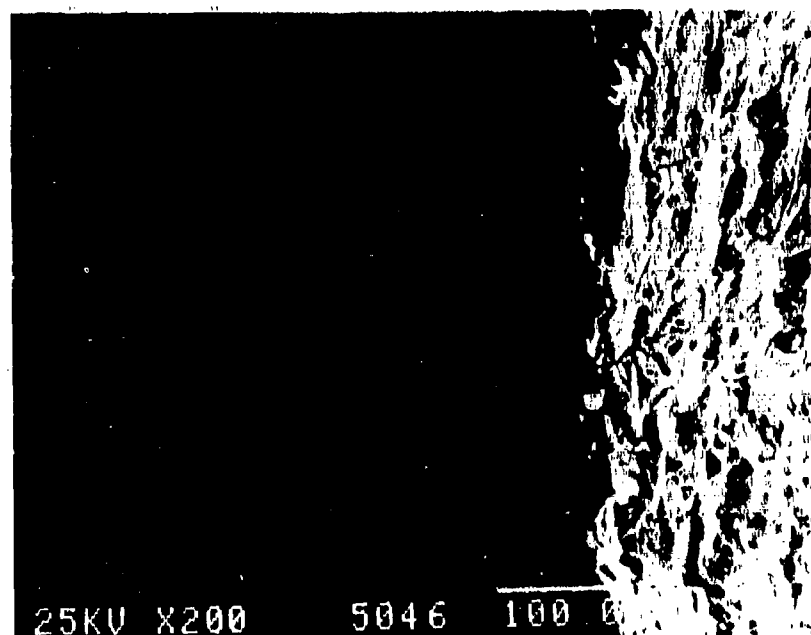
Figure 20. Oblique Fractograph of Specimen 17A; Left Side of Picture (Dark Surface) Is the Stripped Surface; Right Side (Light Surface) Is the Fracture Face. Note the fracture initiated on the stripped surface and the silica particle embedded in the initiation site. MAG: 200X

The second common feature detected by fractography was the texturing of the clad surface by the plastic bead paint removal. The left side of Figure 20 is an excellent example of this texturing. Since 7072 cladding is very soft it was either stripped off or smeared around the surface of the panel during plastic bead paint removal. This effect was confirmed by the metallographic cross sections described and depicted earlier in this report. In some cases, this texturing effect was very extensive and in other cases the effect was minimal. The most critical case for fatigue is when the texturing creates initiation sites, and for protection against corrosion the most critical case is when the blasting removes the cladding. It is important to understand the implications of damaging the cladding by plastic bead paint removal. The first implication is obvious: protection against corrosion offered by the cladding is reduced. Secondly, since the 7072 cladding is metallurgically bonded to the 7075 core, any damage to the cladding, such as pitting, scoring or cracking, can serve as crack initiation sites. Once these sites are introduced into the cladding, a crack can grow into the core material. Therefore, one could conclude that plastic bead paint removal creates surface defects in the soft 7072 cladding which serve as both crack initiation sites and coating defects.
