## **EXPLOSION DAMAGE ASSESSMENT AND STRUCTURAL INTEGRITY EVALUATION**

**MILAN ARMY AMMUNITION PLANT  
LOAD ASSEMBLY AND PACK  
BUILDING A2**

HNDTR 85-70-SD-SE  
OCTOBER 1985

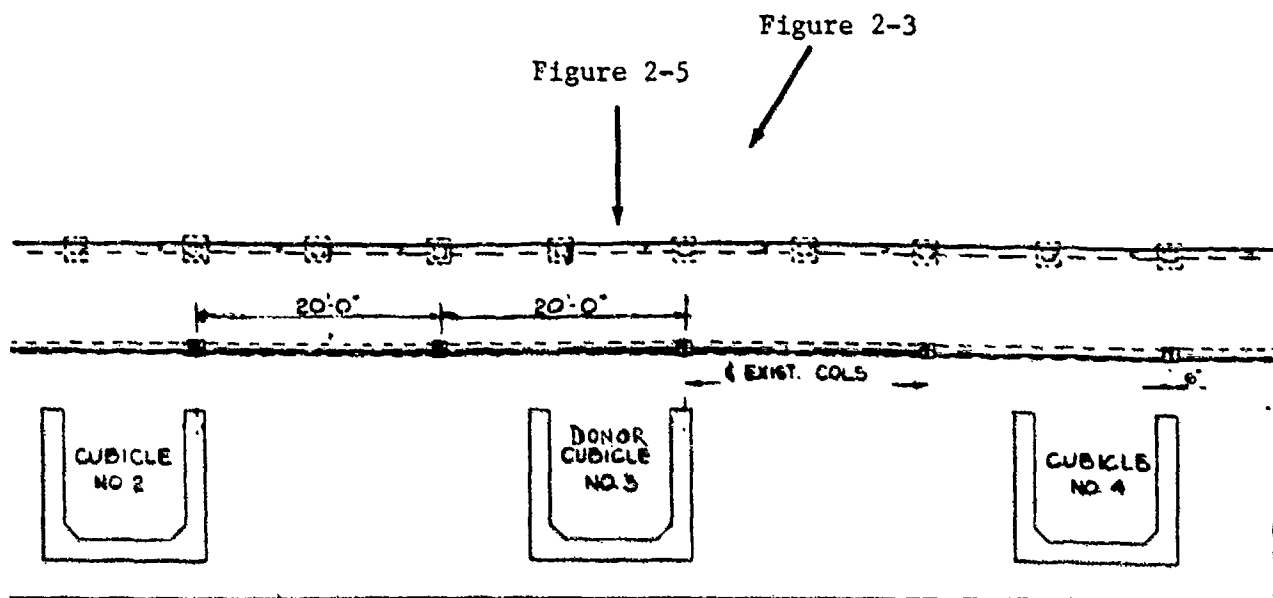
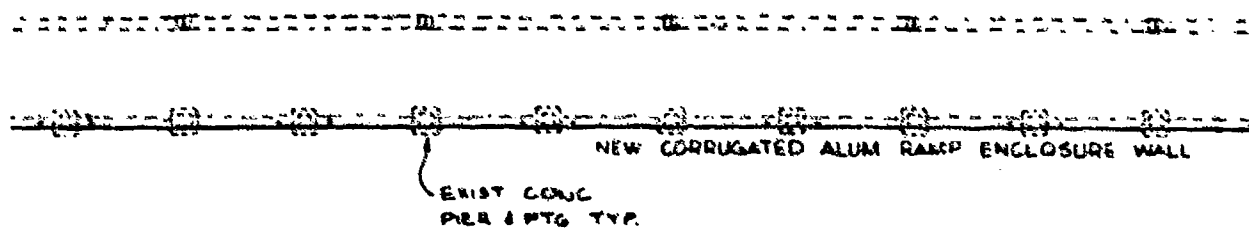
Figure 2-1. Plan View of a Portion of Building A2

A detailed inspection of the overall condition of Building A2 was performed within a few days of the incident. The results of this inspection were favorable to a relatively simple replacement of roofing and siding. Figure 2-1 presents a plan view of a portion of the A2 building showing the area where the donor cubicle was located and designates the direction in which photographs presented as figures 2-2 through 2-5 were taken. (Figures are compiled at the end of chapter 2.) As can be shown in the pictures, the building damage was essentially limited to wall cladding and roof decking. The wall cladding on the east side of the ramp was intended to be a frangible or blowout-type wall designed to fail quickly and vent the shock and gas pressures from the adjacent cubicles. Figure 2-3 clearly shows large sections of the lightweight frangible aluminum ramp wall panels which performed as intended. The bulk of the remaining damage was the failure of the brittle transite roof decking material. The extent of this damage is exemplified in figures 2-2 through 2-4. This material is very brittle and tends to break up into relatively small pieces under low overpressures. It should be noted that the the roofing on the right side of figure 2-4 had already been removed by repair crews and does not represent damage from the incident. The only damage to structural load-carrying members involved two roof deck support beams directly in front of the donor cubicle. These members were twisted sufficiently that replacement was justified. With the exception of these members, the structural framing system was in excellent condition and immediately capable of accommodating the new wall and roof decking materials.

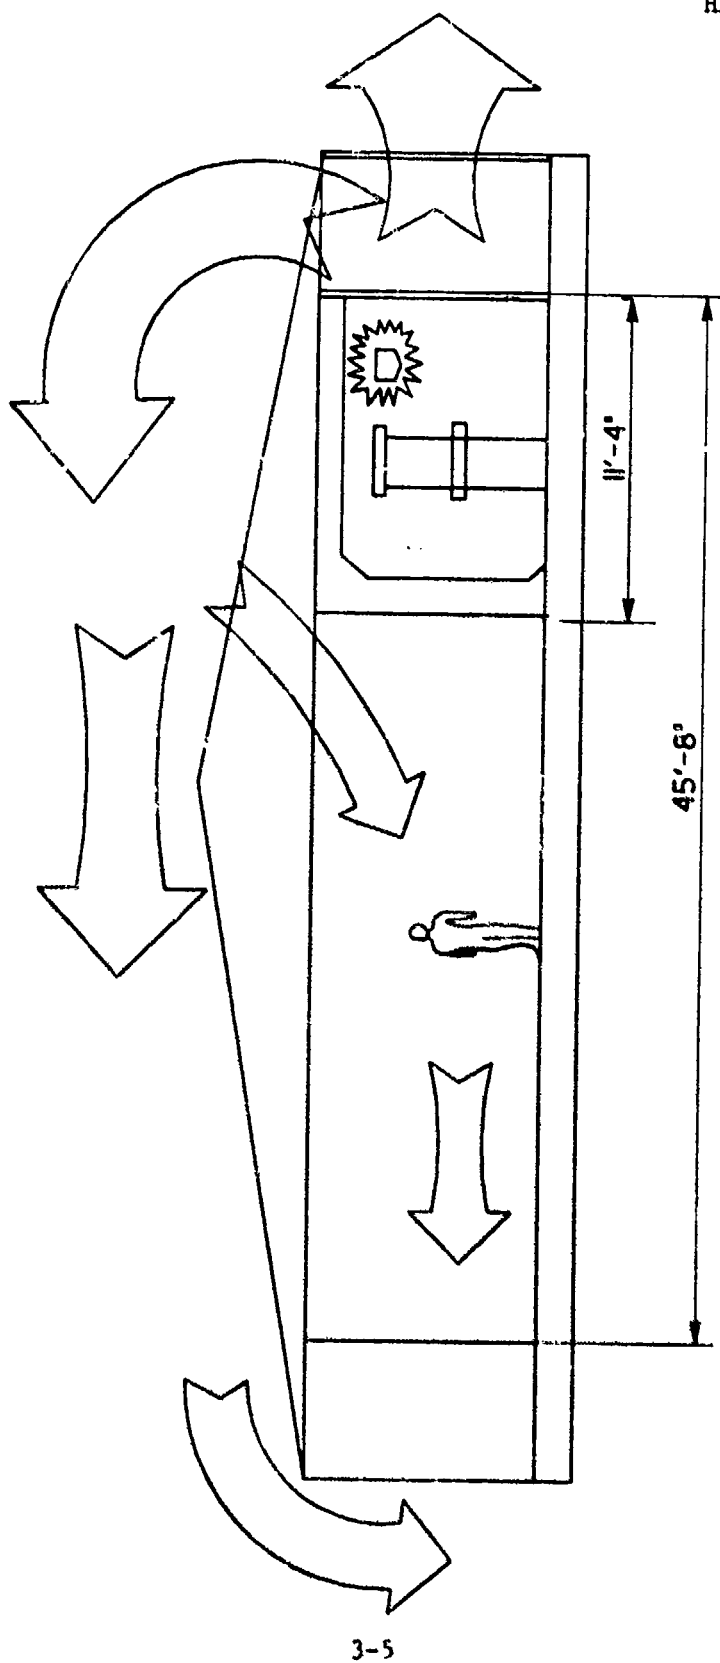
Figure 3-1. Milan Line A Donor Cubicle Overpressures

b. The analysis procedure provides for a modification of the scale distance from a donor charge in a cubicle to a receiver. The method accounts for the effect of the cubicle walls and roof in increasing the effective distance from the donor to the receiver. The location of the feed hopper in the cubicle is such that there is some question as to whether the donor charge should be considered a free airburst or a surface burst, the latter being fully reflected. Because of this question, both situations are considered, and estimated overpressures calculated for each. Airblast parameters for the two cases are given in figures 4-5 and 4-12, respectively, of reference 1. Tables 3-1 and 3-2 show the geometric data and resulting airblast parameters for the estimated overpressures on the roof and at an elevation of 5 feet above the floor (for effects on a standing adult). (Tables and figures are compiled at the end of chapter 3 in the order they are mentioned.) Figure 3-1 presents the same results, as expected--upper and lower bounds of overpressure for the roof and the interior of the building, respectively. Figure 3-2 shows the idealized path of the blast wave over the building. There is another path which must also be considered and it is shown in figure 3-3. The results of this load path were found to be no more severe than those of figure 3-1 and are therefore not further considered.

is a slightly longer span it would be expected to fail at a slightly lower load. Predicting the decking failure load at Milan to be approximately 4.5 psi, the information in figure 3-1 suggests that the roof deck within about thirty feet of the cubicle would probably fail. This is consistent with observed damage as shown in figures 2-2 through 2-4.

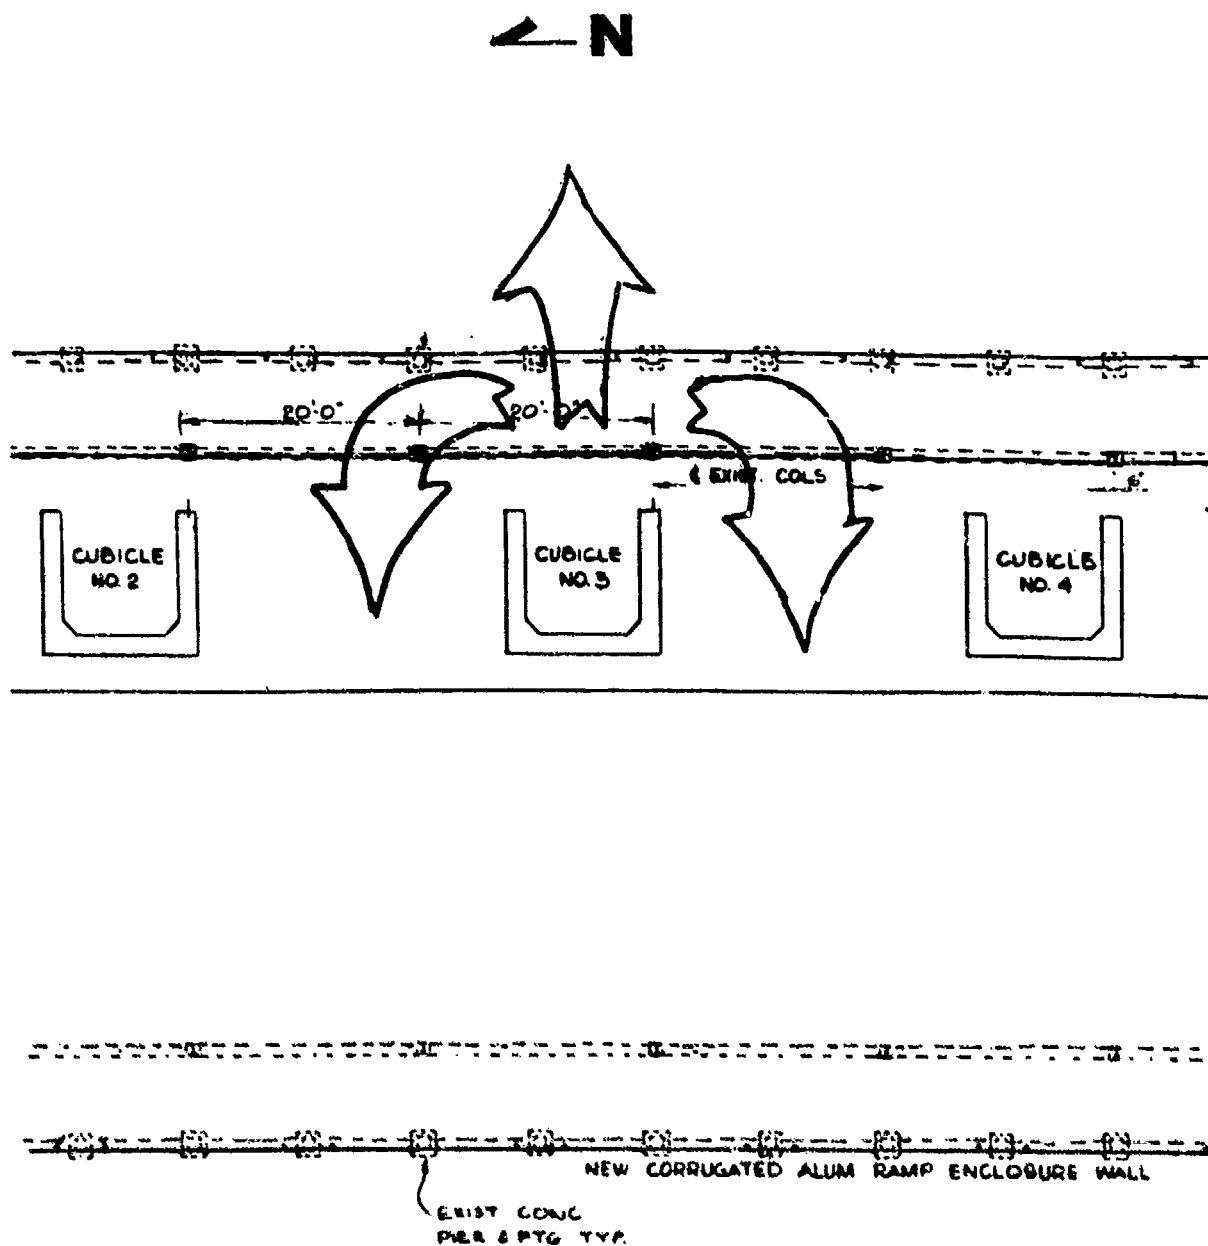
Figure 3-2. Milan Line A Donor Cubicle Blast Path

The environment inside the donor cubicle is also calculated on the information in reference 1. The cubicle has one entire wall open to the adjacent service ramp. The ramp was designed with a frangible exterior wall. As a consequence, gas pressure is not a consideration and only shock pressures are considered. The estimated airblast environment within the cubicle is presented in table 3-3. The information shown is similar to the same data in reference 3 for a similar magnitude donor. The information from this chapter is used in chapter 4 to assess the structural integrity of the cubicle for reuse.
