NAVAL AIR STATION  
ALAMEDA, CALIFORNIA  
FPO-1-82(20)

**UNDERWATER FACILITIES  
INSPECTIONS  
AND  
ASSESSMENTS  
AT**

**NAVAL AIR STATION  
ALAMEDA, CALIFORNIA**

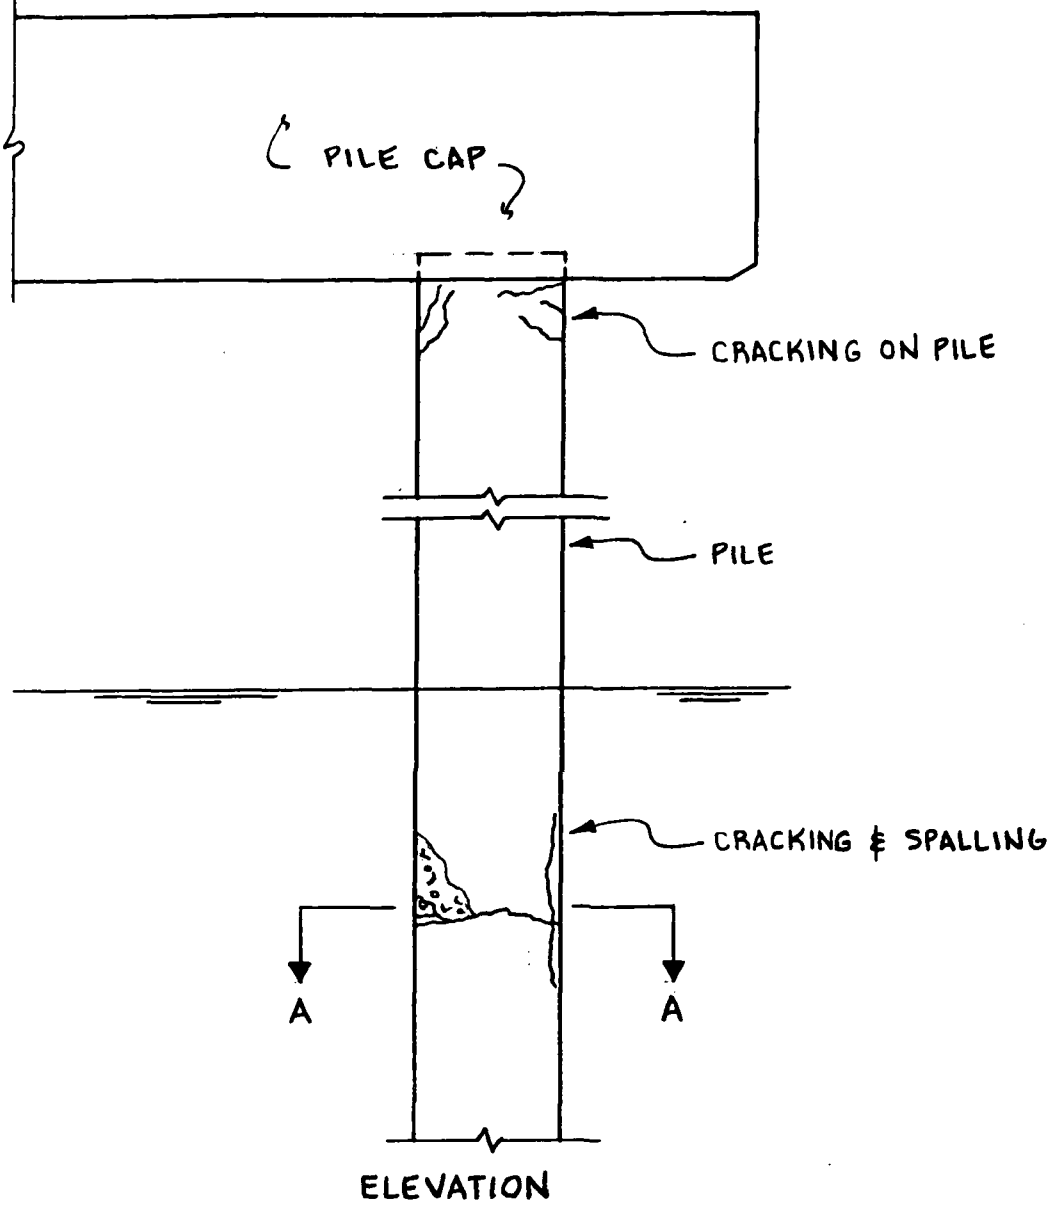
GRAPHIC SCALE	CHILDS ENGINEERING CORPORATION BOX 333 MEDFIELD, MA	CHESAPEAKE DIVISION NAVAL FACILITIES ENGINEERING COMMAND WASHINGTON, D.C.	
NA		NAVAL AIR STATION ALAMEDA, CA <b>PILE CONDITION</b>	FIG. NO. <b>4</b>

- o Piles cracked and broken with rebar still intact  
(see Figure 4).

SEVERE DAMAGE

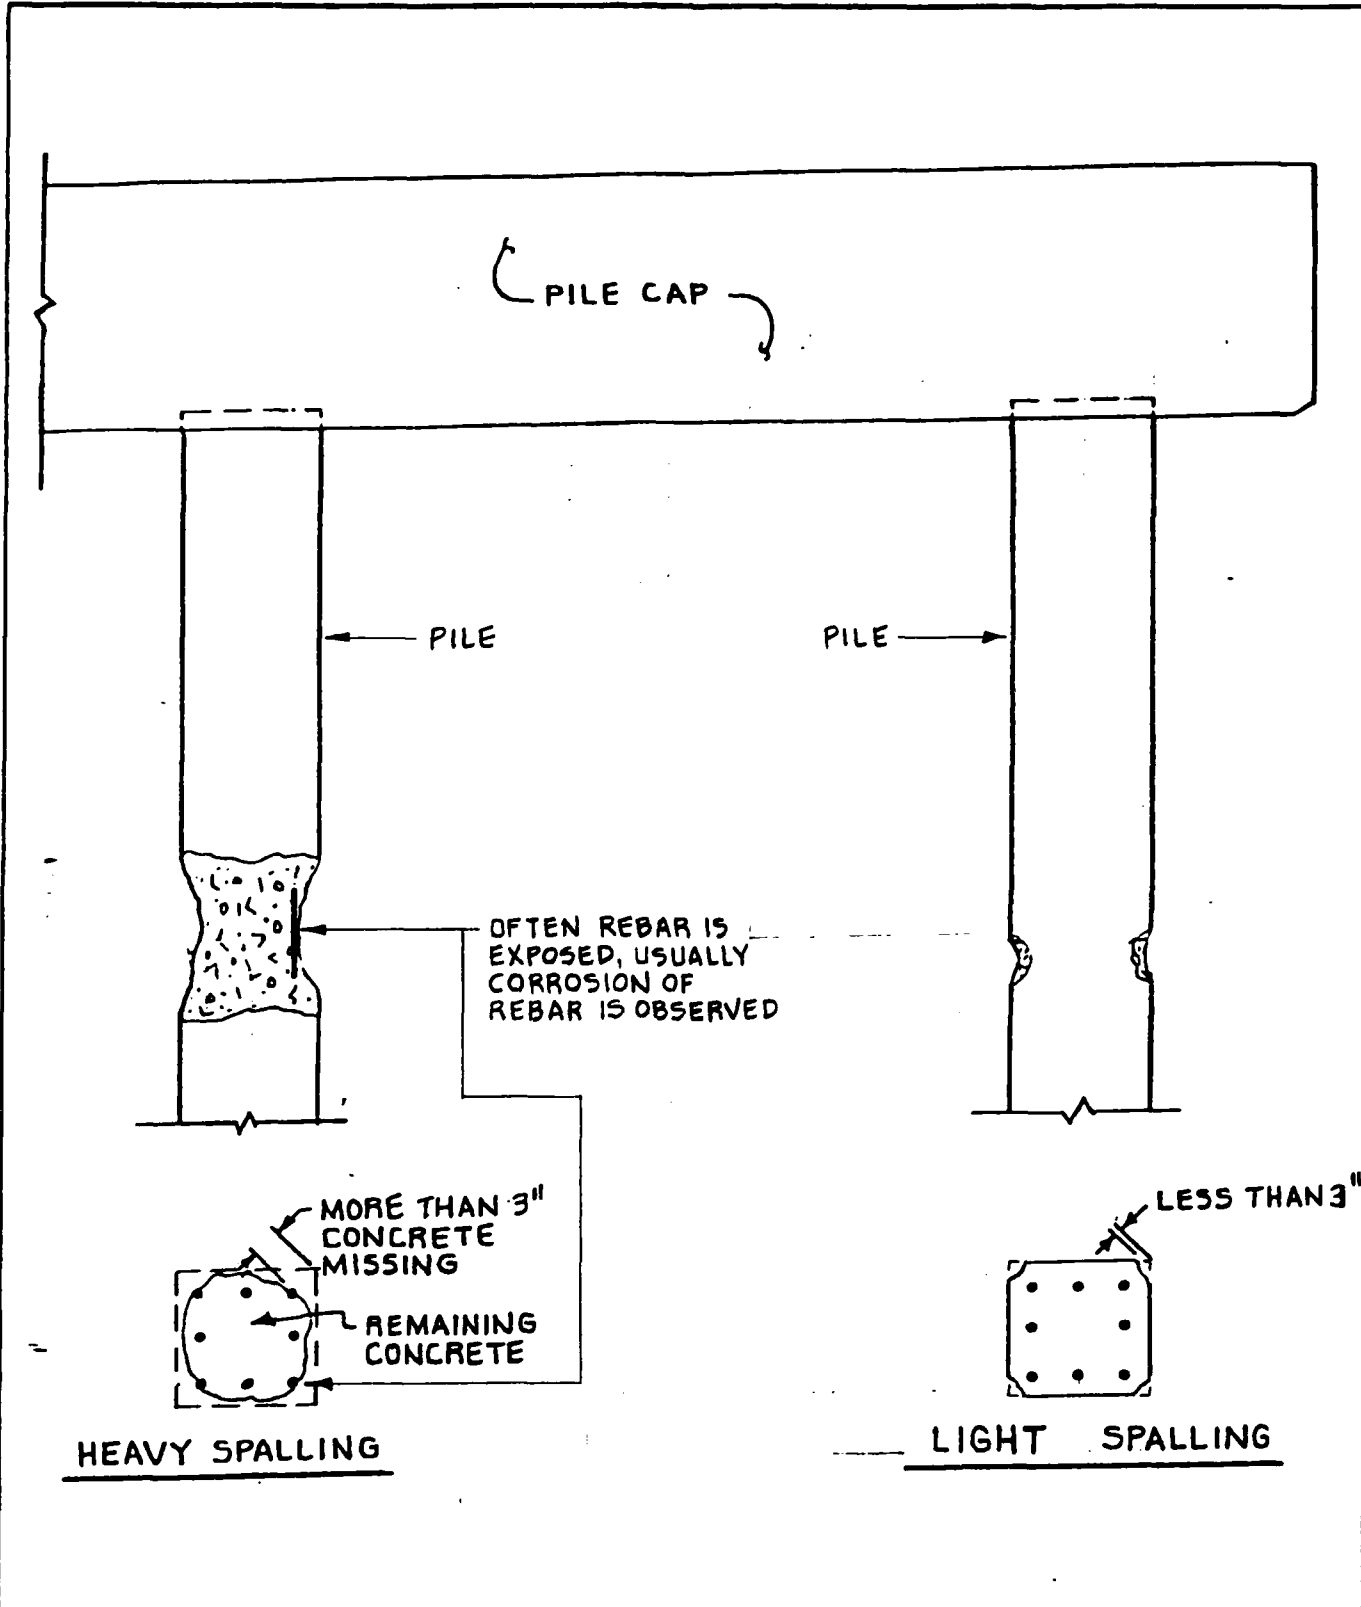
GRAPHIC SCALE	CHILDS ENGINEERING CORPORATION BOX 223 MEDFIELD, MA	CHESAPEAKE DIVISION NAVAL FACILITIES ENGINEERING COMMAND WASHINGTON, D.C.	
		NAVAL AIR STATION ALAMEDA, CA	FIG. NO. 5
NA		PILE CONDITION

A condition where the concrete has spalled to a point where the cross sectional area of the remaining pile has marginal capabilities to support its designed load is noted as heavy spalling (see Figure 5). In many cases of heavy spalling, rebar is exposed to the water and has experienced corrosion.

Spalling that does not immediately threaten the structural integrity of the pile was noted as light (see Figure 5).
