UNDERWATER FACILITIES INSPECTIONS & ASSESSMENTS

HIGH POINT PIER

ANTIGUA, W.I.

NOVEMBER 1982

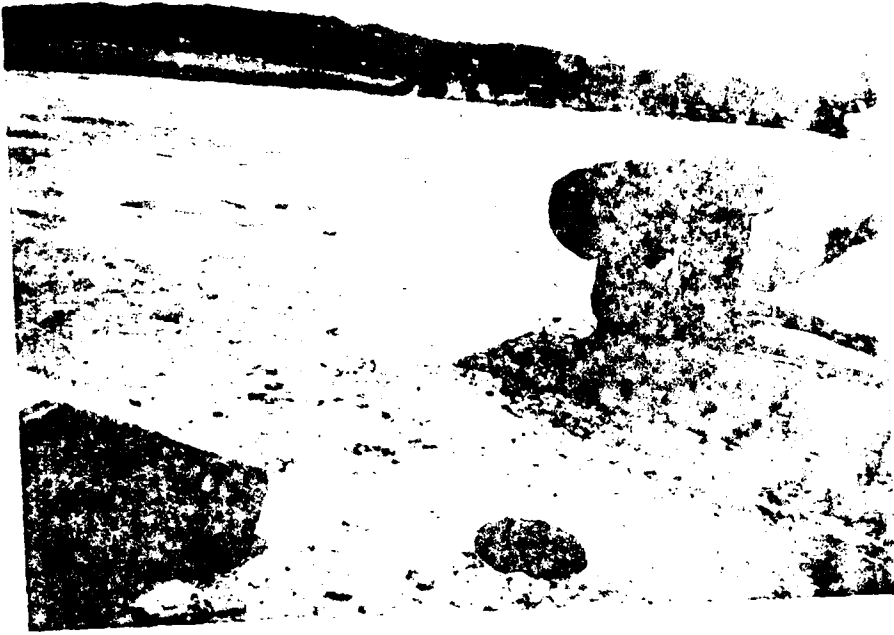
FIGURE 3-1
FROM DECK LEVEL

The decking and mooring fittings of the offshore portion of the High Point Pier are in extremely poor condition as can be seen in the photograph, Figure 3-1. Although there were no drawings available, it appears that at one time a utility tunnel ran part way out along the south edge of the deck. The pier edge is reasonably intact along most of the offshore portion periphery, Figure 3-2, but, in way of the tunnel, the deck has collapsed as shown in Figure 3-3.

The decking of the offshore portion of the pier appears to be structurally capable of performing its intended function. However, the deterioration that has begun will continue unless repairs are undertaken which will both prevent further deterioration and improve considerably the utility and appearance of the pier. It is suggested that the collapsed portions of the deck be removed and that the utility tunnels, which apparently are not required, be filled with aggregate. Furthermore, it is suggested that the entire offshore portion of the pier be covered with a 4-inch layer of reinforced concrete extending 6 inches outboard of the existing 52 by 235 foot deck on the north, east, and south sides of the pier. Poured at the same time should be a 6-inch wide by 4-foot deep facing of reinforced concrete which would extend down to the bottom level of the existing stringers. The reinforcing for this facing should be securely attached to the existing face and the forms should extend beneath the existing deck so as to pour replacements for missing stringers along the north and south faces.

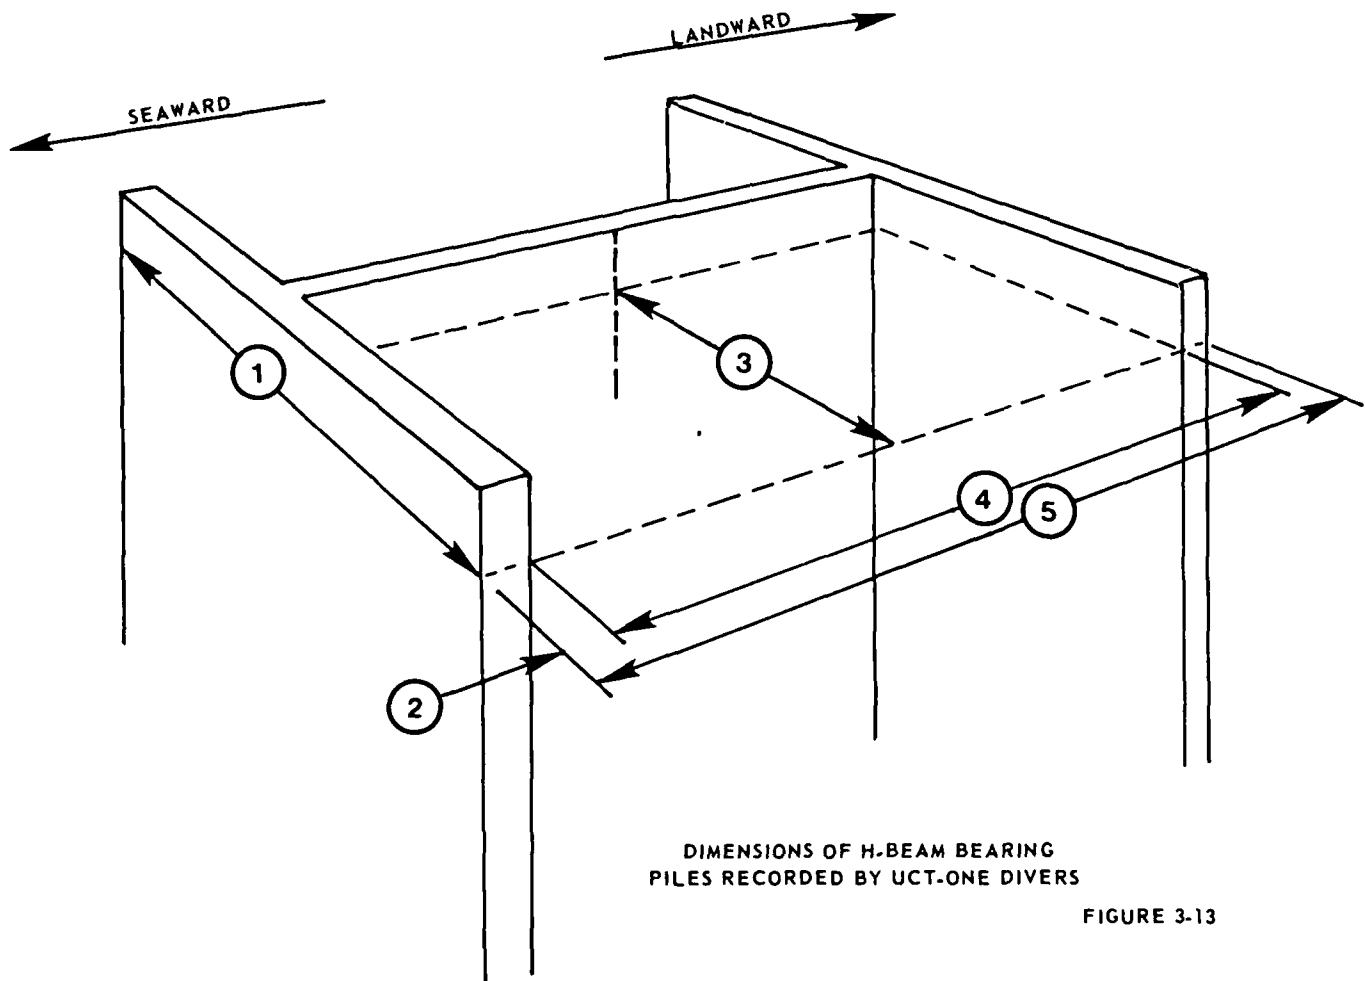
FIGURE 3-13

The measurements on the H-beams were made and recorded in accordance with those diagrammed in Figure 3-13. The H-bearing piles can be identified

by their dimensions as AISC* BP 12 H-beams which have flange and web thicknesses of 0.607 inches and a weight of 74 pounds per foot. These beams are sometimes identified as HP 12 x 74. The piles selected for Level II measurement are identified by the solid squares in Figure 2-6.

Except for the two piles that were missing, the steel supports for the High Point Pier were found to be in surprisingly good condition. There was some pitting and a few H-beam flanges had corroded down to a knife-edge condition but, generally speaking, the loss of material from corrosion was less than might have been anticipated.
