HOLY LOCH  
FLEET MOORINGS  
INSPECTION REPORT

FPO-1-82(22)

# **HOLY LOCH FLEET MOORINGS INSPECTION REPORT**

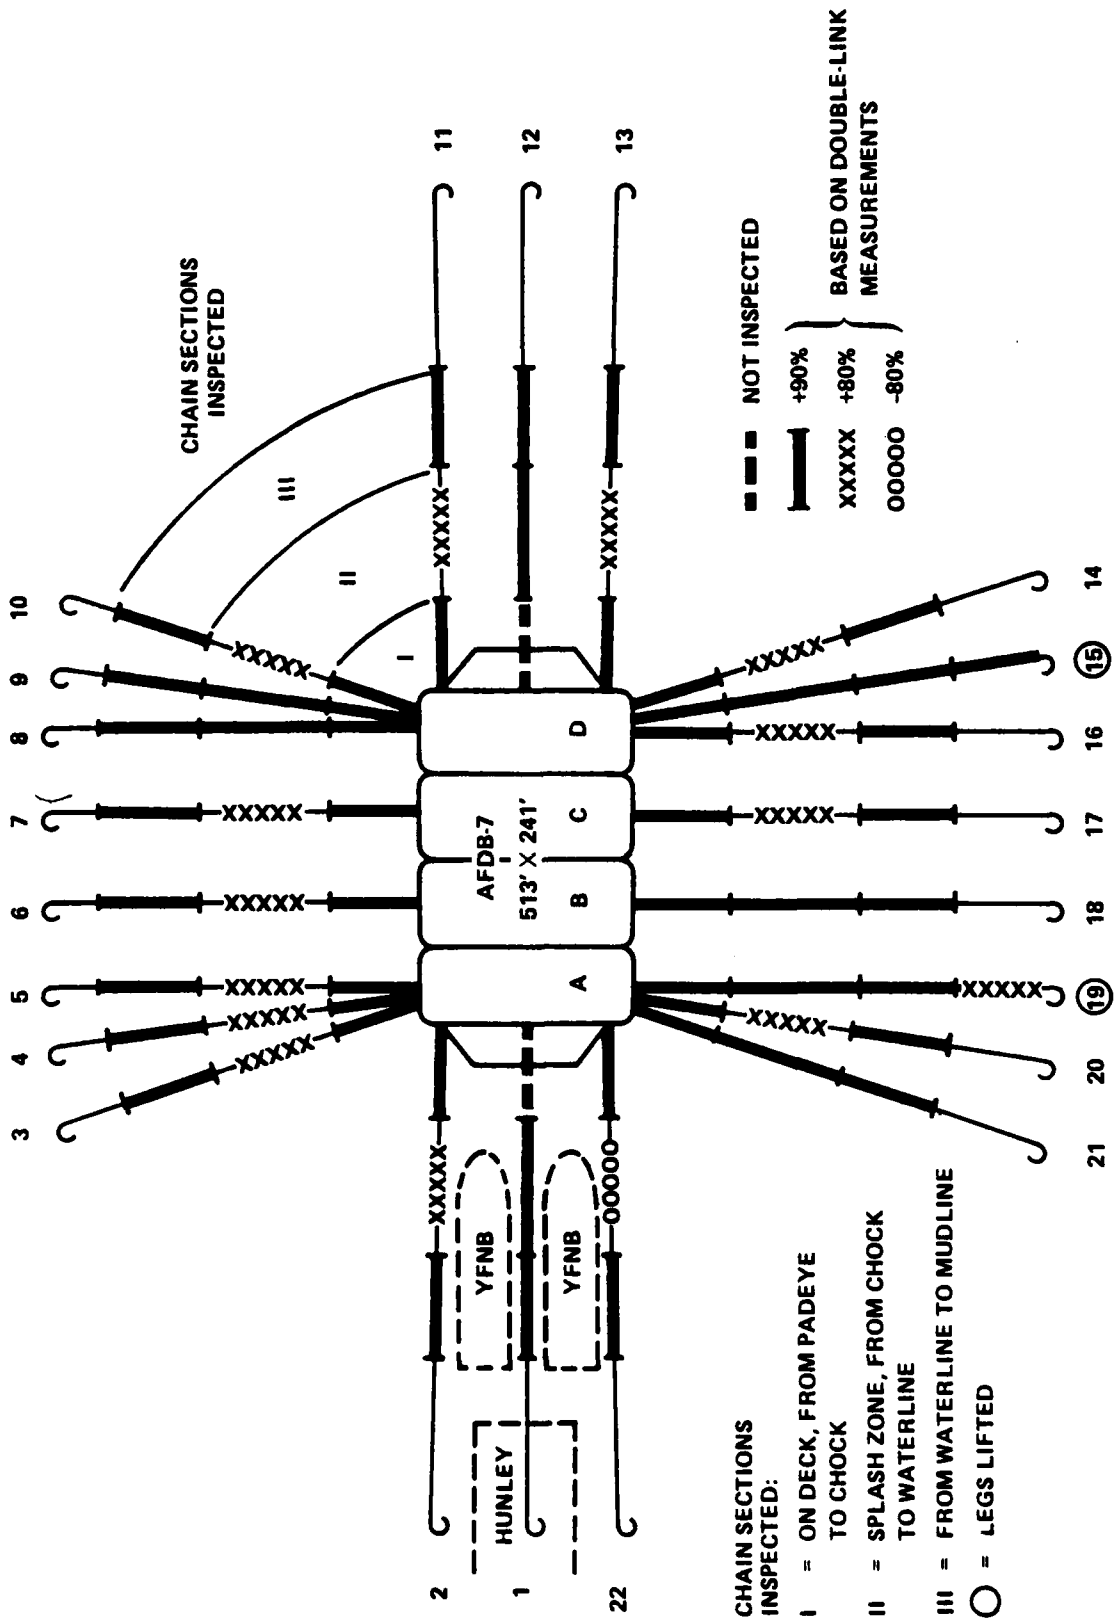
Figure 5. Summary of Ground Leg Chain Measurements

- No broken links or hardware were found; 27% (6 of 22) legs were +90% of original 3" chain wire diameter over the entire inspected length (to mudline); 68% (15 of 22) were +80% at some point along their length; one leg (#22) was -80% in Section II. All but one of the +80% or lower measurements occurred in Section II, the splash zone (see Figure 5). Leg #18 had no on-deck stopper (pelican hook).

- The chain in Section II of Leg #22 which measured less than 80% of original wire diameter must be replaced as soon as possible.
- An engineering analysis of AFDB-7 mooring design should be conducted in order to define the optimum catenary of each leg; pending results of such an analysis, a number of legs should be repositioned to tighten the catenary prior to the 82 - 83 winter season.

**4.1 AFDB-7.** The fact that over 70% of the ground legs had measurements of less than 90% of original wire diameter at some point along their length indicates that the mooring may be in need of overhaul. It is recommended that at least the first two shots of chain in each leg be replaced with new chain, unless a thorough engineering analysis indicates that fewer legs are required. Some legs may require additional new chain depending on the specific location and extent of the wear zone. A cost estimate for new chain and associated hardware is presented in Annex D. Pending results of the analysis to specify the mooring requirements of AFDB-7, it is recommended that only the segment of Leg #22 previously identified be replaced immediately.

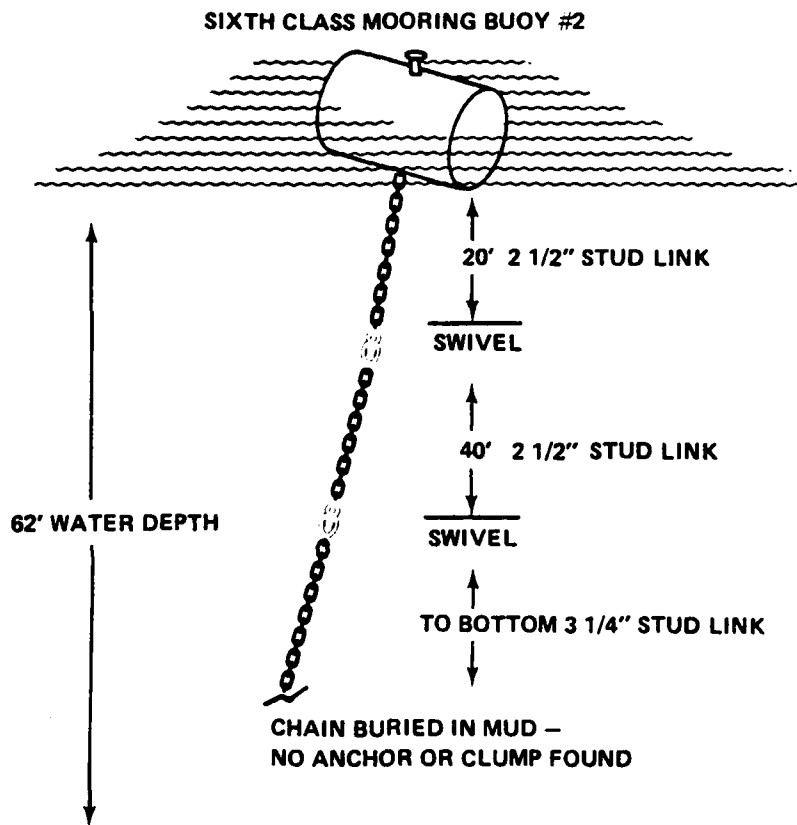
**Figure 8. Sixth Class Mooring #2, Schematic**

**3.2.1 Findings.** The two moorings inspected are in generally good-to-excellent condition. Inspection of the buoys revealed no holes, dents, or pitting, and only medium marine growth was observed. The riser chain was in good condition, with all measurements +90%. Neither of the two anchors was observed. The riser of mooring #2 contained two swivels, while there was no swivel observed in the riser of mooring #3.

ITEM	SIZE	LOCATION OF MEASUREMENT	CONDITION (note)			REMARKS
			+90%	+80%	UNK	
Buoy, Cylindrical, 3rd Class	10' long 6' diam.	-----	-	-	-	British 3rd class buoy; excellent condition; no holes, dents, or pitting; medium marine growth(1/2")
Mooring Ring	UNK.	not measured			XXX	Divers unable to reach buoy topside; condition assumed sat.
Buoy Shackle	Unk.	not measured			XXX	Inside buoy - divers unable to measure
Riser Chain, studlink	2 1/2"	20' depth	XX D			
Swivel	UNK.	not measured	-	-	-	Located at 20' depth; condition assumed satisfactory
Riser Chain, studlink	2 1/2"	60' depth	XX D			
Swivel	UNK.	not measured	-	-	-	Located at 60' depth; condition assumed satisfactory
Riser chain, studlink	3 1/4"	72' depth	XX D			
Anchor swivel and Anchor	UNK	-----	-	-	XXX	Not located - chain buried
<b>SUMMARY:</b> Mooring is in good-to-excellent condition.						
Note 1: S = Single Link Measurement; D = Double Link Measurement

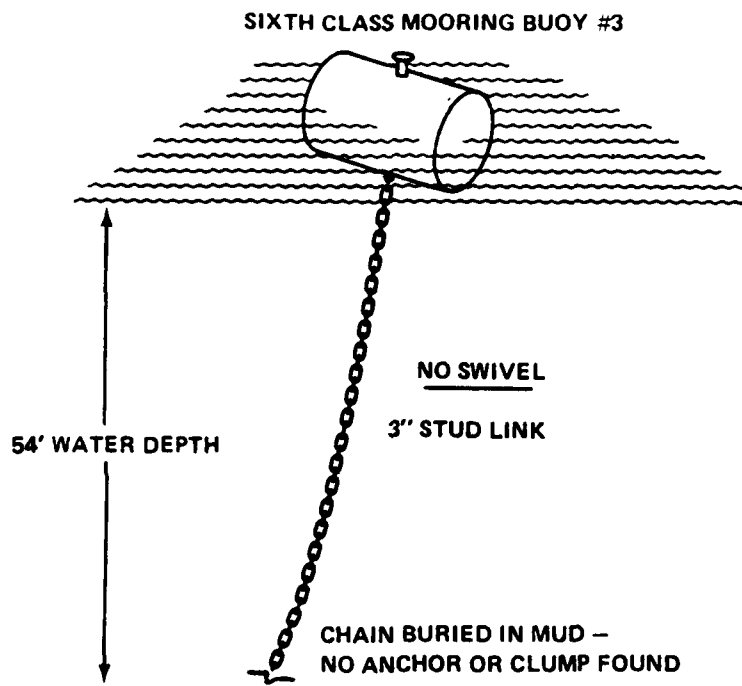
Figure 9. Sixth Class Mooring #3, Schematic

ITEM	SIZE	LOCATION OF MEASUREMENT	CONDITION (note)			REMARKS
			+90%	+80%	UNK	
Buoy, Cylindrical, 3rd Class	10' long 5' diam.	----	-	-	-	British 3rd Class Buoy; excellent condition - no holes, dents, or pitting
Mooring Ring	UNK	not measured	-	-	-	Divers unable to reach buoy topside
Buoy Shackle	UNK	not measured	-	-	-	Inside buoy - divers unable to measure
Riser Chain, studlink	3"	5' depth	XX D			
" "	3"	35' depth	XX D			
" "	3"	65' depth	XX D			
Swivel	UNK	not measured	-	-	XXX	Not located
Anchor Shackle and Anchor	UNK	-----			XXX	Not located - chain buried
<b>SUMMARY:</b> Mooring is in good-to-excellent condition.						
Note 1: S = Single Link Measurement; D = Double Link Measurement

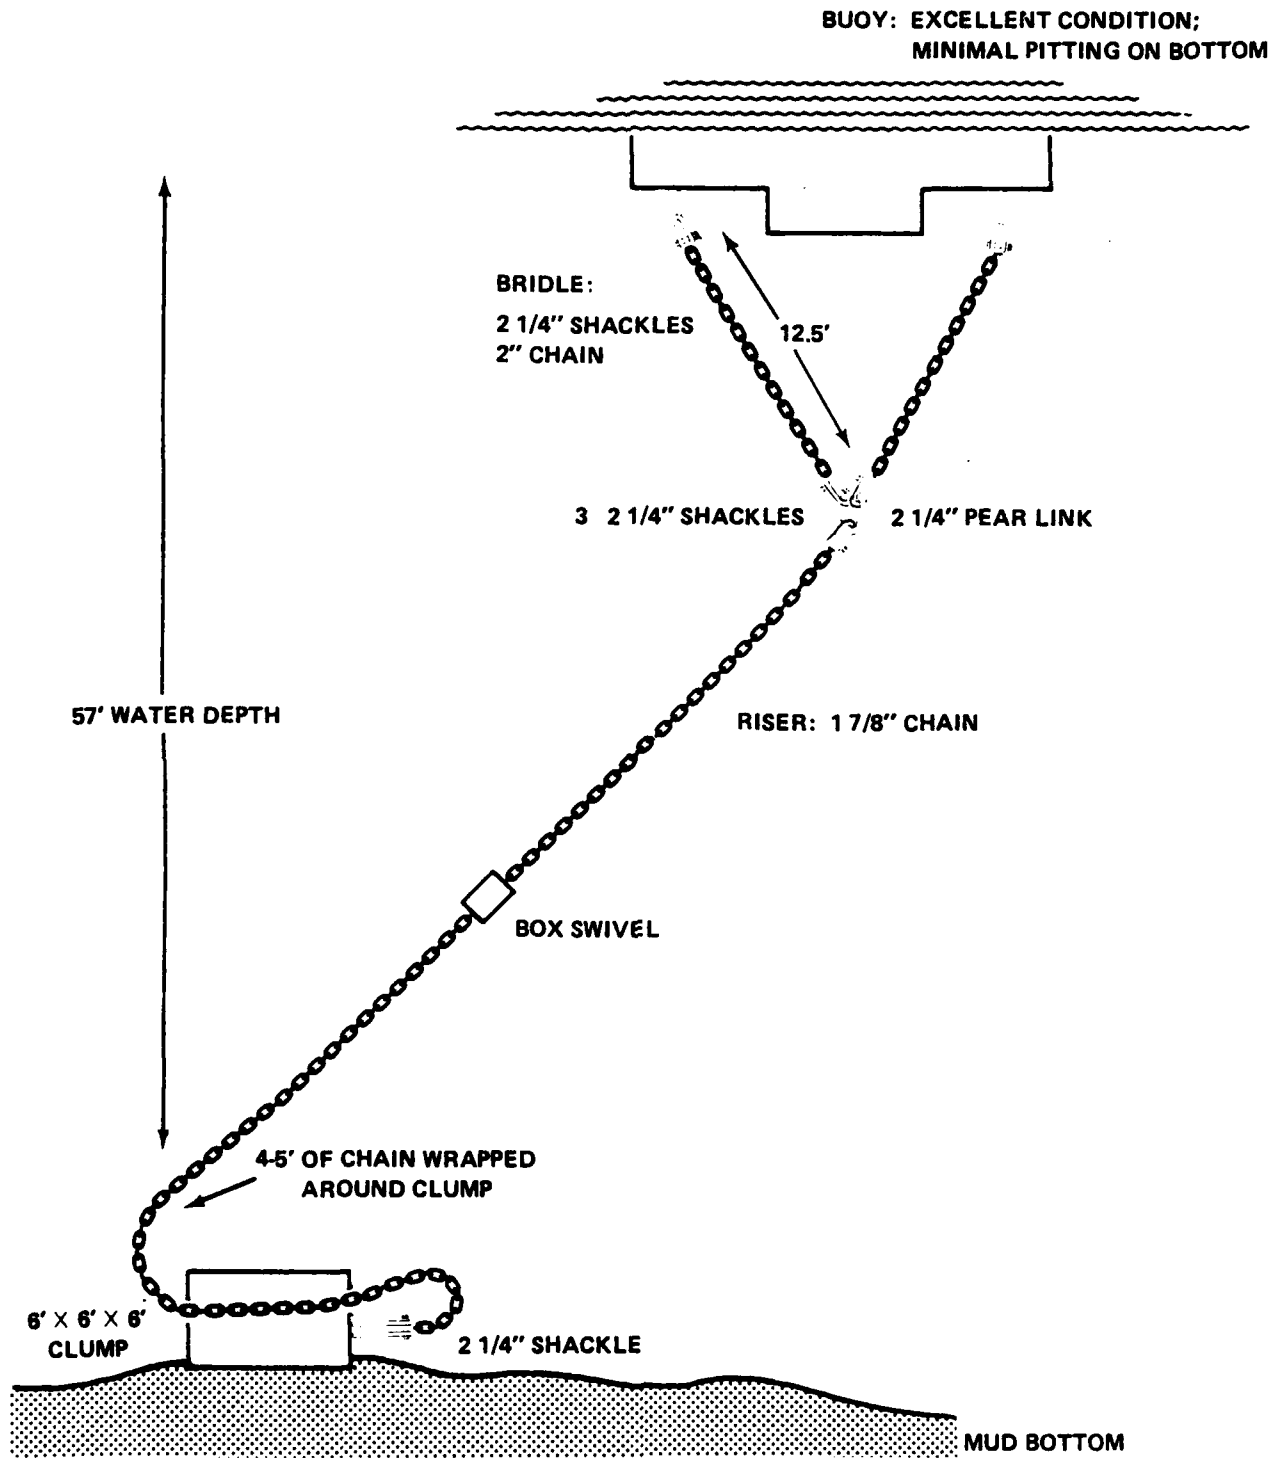
Figure 10. Starboard (Green) Navigation Buoy, Schematic

**3.3.1 Findings.** The condition of these buoys is generally good-to-excellent. The topside portion of each of the buoys is in good condition; minimal pitting was observed below the waterline. The bridles and risers are in good condition; all double link measurements were +90%. The anchors of both buoys were located and there was no evidence of dragging. The only notable observations were the existence of a box swivel in place of a standard swivel in one of the risers, and a 4 - 5' length of riser chain wrapped around the clump anchor, both in the Starboard buoy.

ITEM	SIZE	LOCATION OF MEASUREMENT	CONDITION (note)			REMARKS
			+90%	+80%	UNK	
Marker Buoy	UNK.	----	---	---	---	Excellent condition top and bottom; minimal pitting on bottom
Buoy Shackles (2)	2 1/4"	see drawing	XXX			Connect bridle to buoy
Bridle Chain, studlink	2"	10' depth	XX D			Two legs of 12.5' each
Bridle shackles (2)	2 1/4"	see drawing	XXX			Connect bridle to pear link
Pear Link	2 1/4"	see drawing	XXX			
Shackle	2 1/4"	see drawing	XXX			Connects riser to pear link
Riser Chain, studlink	1 7/8"	45', 60' depths	XX D			
Box Swivel	UNK.	not measured	-	-	-	Condition is assumed to be satisfactory
Anchor Shackle	2 1/4"	see drawing	XXX			
Anchor, Clump Type	6'x6'x6'	-----	-	-	-	Anchor in satisfactory condition; 4-5' of chain wrapped around anchor
						chor
<b>SUMMARY:</b> Buoy is in good-to-excellent condition. No design drawings were available for comparison with inspection data; "+90%" is based on information supplied by NAVACTDET and M.O.D.

**4.3 Navigation Buoys.** These buoys should remain in excellent condition under the current program of inspection and maintenance administered by the British Navy.

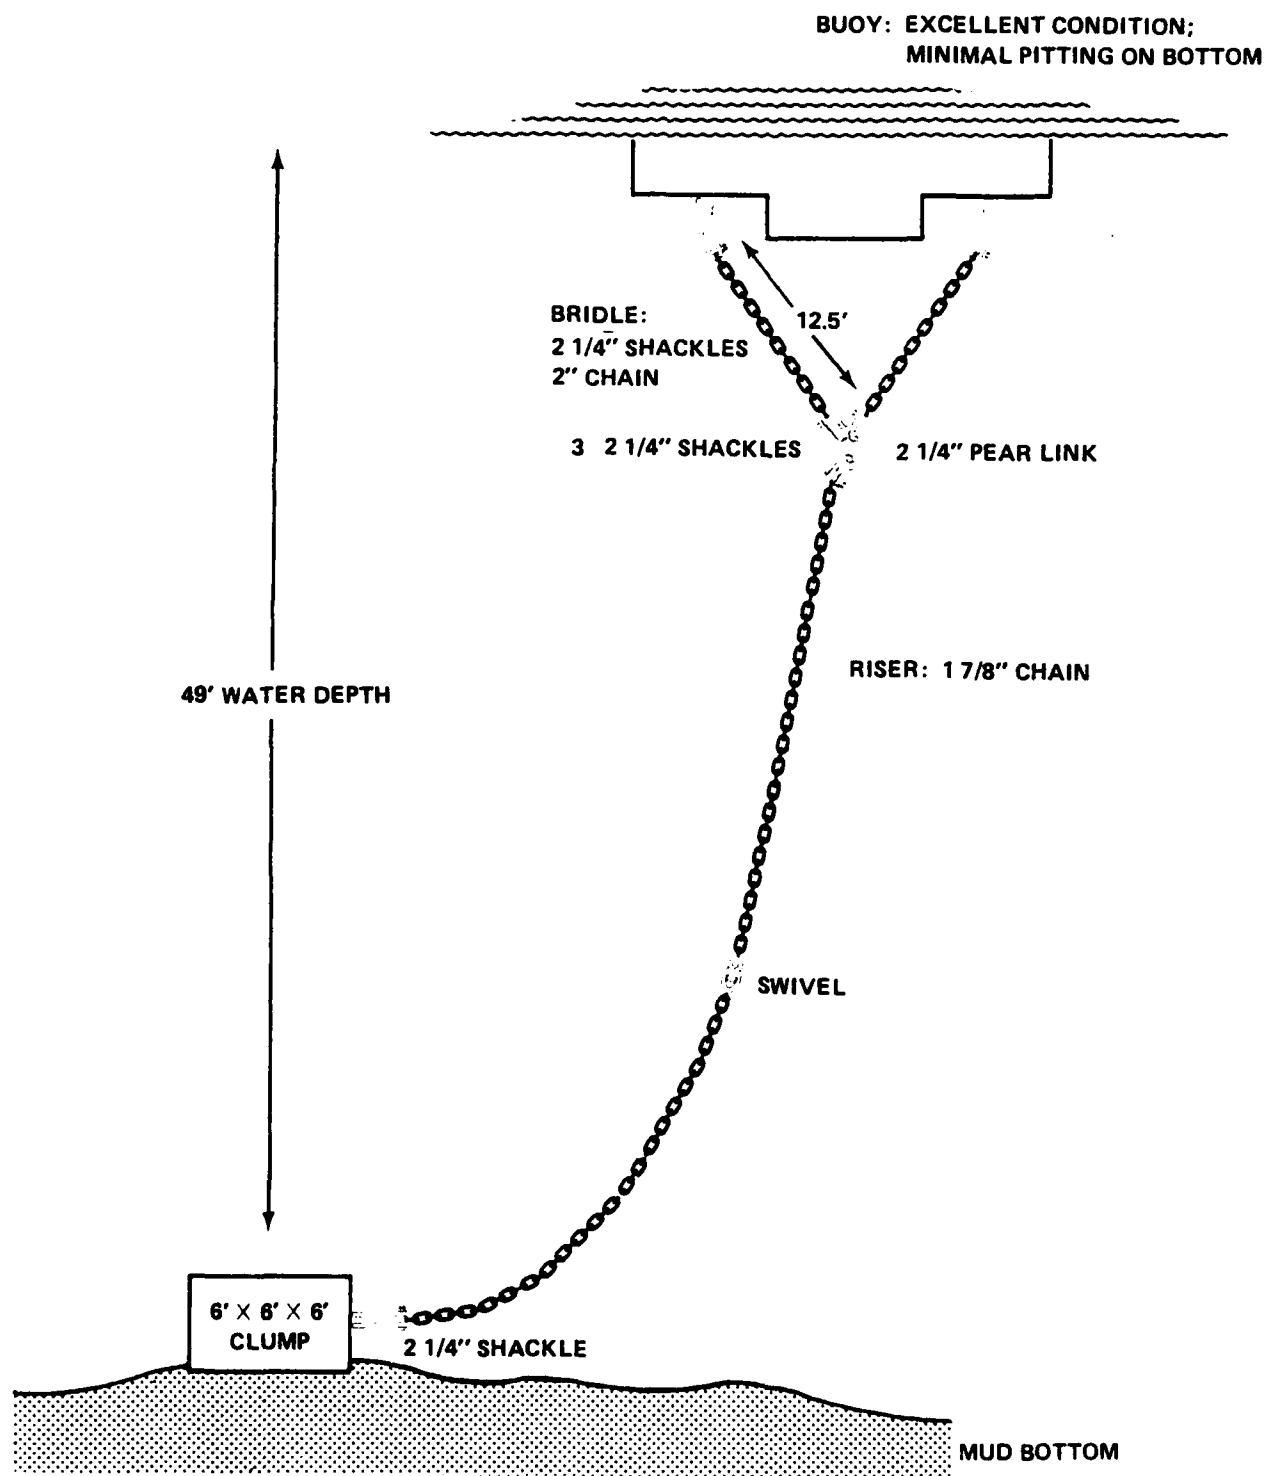
Figure 11. Port (Red) Navigation Buoy, Schematic

ITEM	SIZE	LOCATION OF MEASUREMENT	CONDITION (note)			REMARKS
			+90%	+80%	UNK	
Marker Buoy	UNK.	-----	-	-	-	Excellent condition top and bottom; minimal pitting on bottom
Buoy Shackles (2)	2 1/4"	see drawing	XXX			Connect bridle to buoy
Bridle Chain, studlink	2"	10' depth	XX 0			Two legs of 12.5' each
Bridle Shackles (2)	2 1/4"	see drawing	XXX			Connect bridle to pear link
Pear Link	2 1/4"	see drawing	XXX			
Shackle	2 1/4"	see drawing	XXX			Connects riser to pear link
Riser Chain, studlink	1 7/8"	40', 55' depths	XX D			
Swivel	UNK.	not measured	-	-	-	Condition is assumed to be satisfactory
Anchor Shackle	2 1/4"	see drawing	XXX			
Anchor, Clump Type	6' x 6' x 6'	----	-	-	-	Anchor in satisfactory condition.
<p><b>SUMMARY:</b> Buoy is in good-to-excellent condition. No design drawings were available for comparison with inspection data; "+90%" is based in information supplied by NAVACTDET and M.O.D.</p>
