SUBIC BAY  
FLEET MOORINGS  
INSPECTION REPORT

# **SUBIC BAY FLEET MOORINGS INSPECTION REPORT**

Results of the inspection indicate that eight of the 20 moorings inspected are in satisfactory condition, eight moorings do not meet design classification criteria and should be downgraded, and four moorings do not meet minimum safety requirements and should be removed from service until an overhaul is accomplished.

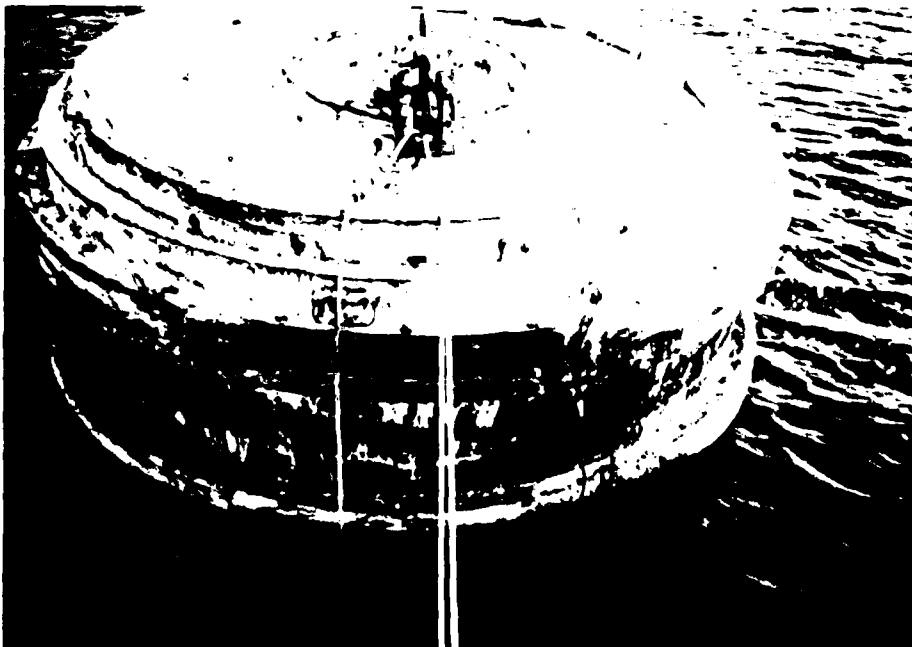
The buoy is in poor condition. The top fender is missing a section and the bottom fender is damaged. The buoy top jewelry is rusted and pitted. The buoy sides are deteriorated and in need of sanding and recoating.

Mooring #26 — Showing Typical Side and Fender Damage.

A downgrade of the mooring to an E Class is recommended.

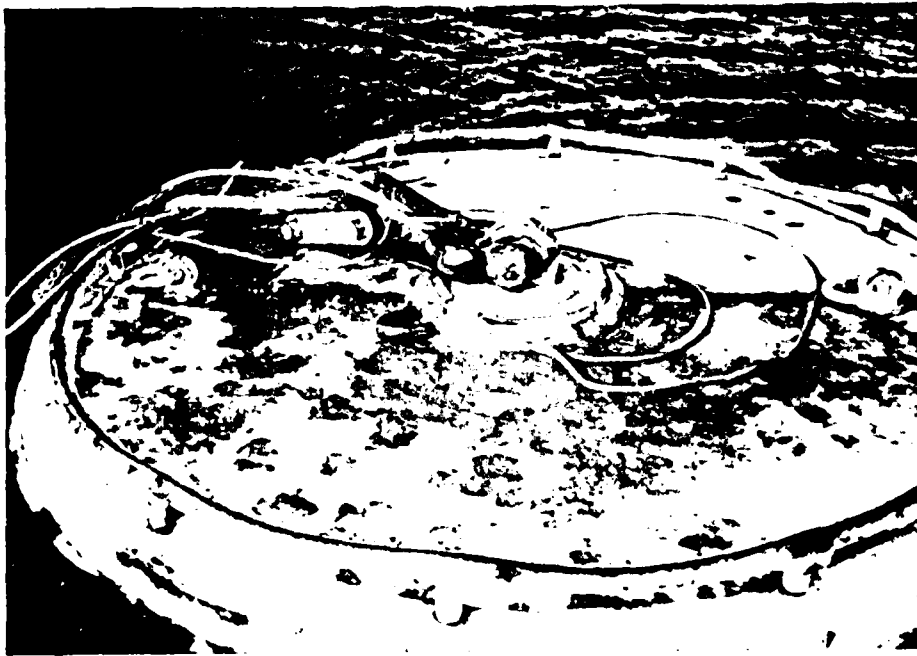
The top buoy steel plate is rusted and loose. The topside hardware was reported as non-standard. Heavy marine growth (2 inches thick) was observed on the underside of the buoy. Overall, the buoy is in fair condition.

Mooring #31 — Topside Steel Decking is Loose and Rusty; Damaged Railing Also Shown.

None. This mooring is in satisfactory condition for continued use.

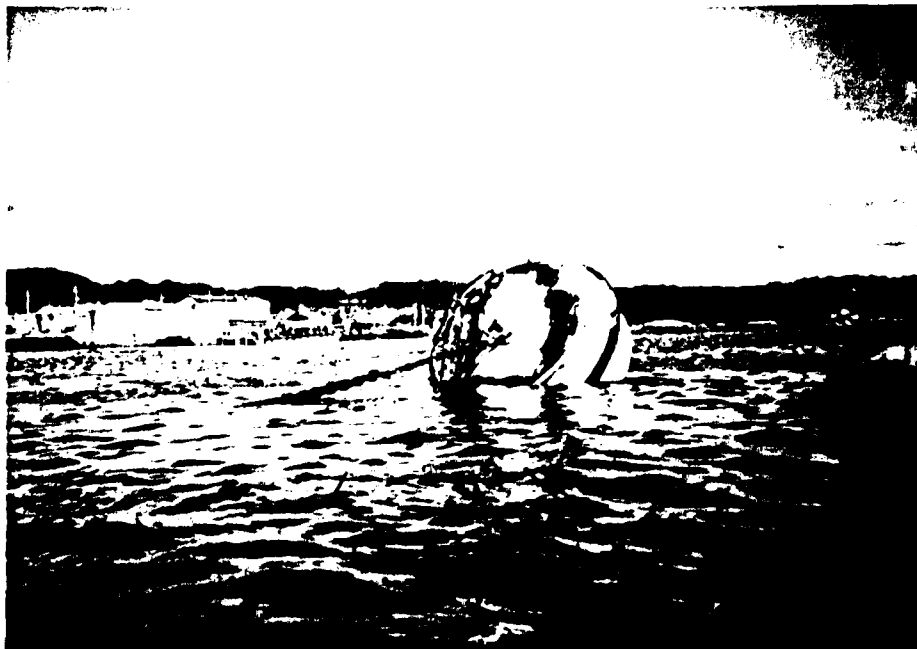
This drum type buoy is in poor condition. Part of the fiberglass layer on the buoy bottom has peeled off and hangs around the riser chain. The buoy is floating on its side with the topside partially submerged. The steel rubbing rail is badly rusted and partially missing.

The center section of the detach link connecting the riser chain to the ground ring is missing. Divers reported no swivel in the riser chain. The ground ring is buried in the mud at 25 feet.

Mooring #10 — Under Load, With Topside Partially Submerged.

Removal from service is recommended until an overhaul takes place.
