NAVAL STATION LONG BEACH FLEET MOORING INSPECTION REPORT

FPO-1-82 (24)

**OCEAN ENGINEERING
PROJECT OFFICE
CHESAPEAKE DIVISION
NAVAL FACILITIES ENGINEERING COMMAND
WASHINGTON, D.C. 20374**

20 DECEMBER 1982

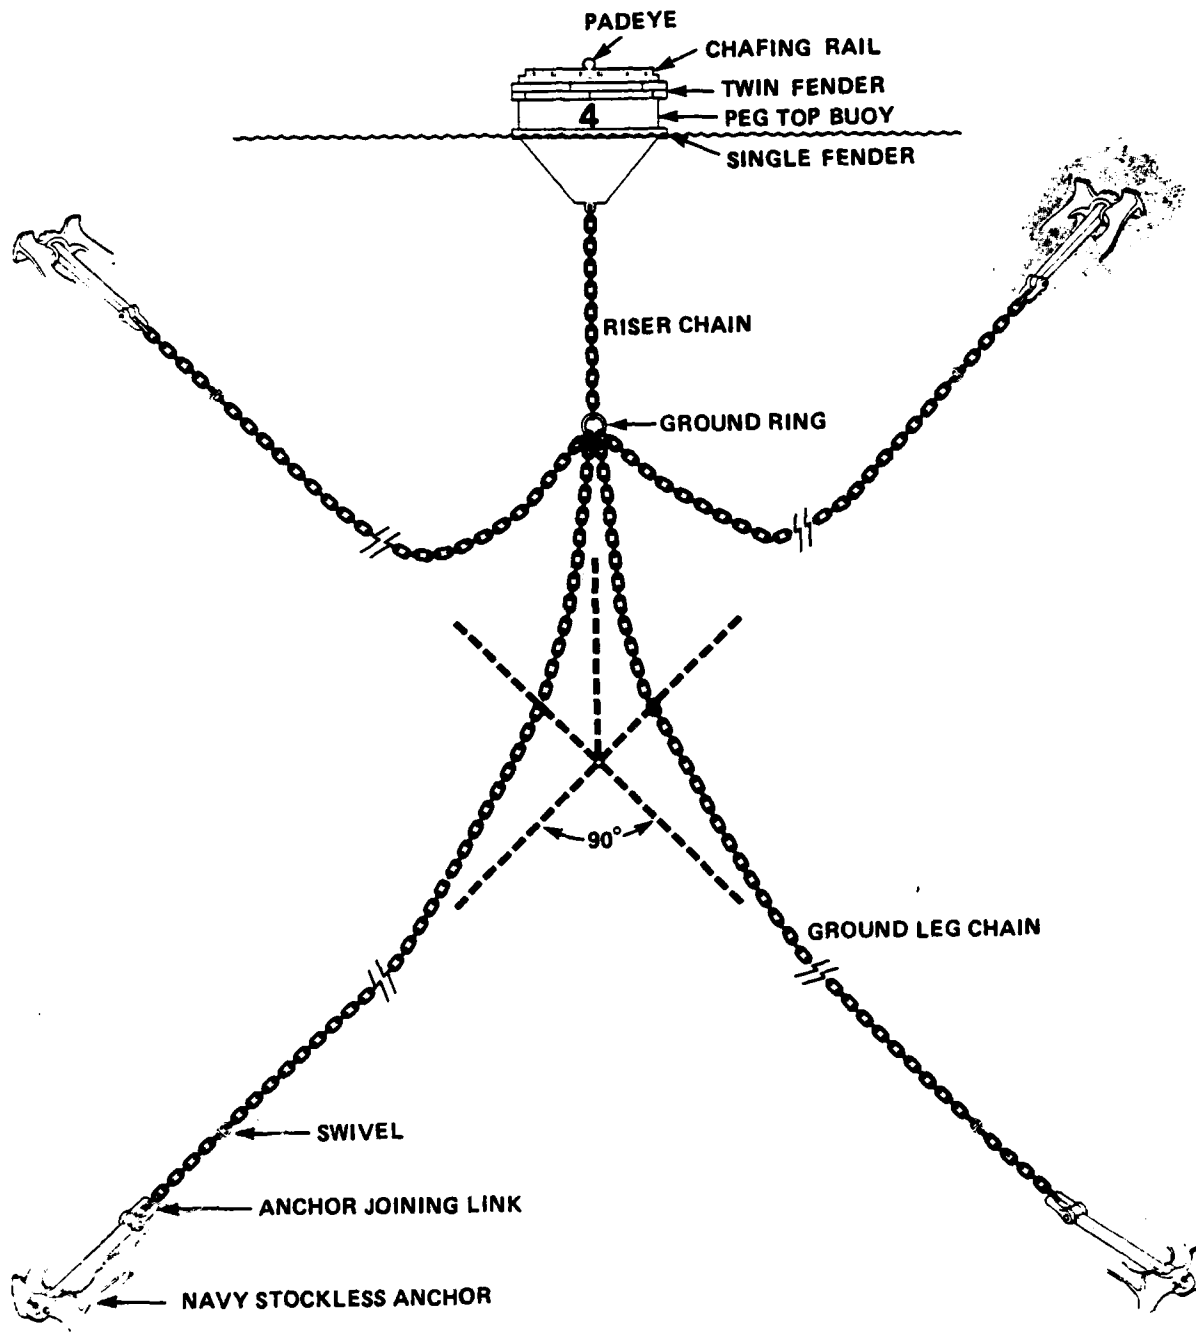
FIGURE A-1: SCHEMATIC DRAWING OF FM 4

This buoy is a painted Mark II 12'0" diameter Peg Top (S/N 181) with a 4'1" freeboard. The buoy has a wooden chafing rail and three wooden fenders, two parallel fenders near the top of the buoy and one at the waterline. Figure A-1 is an isometric view of the mooring. A five foot section of the lower fender is loose, and there are some light rust spots on the buoy's side. All top and bottom chain jewelry on the buoy are in satisfactory condition.

Although this mooring is reported to be a Class A mooring, it does not meet the DM-26 criteria for this class of mooring. A Class A mooring consists of 2-3/4 inch chain in both its riser and ground legs. According to diver measurements, this mooring has a 2-3/4 inch riser but only 2-1/2 inch ground legs which more appropriately meet the size requirements of a Class B mooring assembly. However, each leg of this FM-4 mooring contains only 2-1/2 shots of chain, and this does not meet the minimum requirement of 4 shots of chain per leg for a Class B mooring installed in 50-60 feet of water. In fact, 2-1/2 shots of chain per ground leg do not meet minimum requirements for any class of fleet mooring assembly installed in 50-60 feet of water.

NAVSTA Long Beach personnel should review their mooring requirements, based on the sizes of ships and environmental conditions expected to be encountered and determine the capacities or classes of moorings that are required. The existing mooring does not meet the design requirements for any class of mooring and should not be used by ships. However, it is satisfactory for the current use of securing camels and/or roller logs.

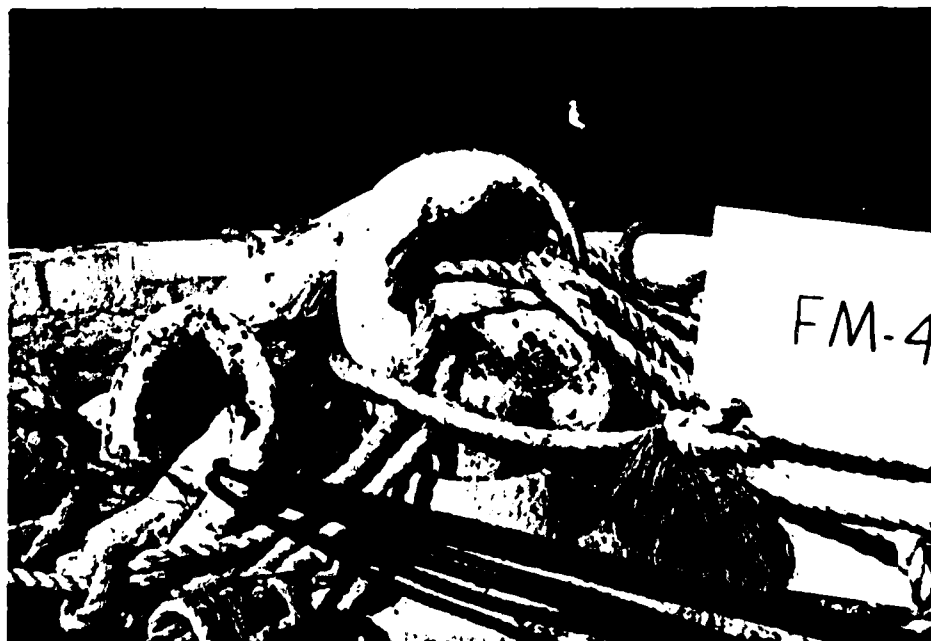
FM-4 top jewelry

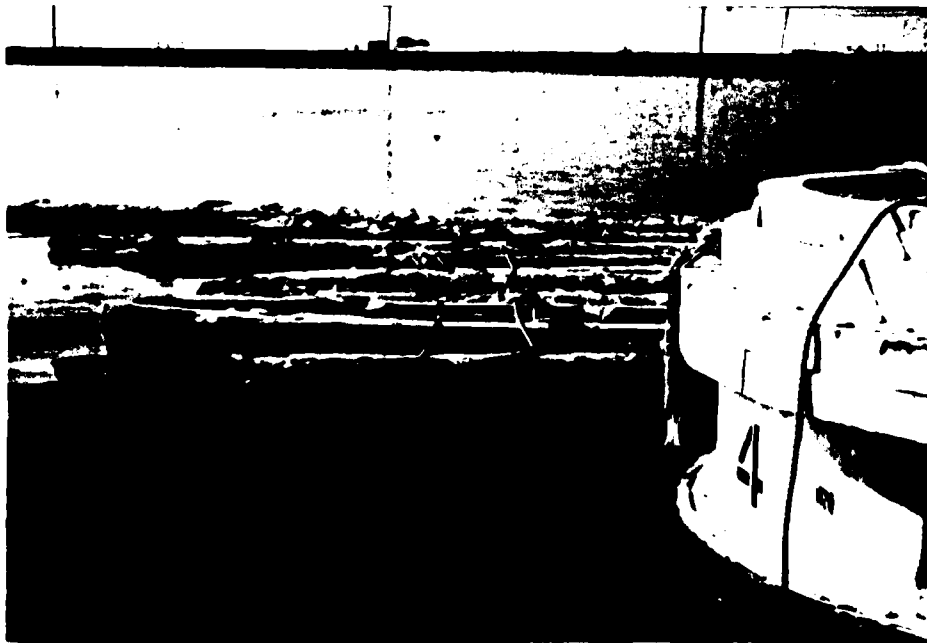
- Measurements taken of chain links and fittings were all greater than ninety percent of the original wire diameters.
- The Harbor Operations Officer advised that, due to more than adequate pier space, this mooring is never used by ships. Instead, it is primarily used for securing spare camels and/or roller logs.

Roller logs lashed together and tied to the mooring
