# **SAN DIEGO FLEET MOORINGS INSPECTION REPORT**

**30 NOVEMBER**

**OCEAN ENGINEERING AND CONSTRUCTION PROJECT OFFICE  
CHESAPEAKE DIVISION  
NAVAL FACILITIES ENGINEERING COMMAND  
WASHINGTON, DC 20374**

**FPO-1-82 (29)**

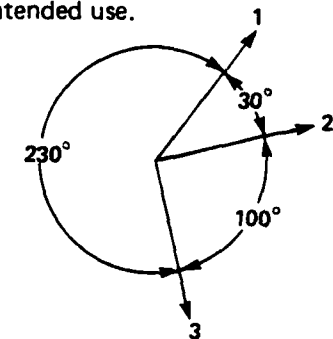
MOORING NO.: DM-3 CLASS: D LOCATION: DETERMINING PIER LAT: \_\_\_\_\_ LONG: \_\_\_\_\_

The riser was found to consist of 2 1/2 inch chain which is larger than the 2 inch chain specified for a class D mooring in DM-26. Double link measurements along the riser chain indicated >80% of the original wire diameter was remaining. Divers reported 5 to 6 inch thick marine growth on the buoy bottom and riser chain. Significant amounts of corrosion were observed on the chain by divers. The ground ring was located at a water depth of 32 feet.

The chain on this mooring was found to have >80% of its original wire diameter remaining, which normally indicates a need to downgrade the mooring by one class. The resulting Class C is still higher than the Class D required so this mooring should be adequate for its intended use.

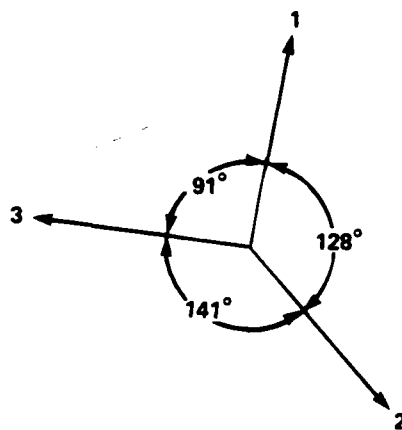
Ground legs 1 and 2, (2 inch wire diameter), were measured and reported to be in good condition. Ground leg 3 (2 1/4 inch chain) was reported to have severe wear and was badly pitted (>75%). The variation in double and single link measurements indicates that ground leg 3 may consist of segments of different sized chain.

It is recommended that this mooring be discontinued for fleet use, until it has been overhauled. The basis for this recommendation is the double link measurement found on ground leg 3 which indicated original wire diameter remaining to be <80%.

- DM-4: Ground leg 3 which measured <80% of original wire diameter must be replaced as soon as possible. Use of this mooring should be discontinued until an overhaul is completed.
