CENTERVILLE BEACH SPLIT  
PIPE REPAIR

4. PERFORMING ORGANIZATION REPORT NUMBER  
FPO 7703.5

14. DATE OF REP. (YYMMDD)  
77-06-09

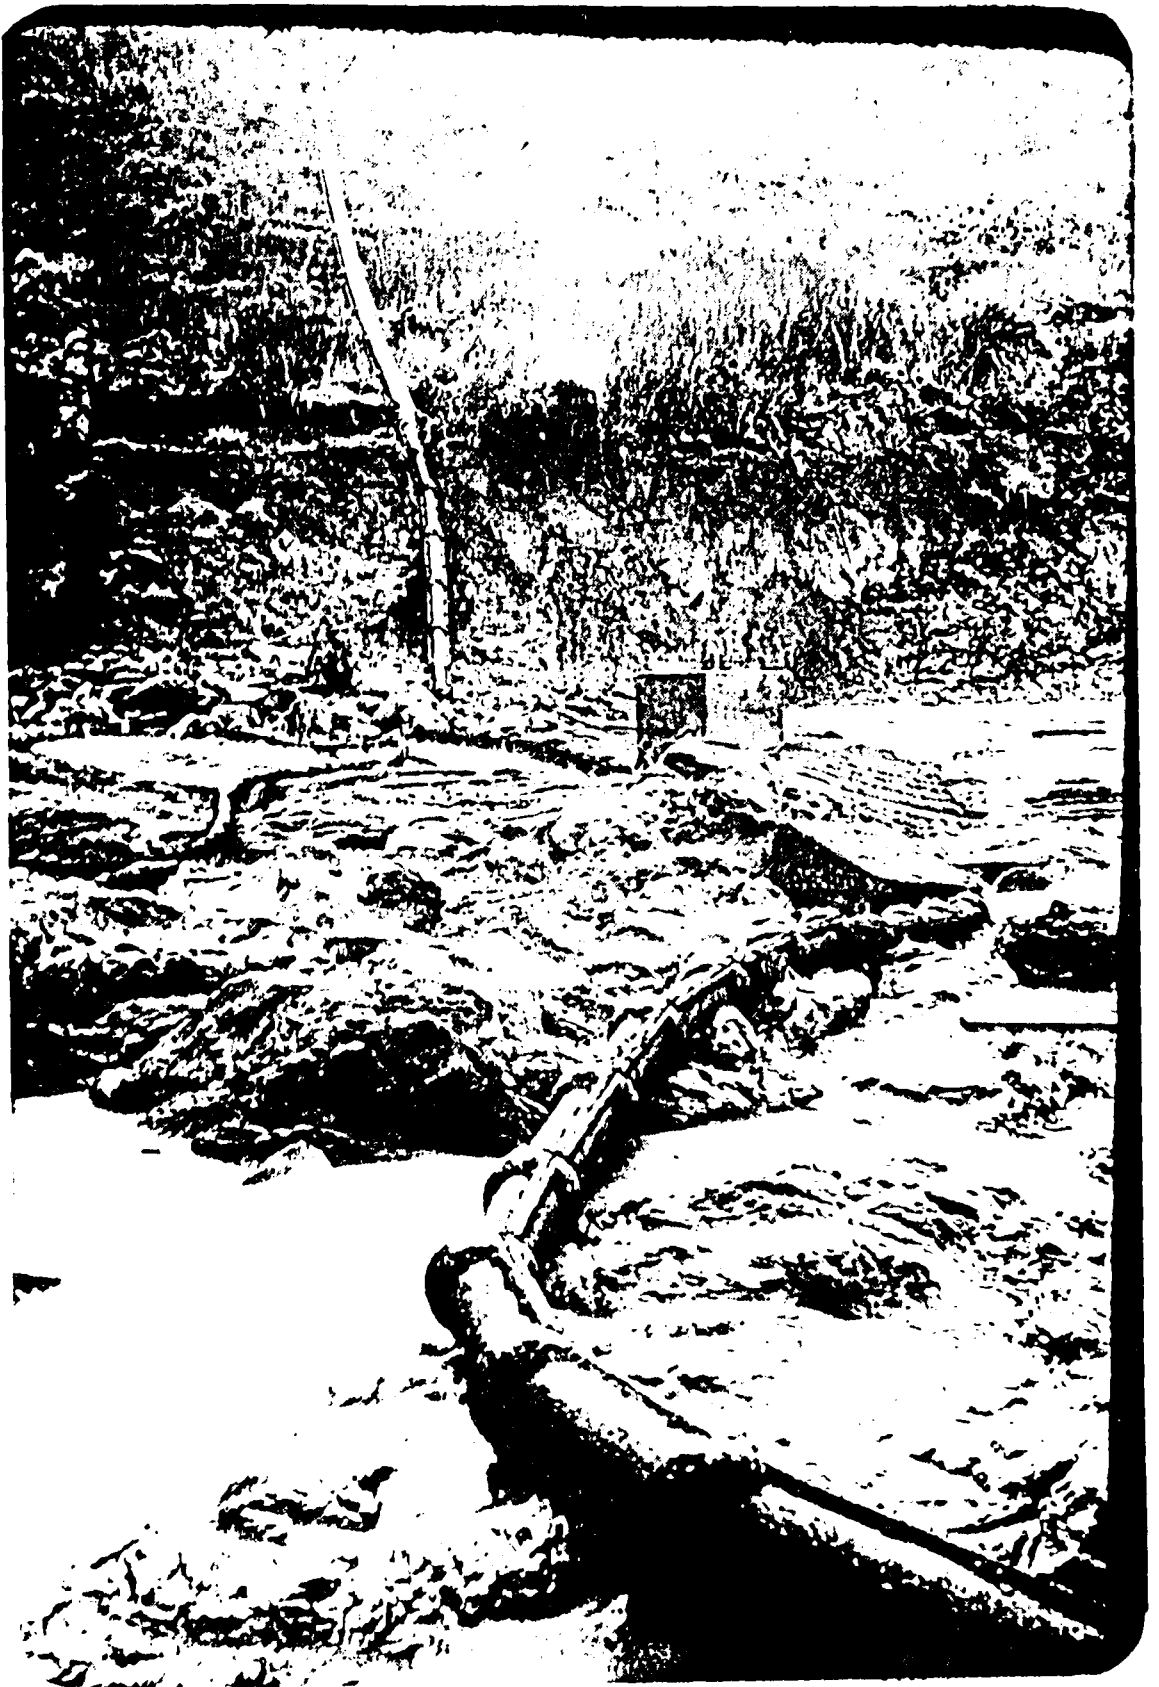
FIGURE 3. South Cable on Beach

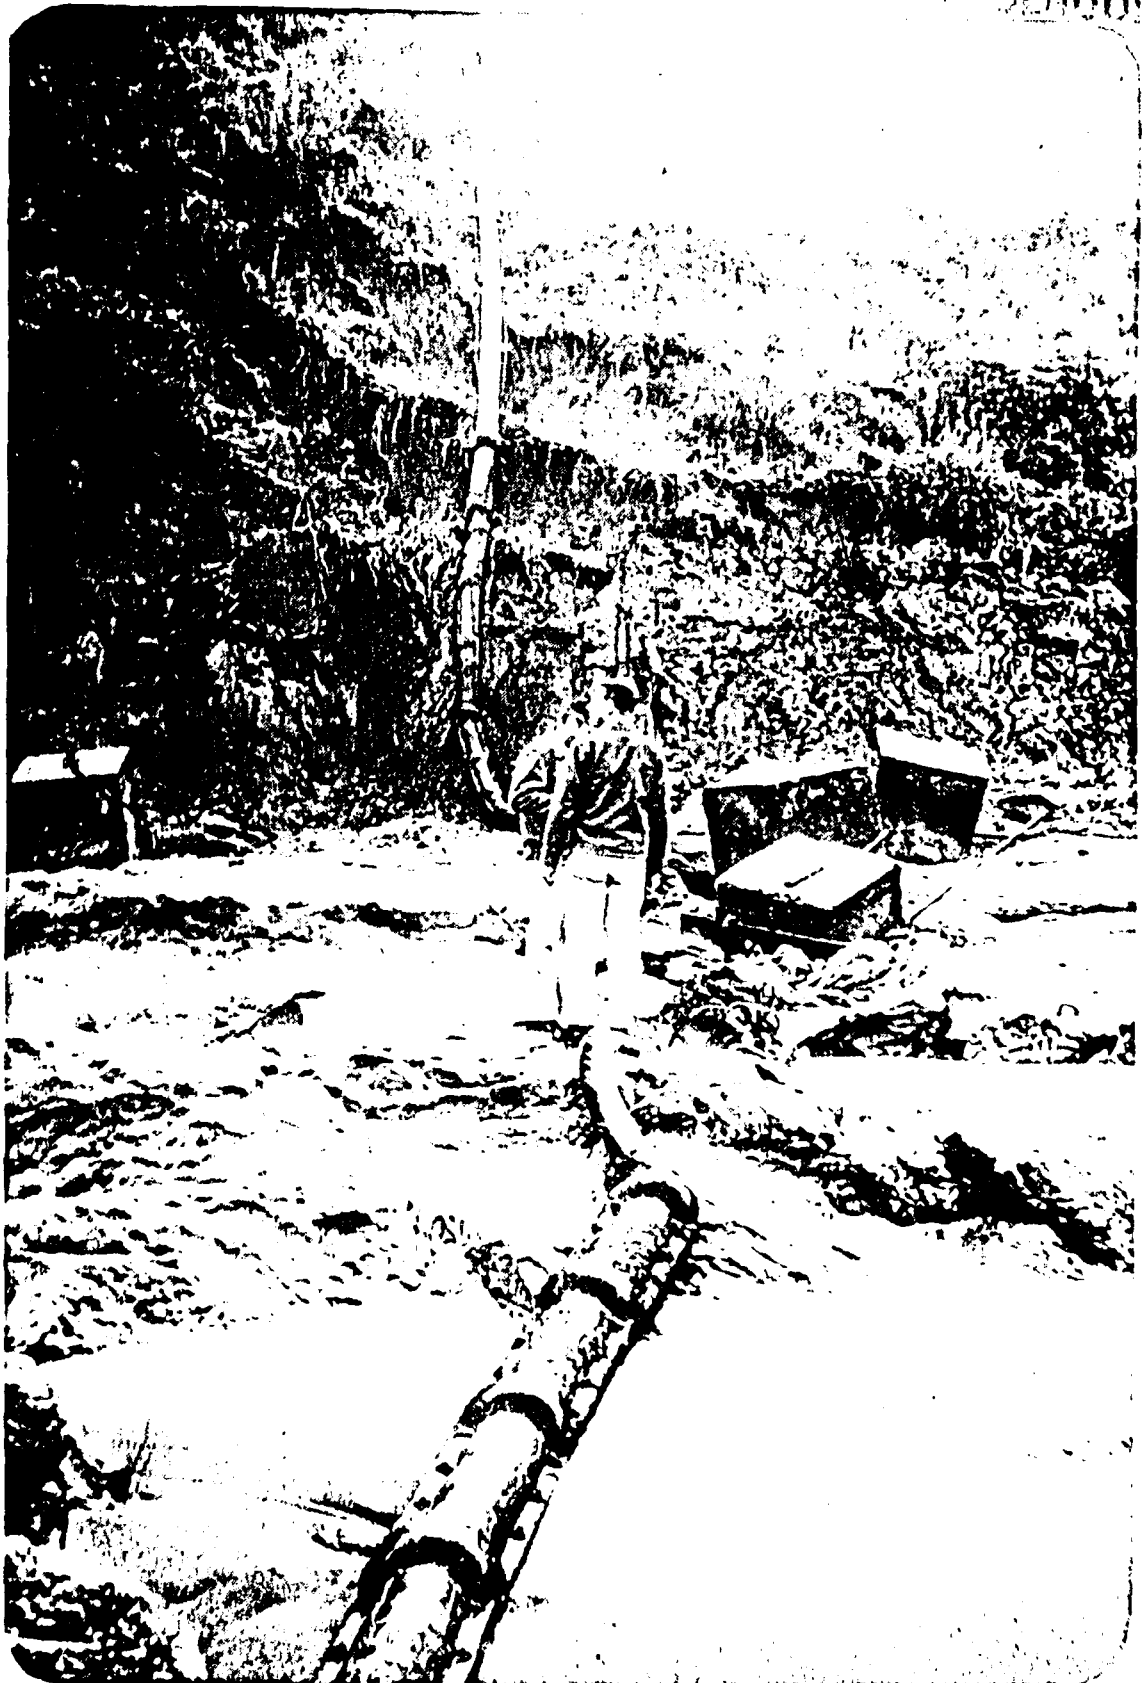
Figure 6. North Cable on Beach

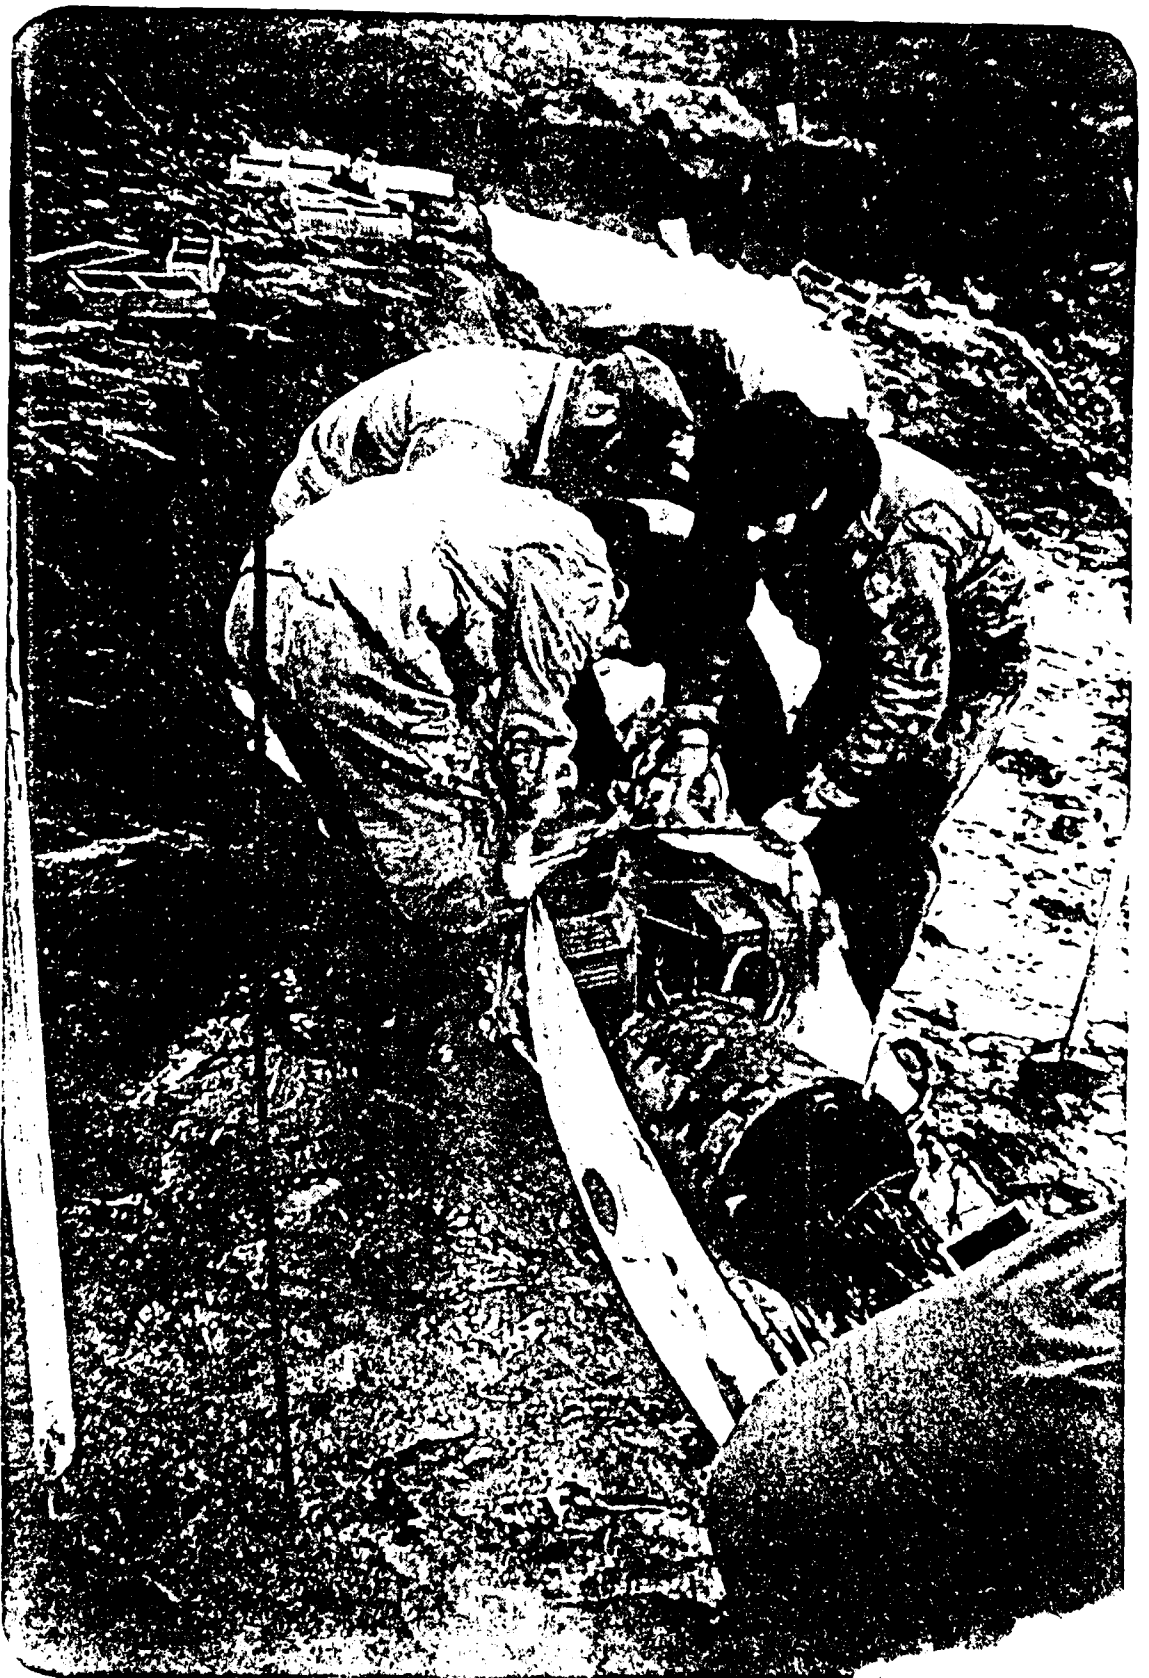
Figure 11. The men working in the trench.

and the end of the bag wired around the bell of a section of split pipe (Figure 10). As more sections of the cage were applied the bag was pulled under the cage and zipped closed (Figure 11). This phase took about 25 minutes for each cable. Concrete reinforcing bar (3/8 inch, 20 feet) was layed in the bag to improve the structural integrity of the form. Rebar stakes were driven through the bottom of each bag into mudstone as the bag was zipped up.
