# Technical Memorandum

UNITED STATES NAVY - CANADIAN FORCES  
SOLID STATE FLIGHT DATA RECORDER/CRASH POSITION LOCATOR  
EXPERIMENT ON THE B-720 CONTROLLED IMPACT DEMONSTRATION

11 November 1985

TM 85-76 SY  
11 November 1985

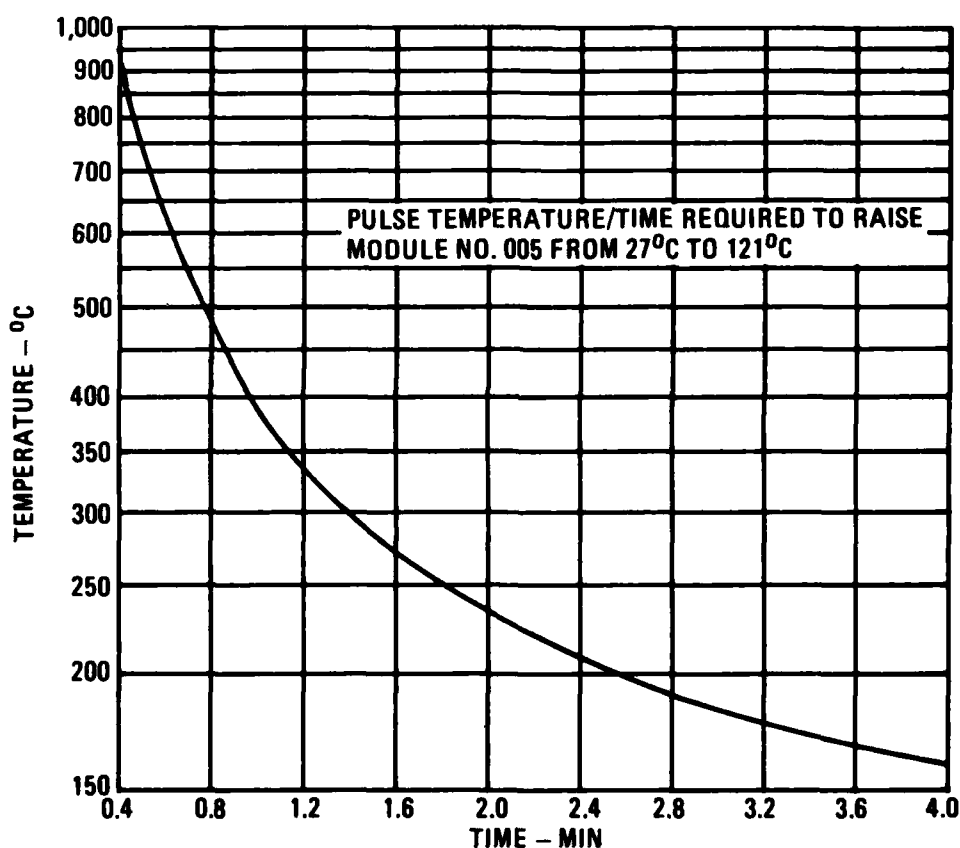
Figure 15  
PULSE TEMPERATURE RECEIVED BY SSFDR DURING B-720 CID

26. Analysis of the B-720 video tape indicates the airfoil was awash in flames for approximately 6 sec. Thermal calculations are based upon the 121°C reading on memory module No. 005. As shown in table I, this module could have attained the 121°C by the application of a heat equivalent to a step function temperature as shown in figure 15.

27. The intumescent coating (Ocean 477) used on the SSFDR is manufactured by Ocean Chemicals Inc., Savannah, Georgia. Discussions with Ocean Chemical's technical representative determined that the coating will intumesce in approximately 6 sec when exposed to a temperature of 925°C (1,700°F). Considering that the intumescent paint did not intumesce and that the fire crews were on site within approximately 1 1/2 min, it can be speculated that the temperature seen by the airfoil was equivalent to a pulse temperature of 160°C to 400°C for a duration of 3 min as shown in figure 15.

28. The apparent discrepancy between the airfoil being awash in flame and the calculated pulse temperature can be explained by a film of cool fuel separating the flames and the airfoil during the crash sequence and prior to deployment.
