**NAVAL WEAPONS  
STATION  
EARLE  
FLEET MOORINGS  
UNDERWATER  
INSPECTION  
REPORT**

**MAY 1983**

OCEAN ENGINEERING  
AND CONSTRUCTION PROJECT OFFICE  
CHESAPEAKE DIVISION  
NAVAL FACILITIES ENGINEERING COMMAND  
WASHINGTON, D.C. 20374

FPO-1-83 (16)

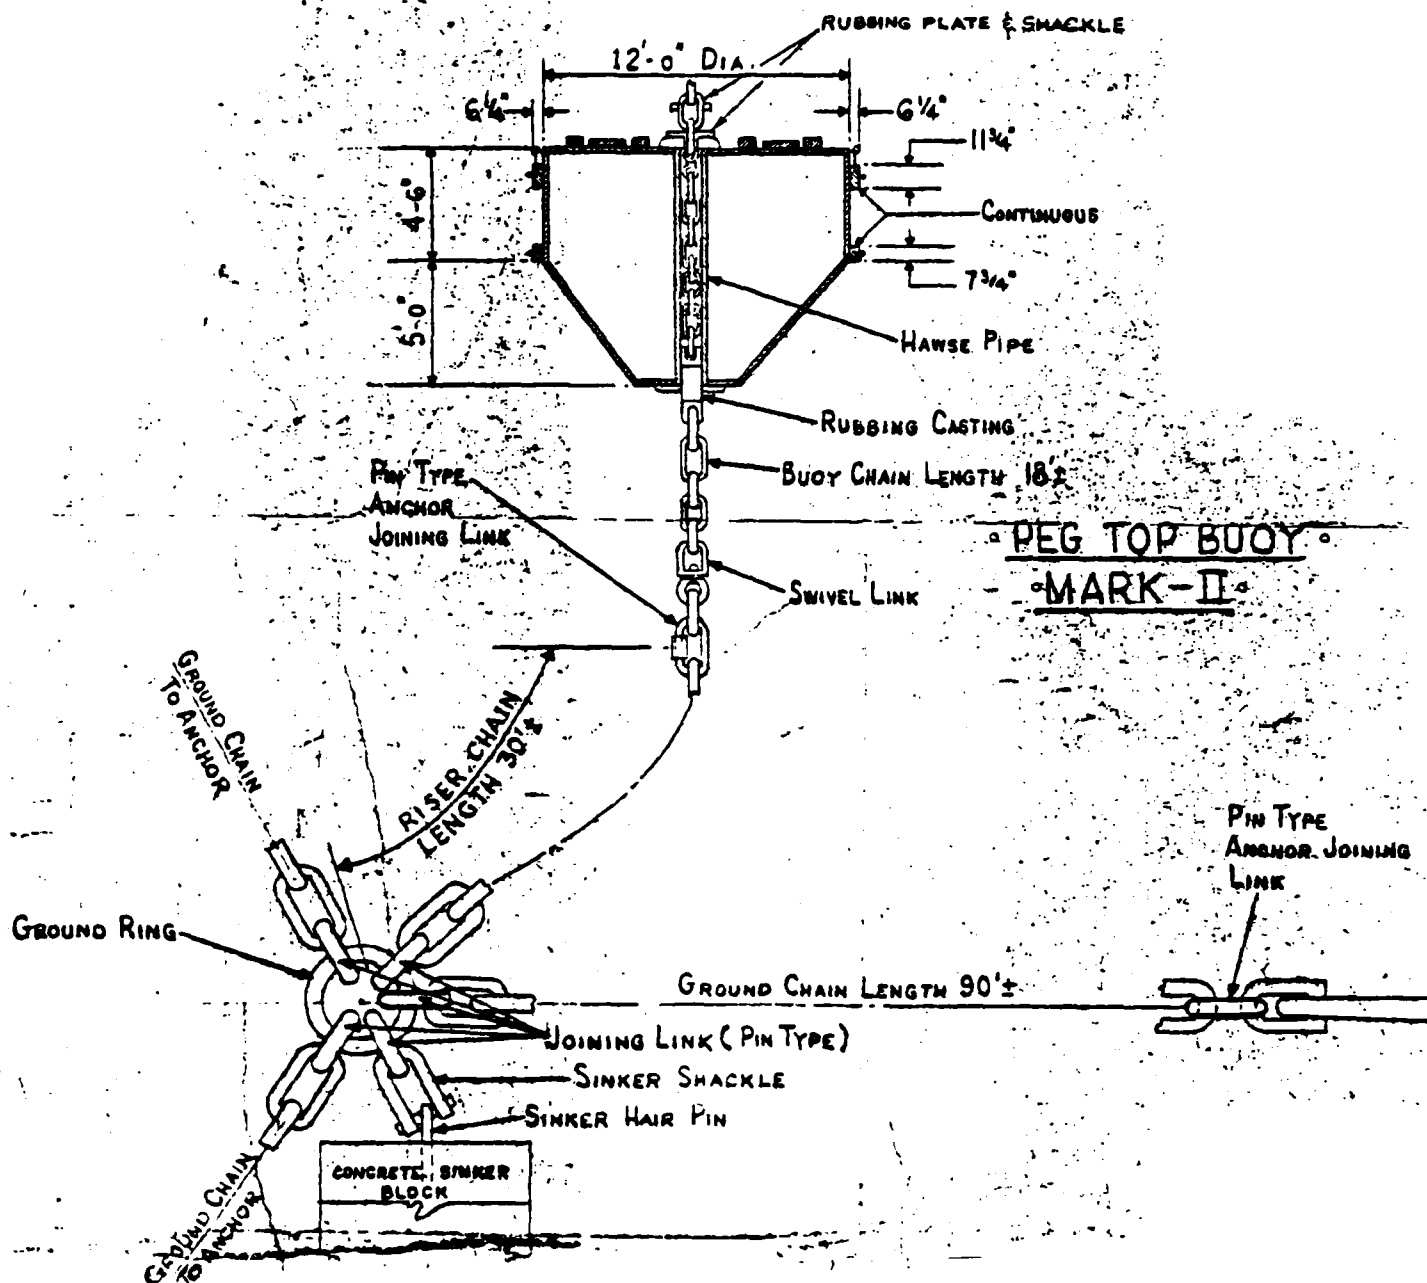
Figure 4. As-Built Drawing

- Mooring Number One has a 2 1/4-inch chain riser which was measured to be greater than 90 percent of its original wire diameter. The riser has no swivel and the center section of a detachable link was found to be missing. UCT 1 divers replaced this detachable link with a spare.

- Mooring Number Two has a 2 1/4-inch chain riser which was measured to be between 80 and 90 percent of its original wire diameter. The buoy has a 20° to 25° list.

- Mooring Number Three has a 2-inch chain riser which was measured to be between 80 and 90 percent of its original wire diameter. The buoy is in a position about 150 feet south of its planned position.

- Only one serious material deficiency (broken detachable link) was noted, and this was corrected by UCT 1 divers.
- The watertight integrity of the buoy in Mooring Number Two should be checked for possible leaks.
- Attempts should be made to locate the chain and anchor assemblies which have been buried since two buoys broke loose about two years ago. This material would be a significant addition to the NWS Earle inventory ashore which at present does not include any chain or chain accessories.
- A swivel should be inserted in the riser of Mooring Number One.
- Due to measured riser chain wear, Moorings Number 2 and 3 would normally be downgraded to a lower classification. However, since the chain is oversized, these moorings are in satisfactory condition for continued use in their current capacity as Class E moorings.
