# PEARL HARBOR Z-LOOP UPGRADE PROJECT COMPLETION REPORT

FPO-1-83(34)  
OCTOBER 1983

ROBERT TAGGART INCORPORATED  
FAIRFAX, VIRGINIA

OCEAN ENGINEERING AND CONSTRUCTION PROJECT OFFICE  
CHESAPEAKE DIVISION  
NAVAL FACILITIES ENGINEERING COMMAND  
WASHINGTON, D. C. 20374

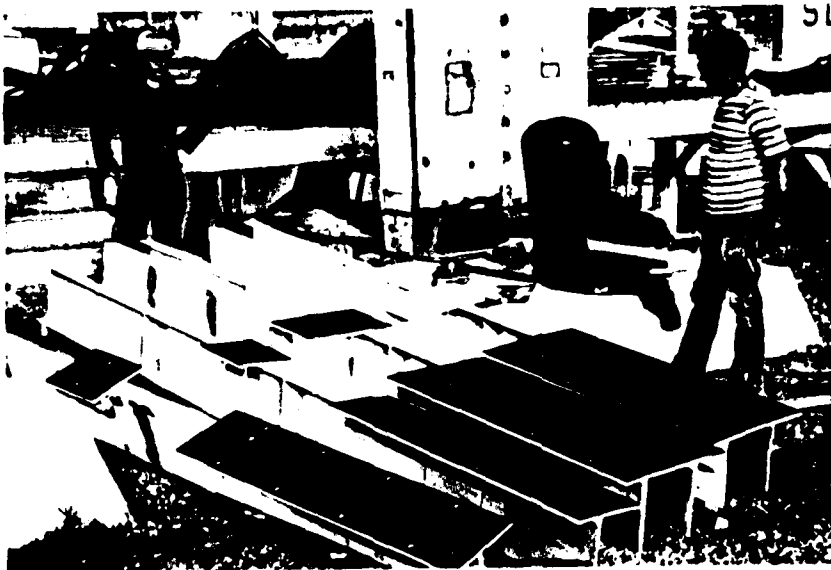
FIGURE 7-11

ORIGINAL SWITCHING MATRIX  
SHOWING PLATING AND  
SPACING PROBLEMS

discussed with the design contractor. Resolution was deferred until the arrival of the contractor's representative on 12 January. At that time, it was determined that all copper contact surfaces needed to be cleaned and replated properly.

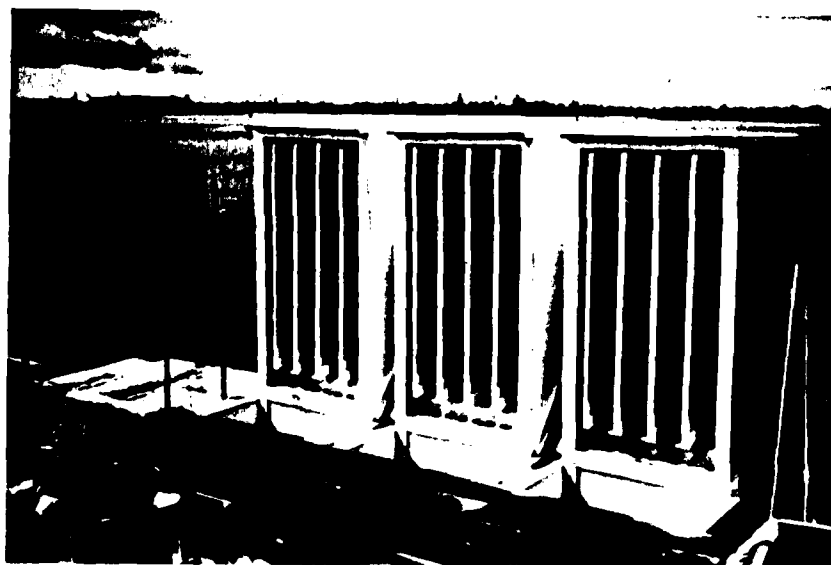
**FIGURE 7-19**

After inspection in his shop, the contractor determined that the existing system would require replacement rather than modification. He also confirmed that the doors did not meet code requirements for thickness, rigidity, or watertight integrity. Both components were redesigned to meet code specifications. The terminal strip redesign was approved by CHESNAVFACENGCOM on 25 March 1983 and the replacement doors were approved on 19 April 1983.

**BOXES PRIOR TO ATTACHING  
NEW DOOR ASSEMBLIES**

*DOOR ASSEMBLY INSTALLATION.* The frames and doors were installed on 28 and 29 May. A final top coat was applied to them and the required "High Voltage" decals were applied to the insides and outsides of each of the six doors. This completed the contractor's obligations. The CHESNAVFACENGCOM representative remained to complete the installation.
