GUANTANAMO  
NAVAL STATION  
SEWER OUTFALL  
INVESTIGATION

FP0-1-81 (13)  
JUNE 1981

OCEAN ENGINEERING  
AND CONSTRUCTION PROJECT OFFICE  
CHESAPEAKE DIVISION  
NAVAL FACILITIES ENGINEERING COMMAND  
WASHINGTON, D.C. 20374

Subj: Guantanamo Naval Station Sewer Outfalls Investigation

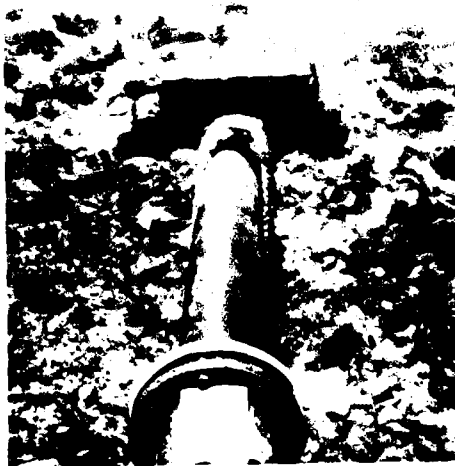
Outfall No. 8

| OUTFALL<br>NUMBER | FINDINGS FROM THE<br>LAND INSPECTION | FINDINGS FROM THE<br>WATER INSPECTION |
|---|---|---|
| 8. | Shore end looks good with new plastic pipe added. | Leaking at plastic/C.I. flange, could not see end. |

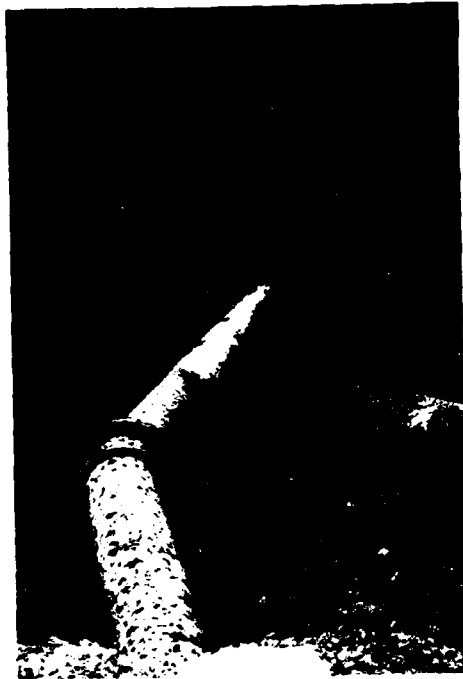
Outfall No. 15

| OUTFALL<br>NUMBER | FINDINGS FROM THE<br>LAND INSPECTION | FINDINGS FROM THE<br>WATER INSPECTION |
|---|---|---|
| 15. | Looks good as it enters the water. | End of the outfall looks clear. |

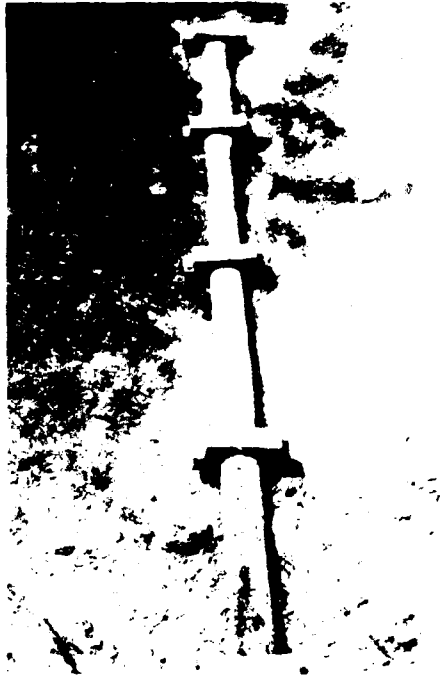
These two pictures are of outfall No. 19

| 19. | Shore end looks good with new plastic pipe added. | End of outfall looks clear. |

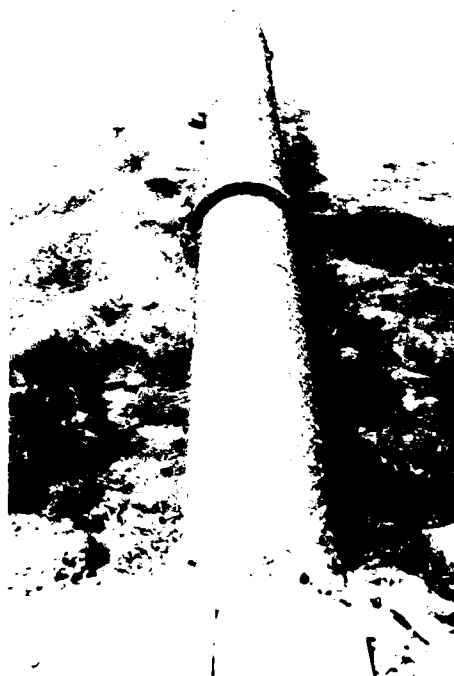
| 23. | New C.I. outfall. | End of outfall clear but just below the waterline. |

Outfall No. 23  
is a new C.I. outfall

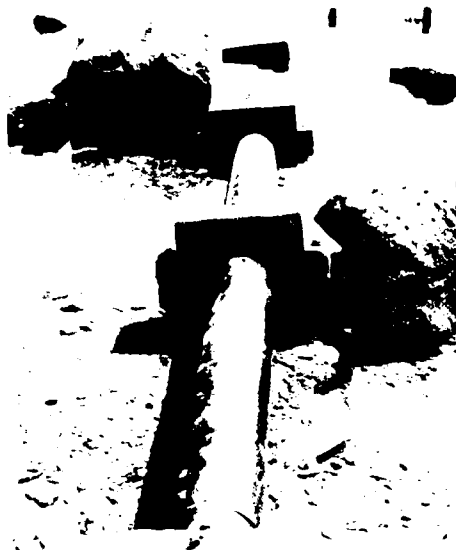
| 31. | The outfall and new plastic pipe look good but a tank up the line is overflowing. | N/A |

Outfall No. 31  
the outfall is intact
