DOT/FAA/CT-85/33

Galley and Overhead Compartment Experiment Results - Full-Scale Transport Controlled Impact Demonstration

Roger M. Lloyd
RMS Technologies, Incorporated
Trevose, Pennsylvania

December 1985

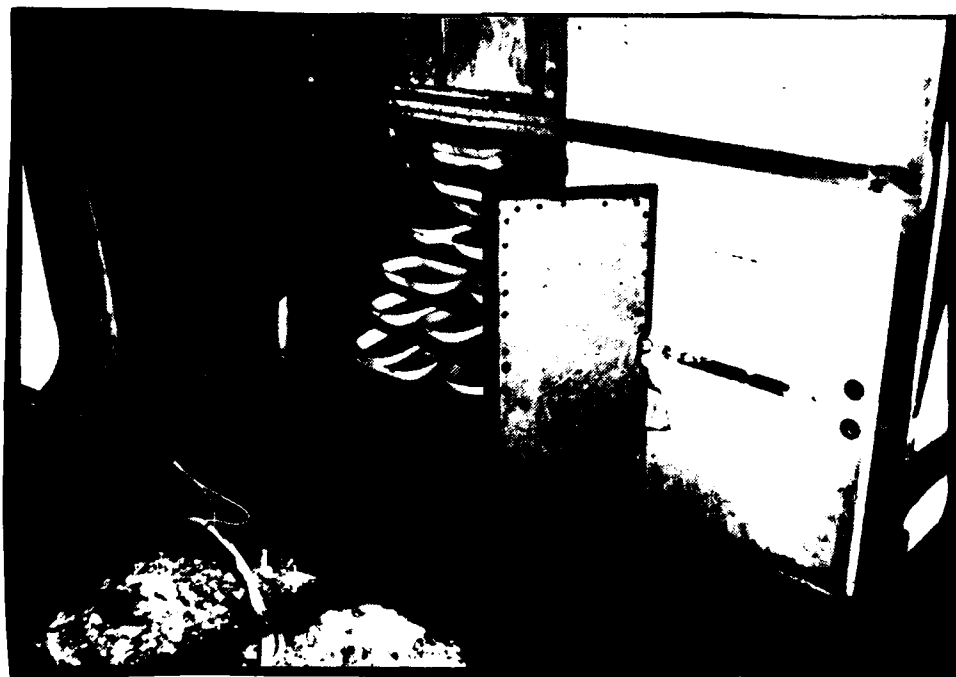
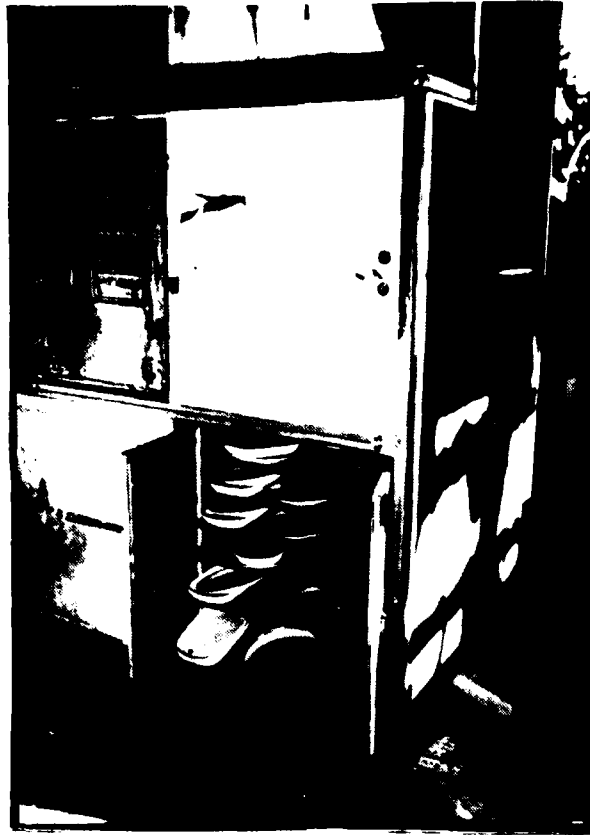
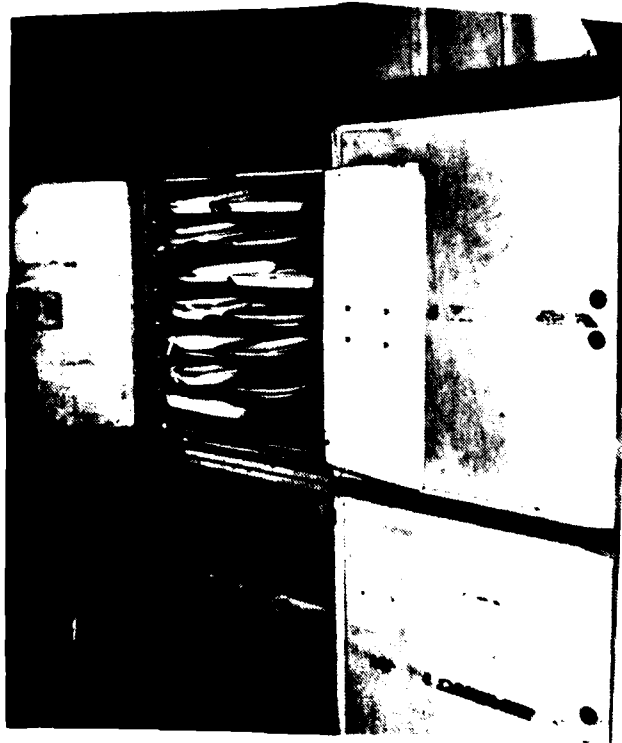
Post-test examination of the galley modules also revealed that the interior latching devices and exterior sliding galley restraint doors, performed satisfactorily without loss of interior contents and equipment. The galley interior and container equipment showed evidence of smoke residue due to the fire. Also, minor chips on some of the dishes were noticed. The forward galley performed equally well. Notwithstanding that the hazardous material packages were ignited by the lower cargo compartment fire and that some of the packages were damaged by the fire crew, there appeared to be no evidence of prior impact damage to the forward galley or interior contents (see figures 28 through 30).

FIGURE 28. AFT GALLEY CHINA POST-CRASH

FIGURE 29. AFT GALLEY CHINA, TRAYS POST-CRASH (LOWER)

FIGURE 30. AFT GALLEY CHINA, TRAYS POST-CRASH (UPPER)

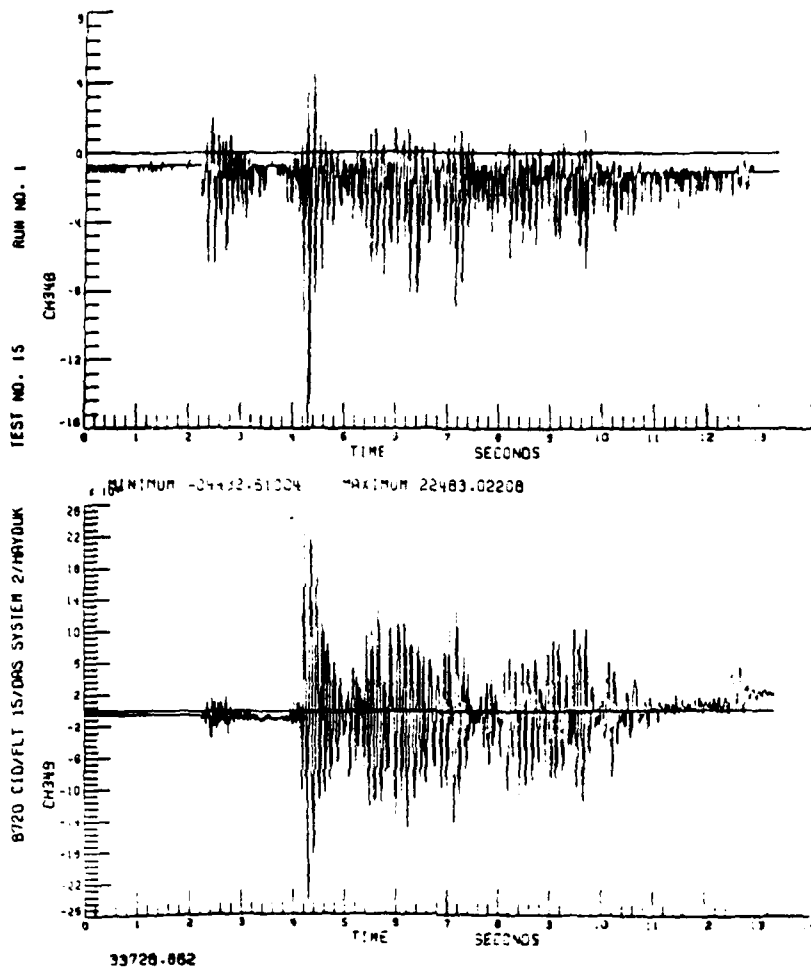
In figure 33, an identification of the pre and post-impact loads across the upper (channel 348) and the lower (channel 349) instrumented support links are shown. Notwithstanding that the identified loads in the lower link are undetermined due to a drift in the data (cause unknown), the relative variation of loads in the upper link after the crash is about 60 percent greater than before the crash. It is believed that this increase in load as carried by the upper link could have been contributed by failures of one or more of the other support links. (NOTE: Due to a scaling factor error under figure 25 (channels 348 and 349), the exact magnitude of peak loads are not correctly identified. The qualitative assessment of upper link performance was therefore, based upon the relative change in load.) Another indication of possible link failure may be seen by comparing the general forms of the compartment mass accelerations and link load data in figures 34 through 38. In figures 34 through 37, the range of the accelerations or loads are roughly the same before and after the implanted obstacle impact at about 4000 milliseconds. In figure 38, the range is much larger after impact than it was prior to impact. Again, either some links broke or the instrumentation on the lower support links failed at that time. Unfortunately, the fire devastated the area and made absolute determinations impossible.

FIGURE 33. SUPPORT LINK DATA WITH EXPANDED TIME SCALE

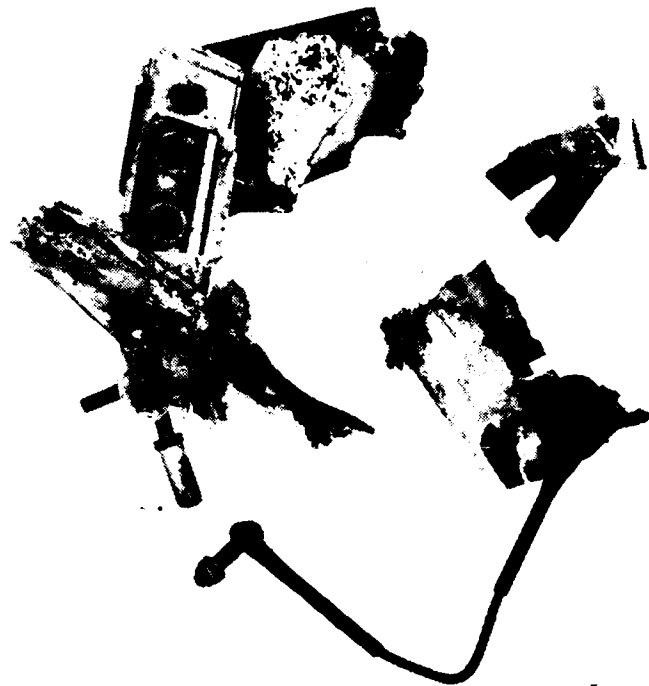
Visual/Macroscopic Examination: The remnants of seven support links were arranged in their relative positions in order to assess the loading and sequence of failure, as shown in Figures 1, 2, 3, and 4. Three links fractured in a plane perpendicular to the axial direction of the links through the holes in the unthreaded area. One link fractured in the same manner through the two small holes in the threaded area. In addition, two links failed through the eye-bolt attached to the threaded link. One of the seven links did not fail. The fractures in the failed links were relatively smooth and flat, as shown in Figure 5.

Analysis of Results: The results of this investigation indicate that the probable cause of failure in the six broken links was due to overheating caused by the fire after impact. Evidence of incipient melting at the grain boundary in all samples indicates that these support links were subjected to a temperature very close to the melting point of the material.

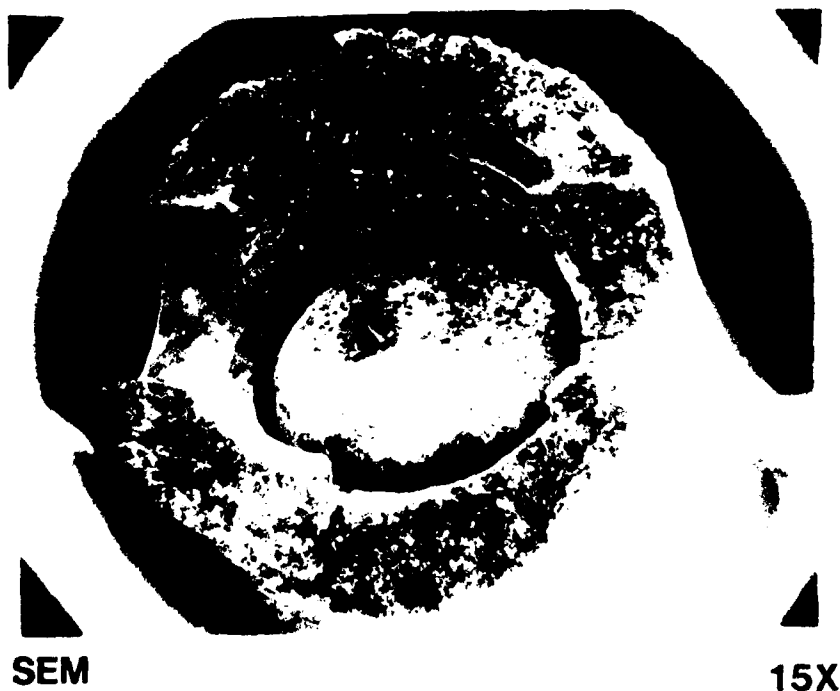
FIGURE A-5. TOPOGRAPHY OF FRACTURE SURFACE

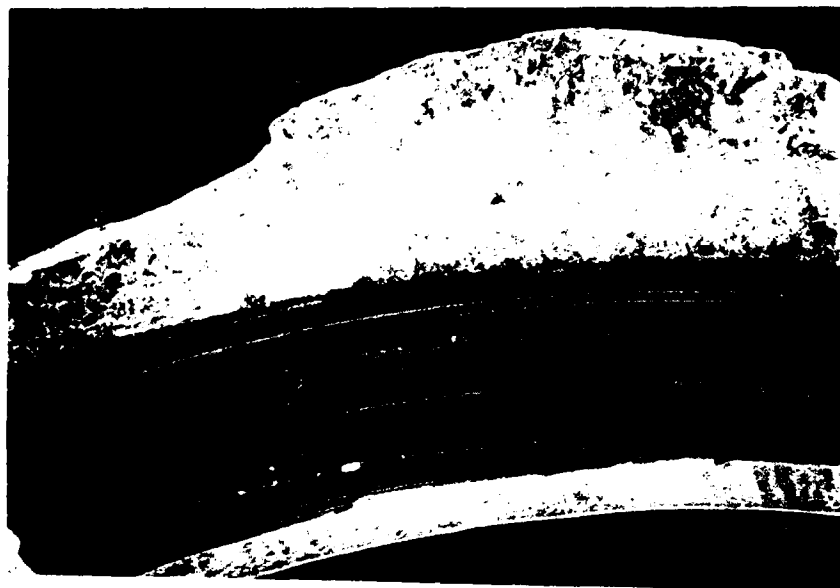
prominent shear lips as shown in Figure 8. The elongated dimple rupture as shown in Figure 8 indicates that the material failed in a ductile manner at room temperature. The elevated temperature failure was flat and intergranular as shown in Figure 9. Comparison of the test program failure with the crash failures revealed that the crash fractures have characteristics that were most similar to the elevated temperature failures, as shown in Figure 6.

FIGURE A-8A. SURFACE AFTER FRACTURE AT ROOM TEMPERATURE SHOWING SHEAR LIPS

FIGURE A-8B. SURFACE AFTER FRACTURE AT ROOM TEMPERATURE SHOWING ELONGATED DIMPLES
