**NAVAL WEAPONS
STATION
CHARLESTON
FLEET MOORINGS
UNDERWATER
INSPECTION
REPORT**

JUNE 1985

**OCEAN ENGINEERING
AND CONSTRUCTION PROJECT OFFICE
CHESAPEAKE DIVISION
NAVAL FACILITIES ENGINEERING
COMMAND
WASHINGTON, D.C. 20374**

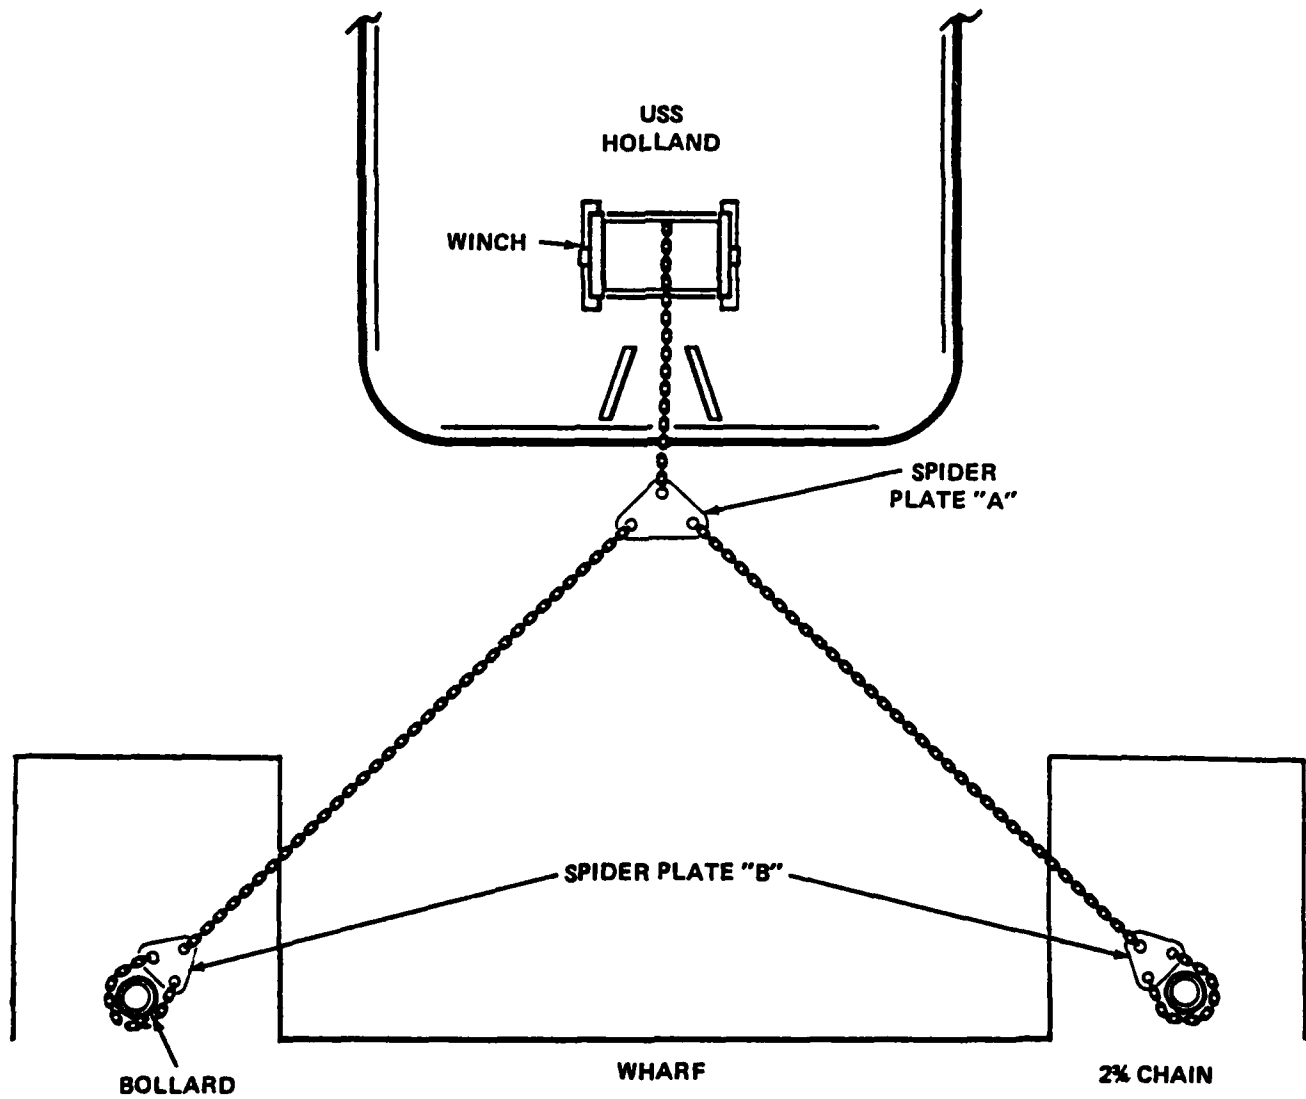
Figure A-2. USS HOLLAND (AS-32) Stern Legs

Stern Legs. The stern legs consist of 3 1/2-inch cast and Dilok chain and are connected to the southeast end of Pier C. Chain measurements were greater than 90 percent of original wire diameter but showed some surface rust. A schematic diagram of the moorings stern leg assemblies is contained in Figure A-2.

- o The visible portions of the bow legs and the stern legs are in good condition.
- o The retriever buoys are in good condition.
- o When the tender is away from the mooring, the stern legs are dropped in the water. To reduce corrosion, it is recommended that the stern legs be placed on the pier when not in use.

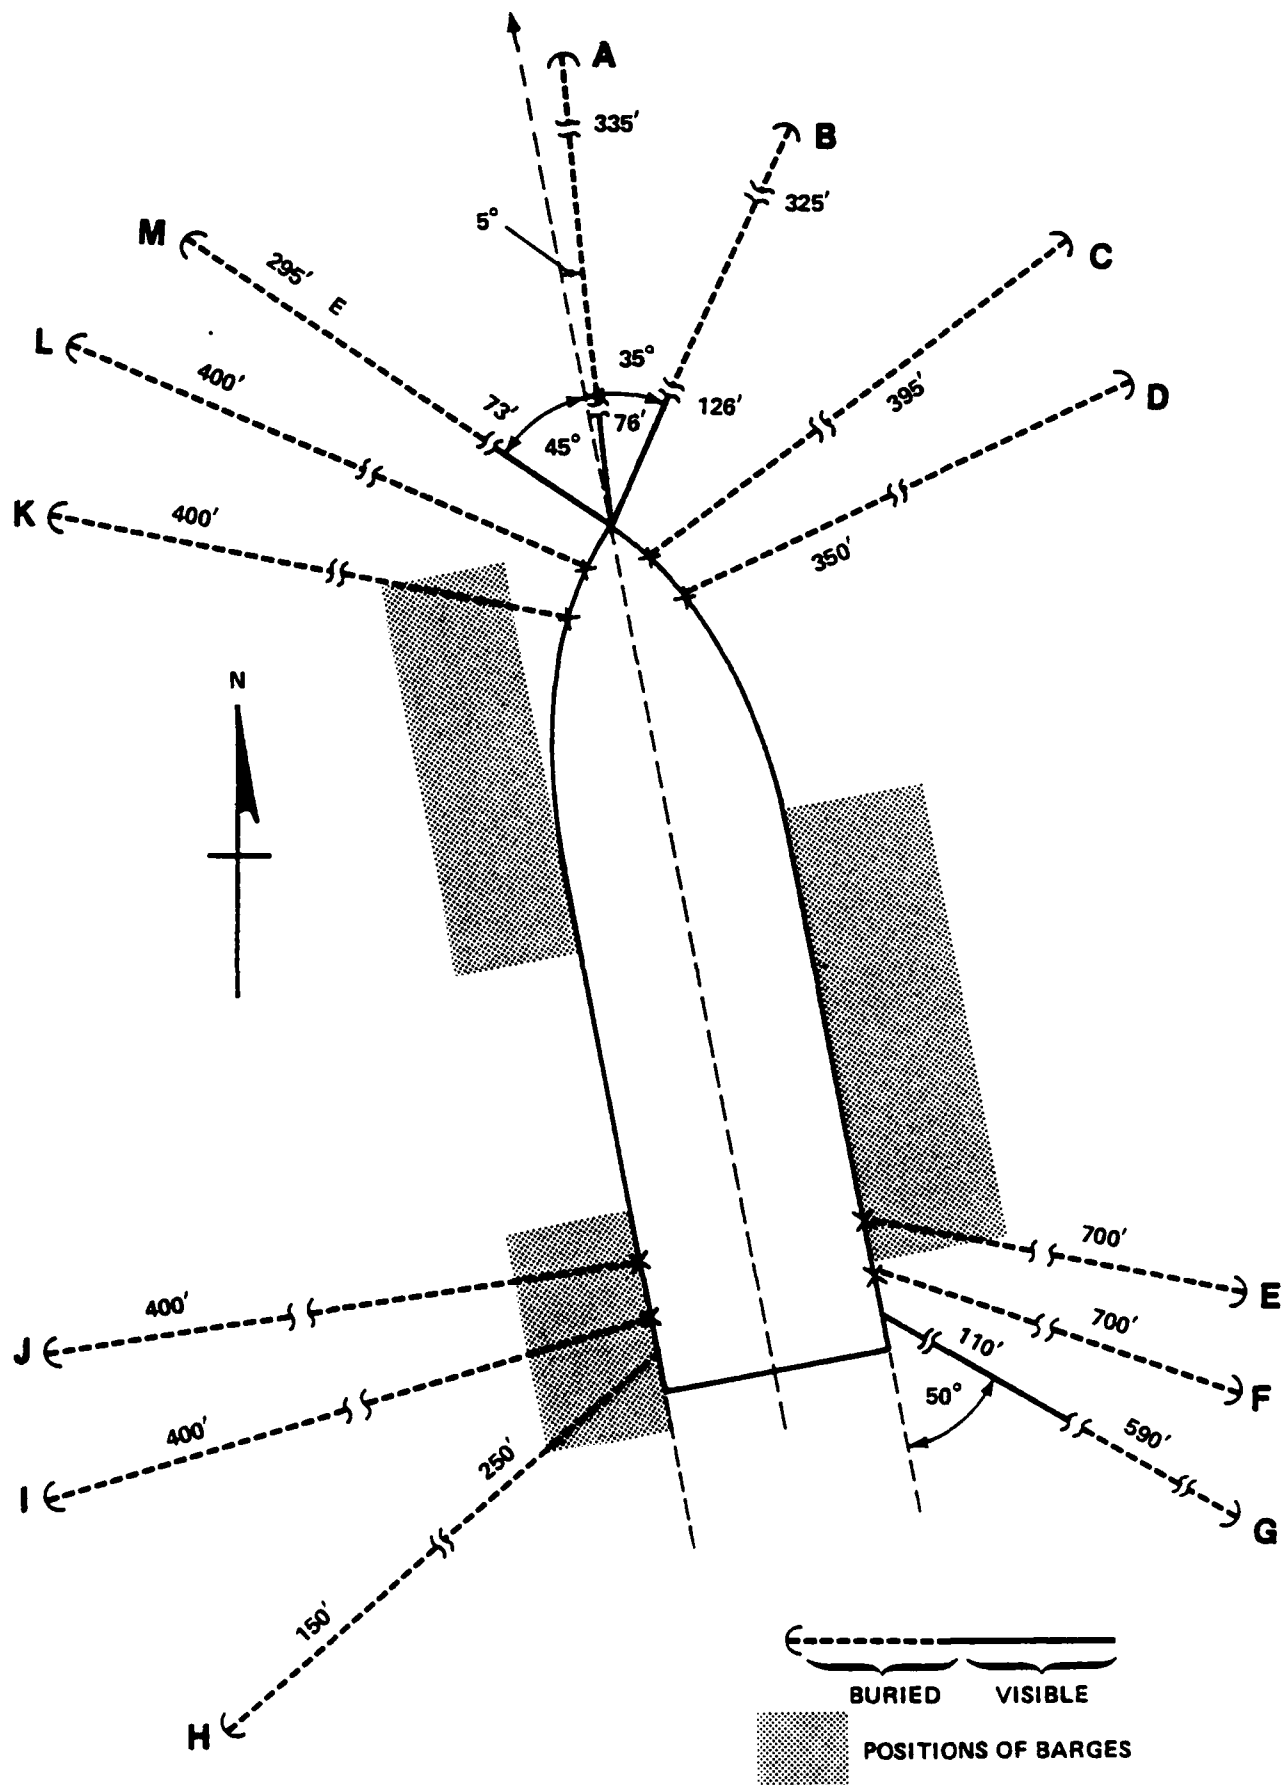
Figure A-5. ARDM LEG POSITIONS

Except for some heavy pitting and rusting, the chain appears to be in fair to good condition. Only four legs out of the eight inspected have catenaries and Table A-1 shows the measurements for these legs. The remaining four legs are slack and drop vertically into the bottom. Figure A-5 shows which legs are under tension, while Table A-2 provides a summation of the condition of the ARDM-2 ground legs.

- o Four legs, (A, B, G, and M), out of the eight inspected have catenaries. The other four legs, (C, D, F and L), drop vertically into the bottom. Tightening these legs should prevent some of the lateral motion noted.

- o Ground legs J and K were not inspected this time because of barge positions. Both legs, at last inspection, measured near 80 percent of their original wire diameter. It is recommended that these legs be changed out during the next scheduled maintenance period.

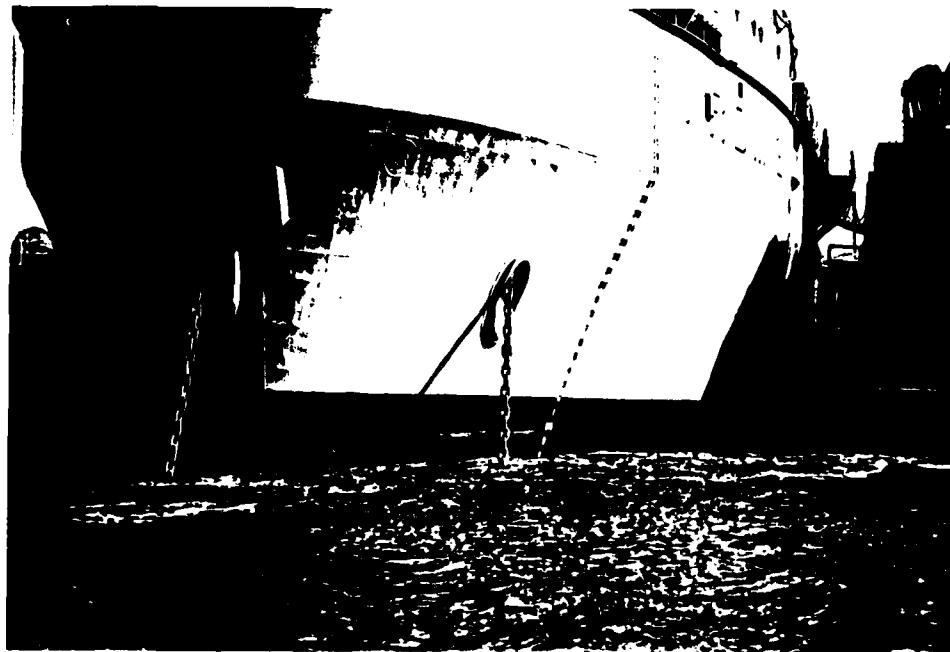
ARDM 2 Bow Chains in
Good Condition.
