# UNDERWATER FACILITIES INSPECTIONS & ASSESSMENTS

NAVAL AIR STATION,  
NORTH ISLAND  
SAN DIEGO, CALIFORNIA

FPO-1-84(19)

OCTOBER 1984

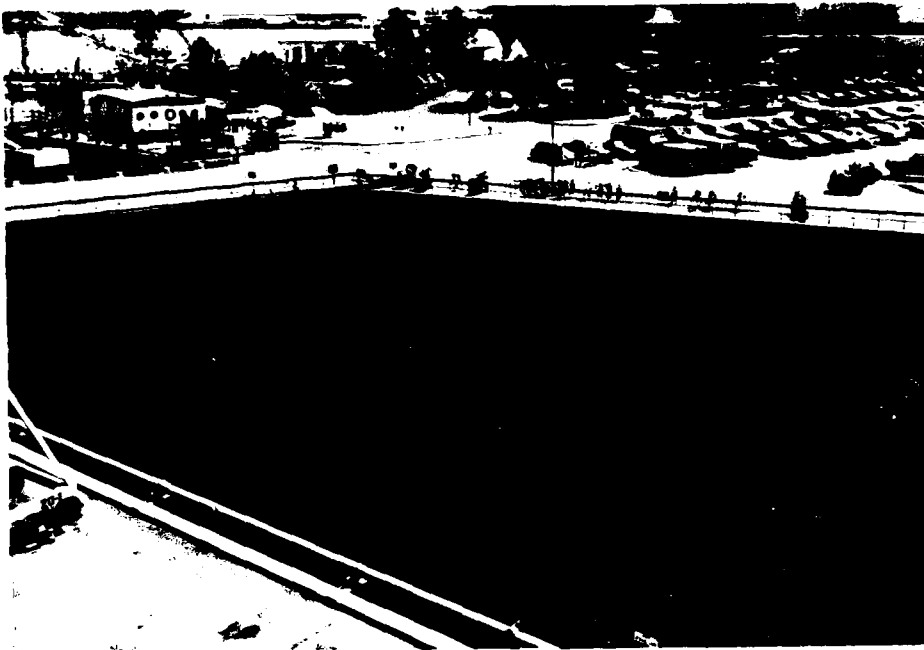
1. Old Air Station Bulkhead at Pier J/K. Picture from derrick platform looking South.

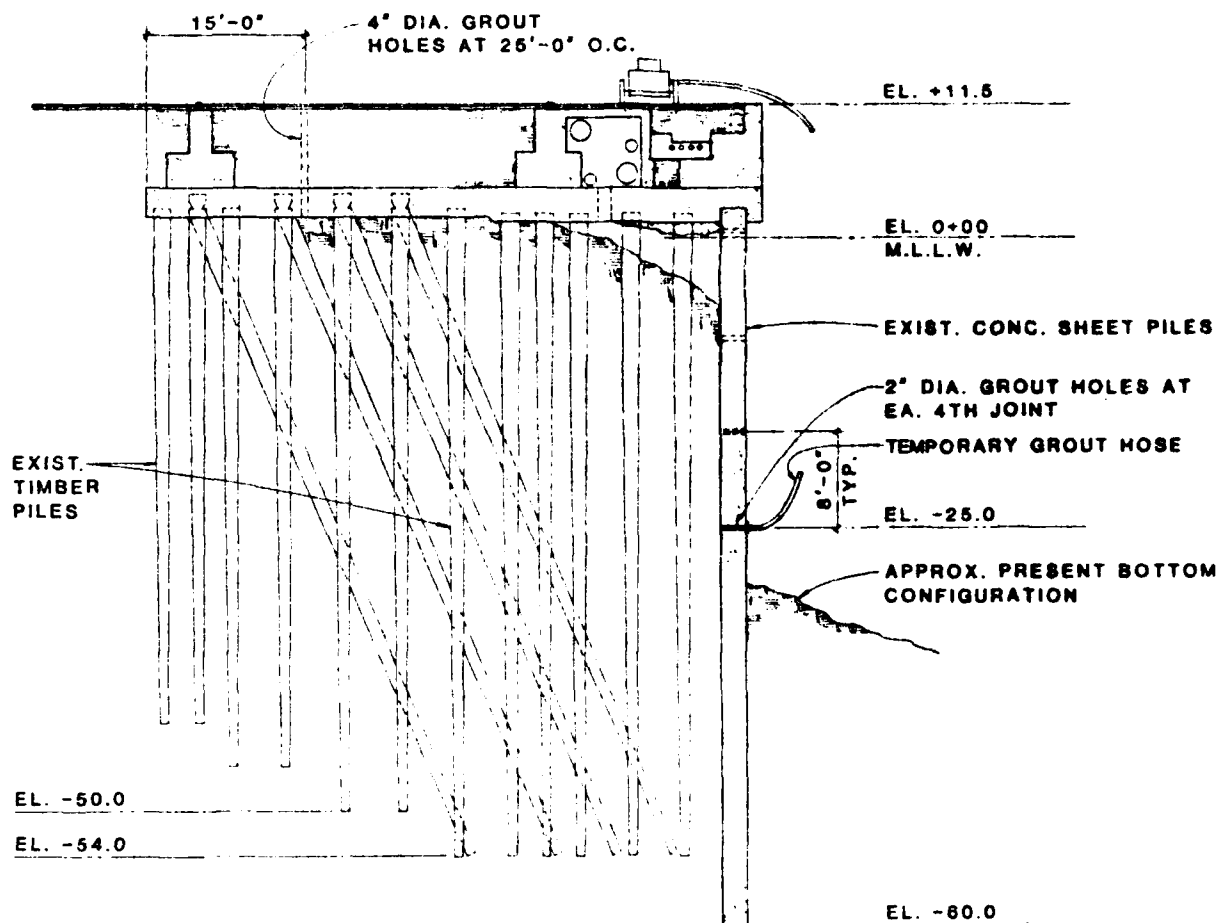
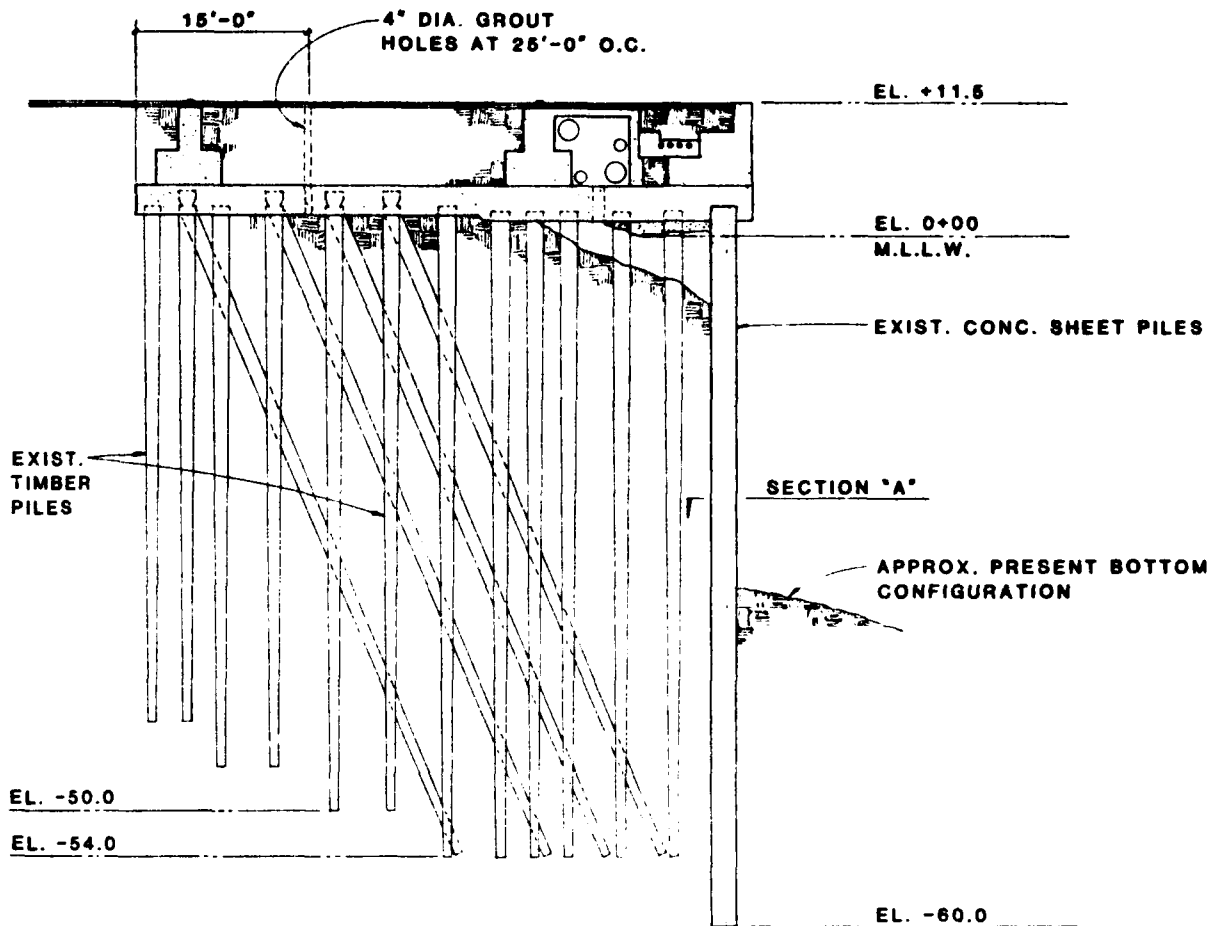
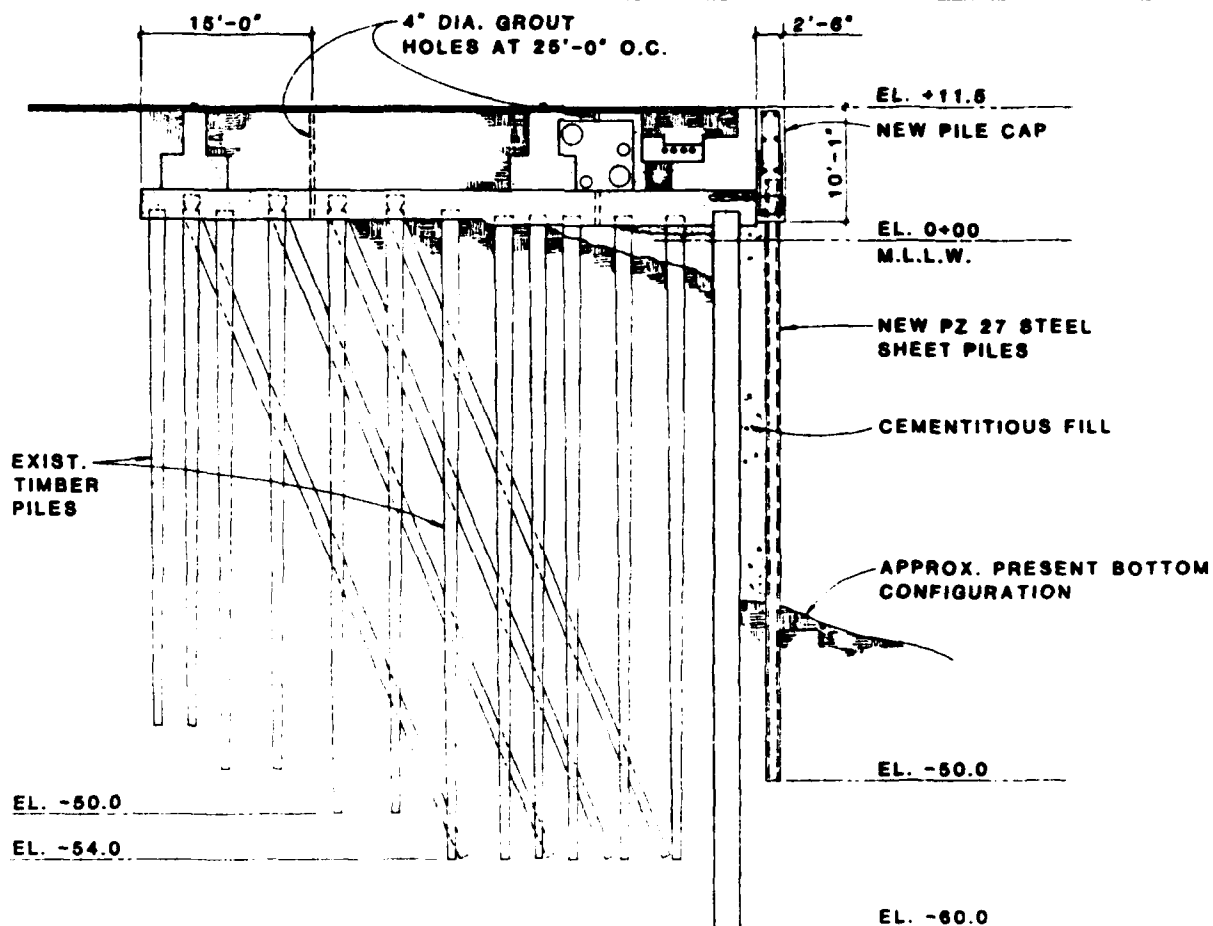
Method 2 would appear to rely very heavily on the selection and successful filling of small joints. Future leakage of the lower wall is also a problem.

Method 3 although the most expensive has the greatest chance of complete success of all methods. This method is recommended.
