UNDERWATER INSPECTION  
AND RECOMMENDATIONS FOR THE  
BRIGHTON DAM ACOUSTIC FACILITY  
Naval Surface Weapons Center  
Brighton, Maryland

FPO-1-84 (40)  
March 1985

William N. Seelig, P.E.  
and  
James Hansen

OCEAN ENGINEERING & CONSTRUCTION PROJECT OFFICE  
CHESAPEAKE DIVISION  
NAVAL FACILITIES ENGINEERING COMMAND  
WASHINGTON, DC 20374

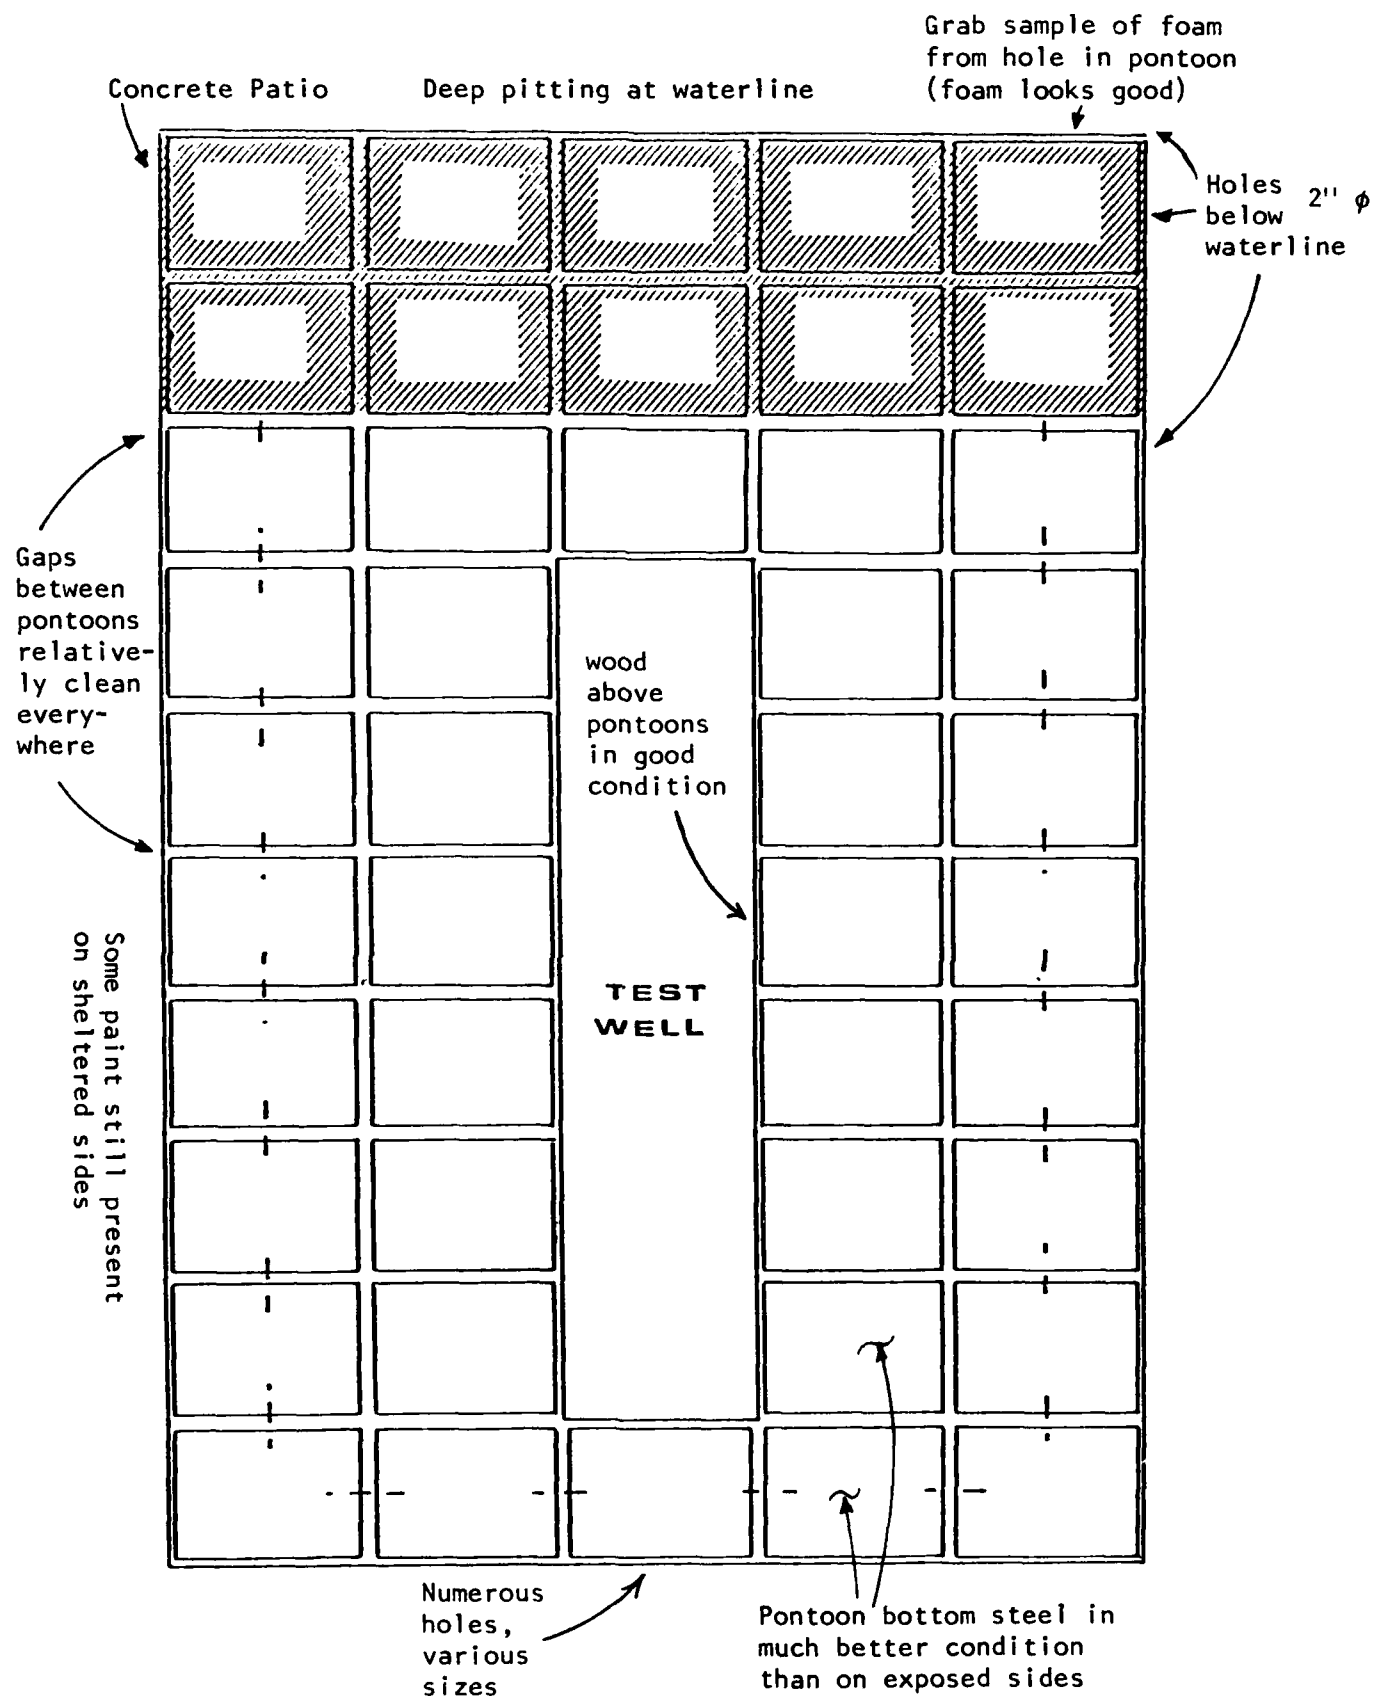
Figure 5. Underwater Inspection Notes

3. Corrosion occurs from the waterline to one-foot below the waterline on the faces of the pontoons (see Figure 5). A number of holes are present in pontoons A-5, C-5 and K-3. The combined action of small waves and/or ice motion is probably responsible for the corrosion and damage near the waterline.

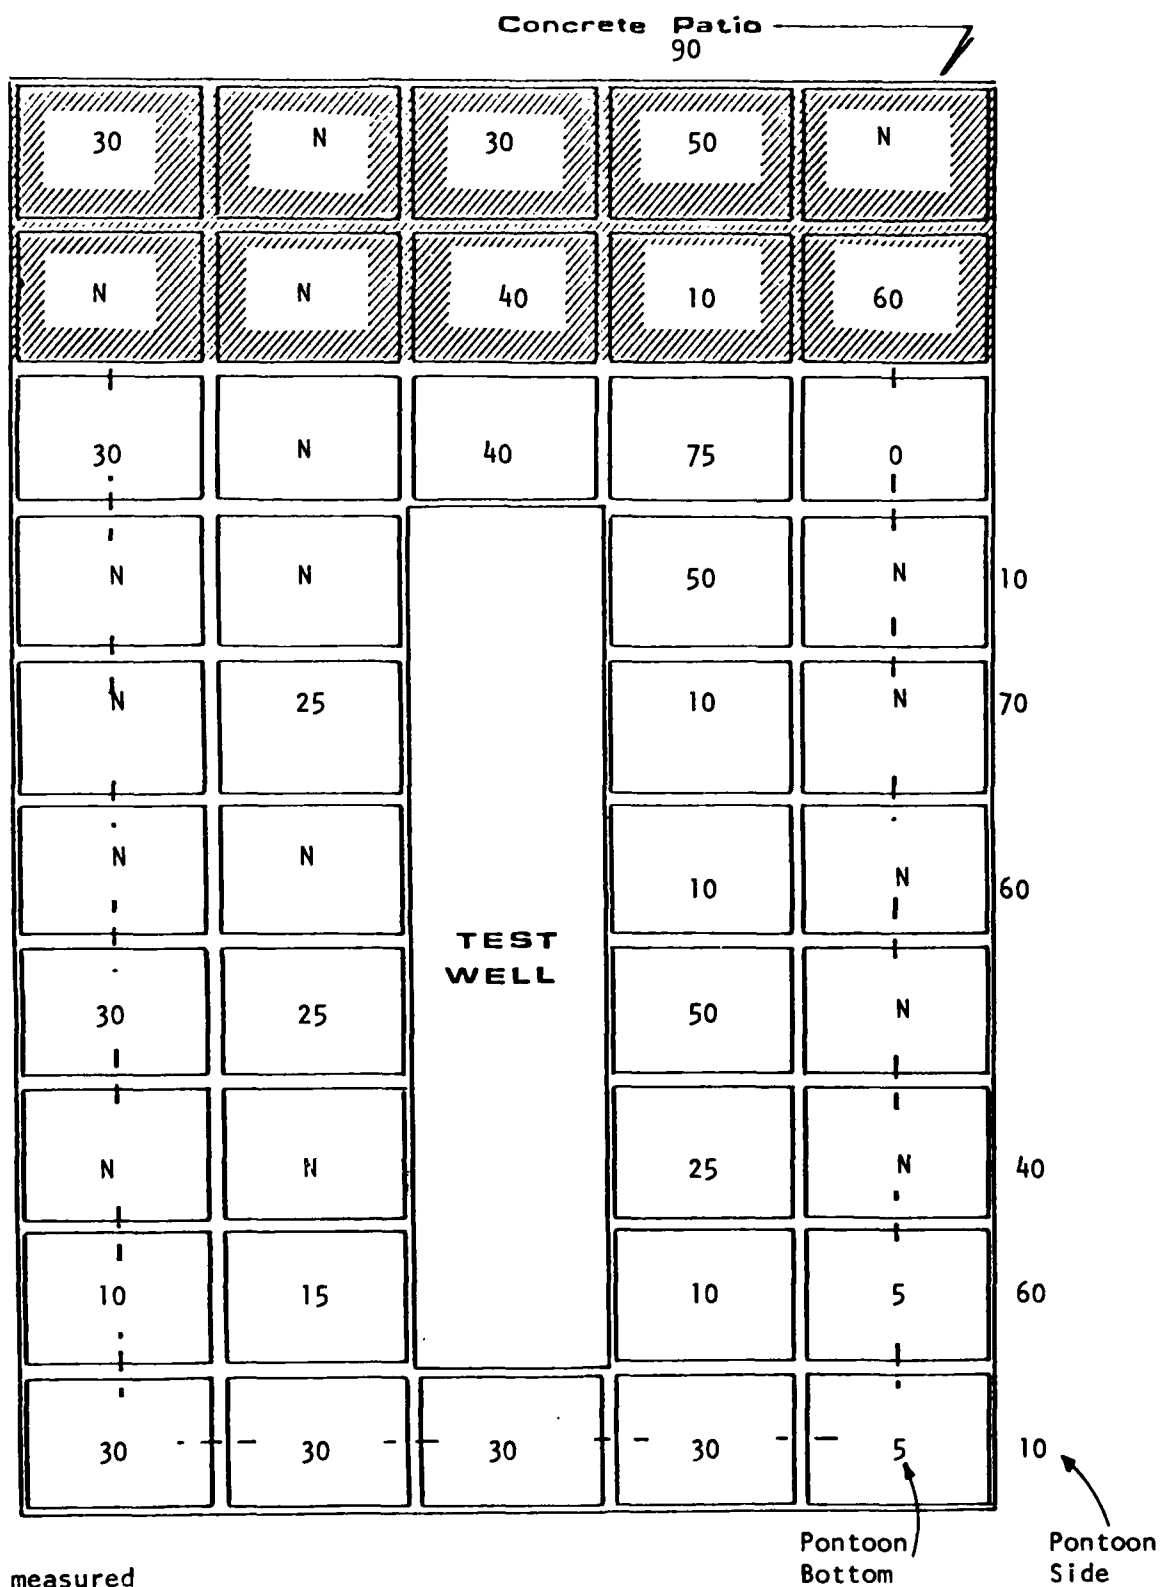
Figure 6. Percent of Cleaned Area That has Pitting

4. Pitting type corrosion controls elsewhere (Figure 6). The amount of pitting varies from one pontoon to the next and from one spot on a pontoon to another. These "hot spots" of corrosion may be in part due to imperfections in the metal and break down in the coating system.

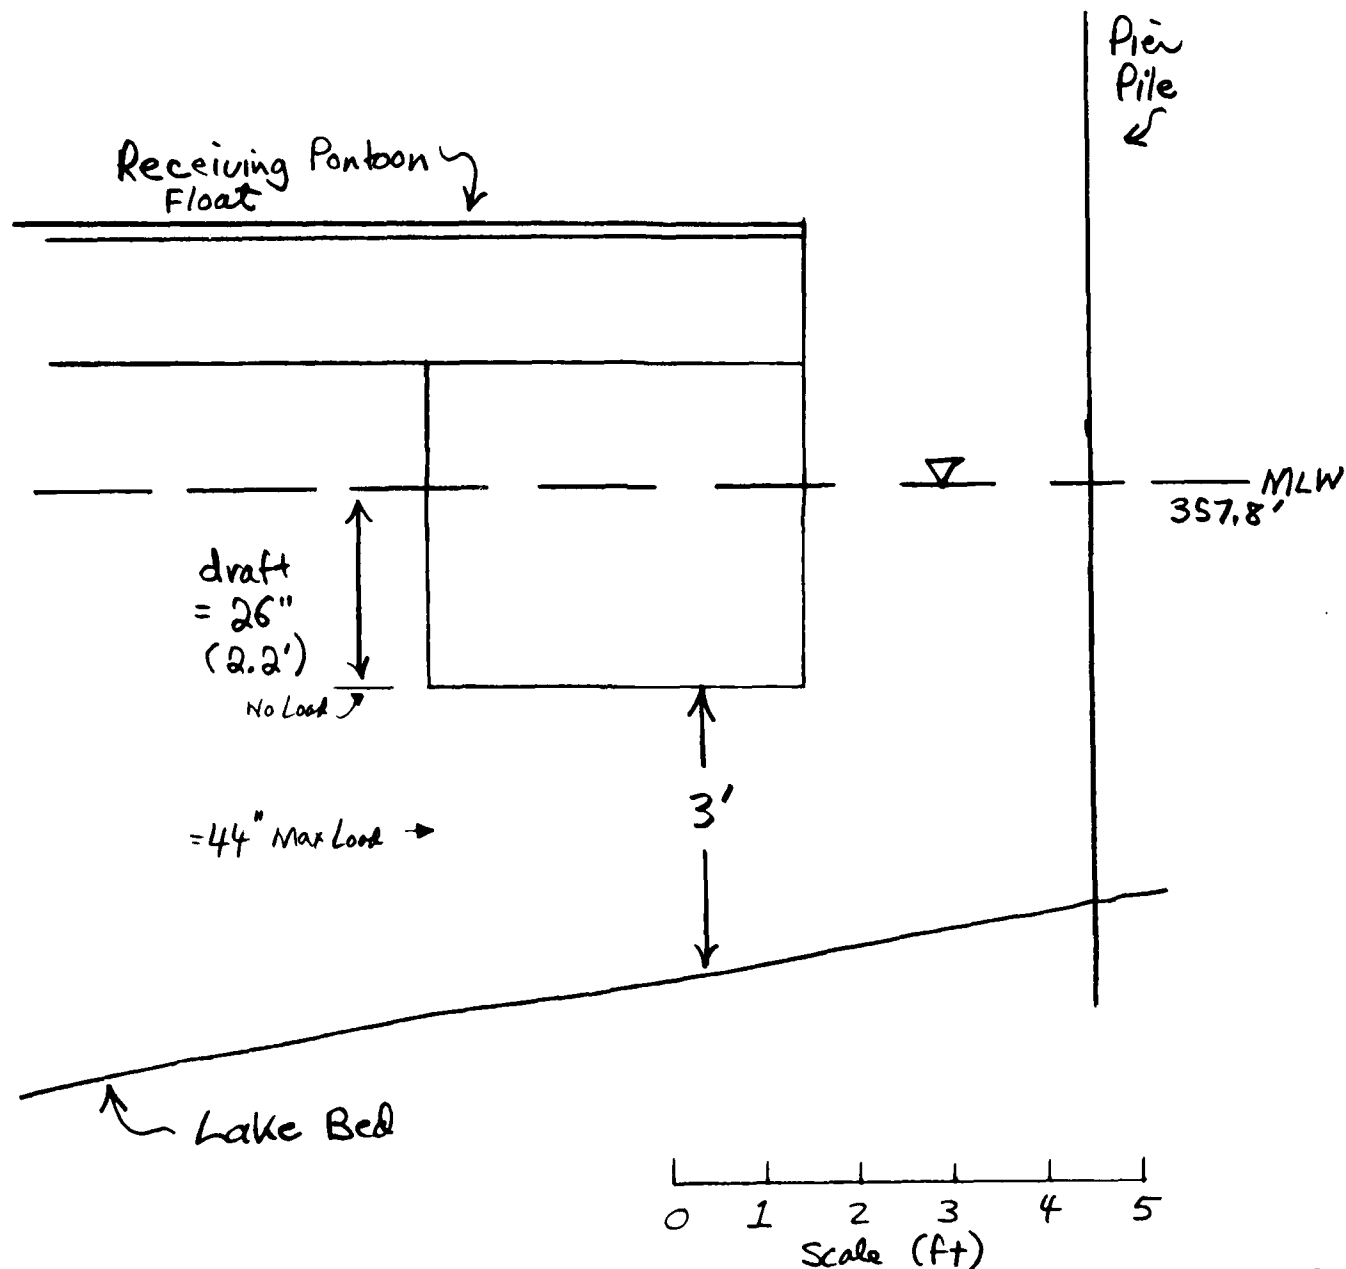
Sketch 1.

When the lake level is less than 357.8', then the pontoons rest on the lake bed and the receiving float slopes (see Sketch 2). The lake level is lowered for periodic maintenance of the dam conducted every four or five years (phonecall to Michael Greer, WSSC, 3/25/85 phone 774-9124) or when emergency repairs need to be made. Repairs are most often made during the winter months of January and February. For example, 21-23 Jan 85 the lake level was drawn down to 348.4' for dam repairs. The lake level is most often low during the winter. Ice on the sloping receiving platform produces hazardous working conditions.

Redesign of the receiving float could save between 2.0' and 2.7' of pontoon draft (depending on loading) and thereby reduce the range of conditions when the pontoon hits the lake bed. The attached analysis outlines a proposed design and compares performance with the present float. A new receiving float is estimated to cost \$20 K. Replacing the present float would result in minimum down time at the facility.
