UNDERWATER FACILITIES INSPECTIONS AND ASSESSMENTS AT

PHILADELPHIA NAVAL SHIPYARD

VOLUME I FILE COPY

FPO-1-83-(48) OCTOBER 1983

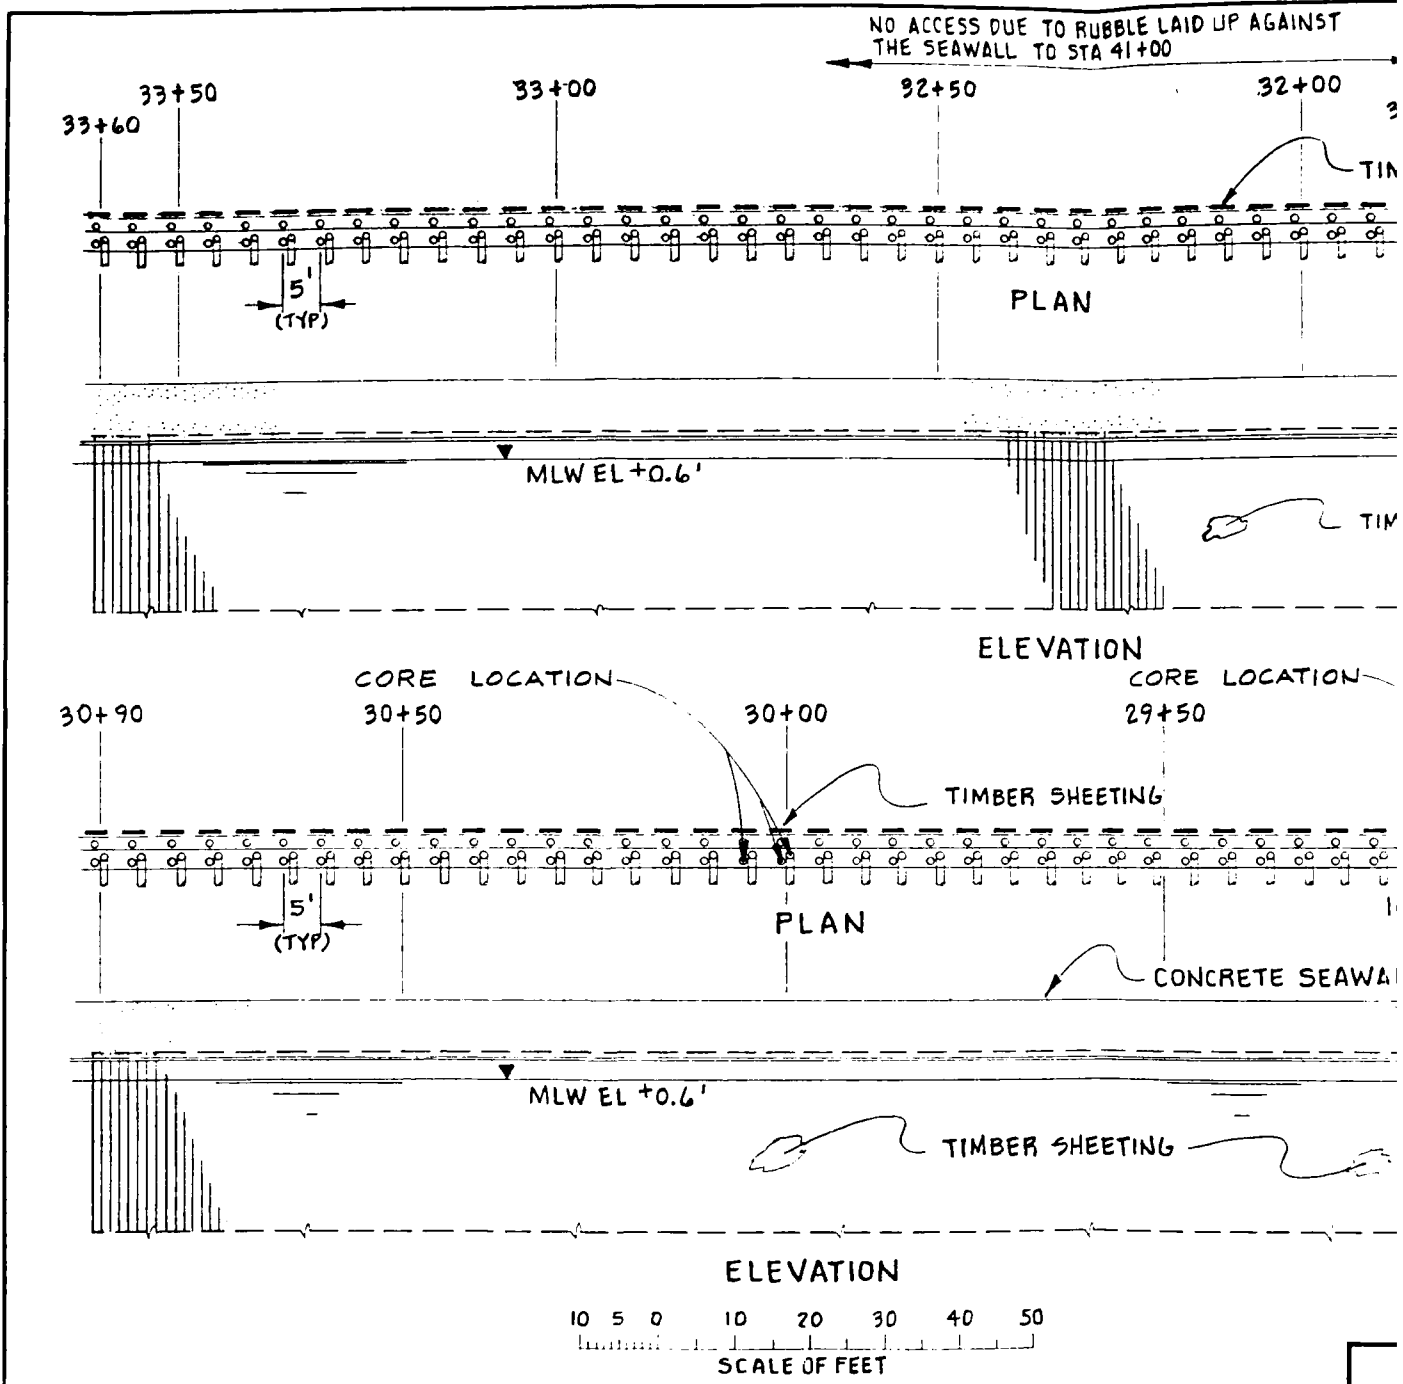
NO ACCESS DUE TO RUBBLE LAID UP AGAINST THE SEAWALL TO STA 41+00

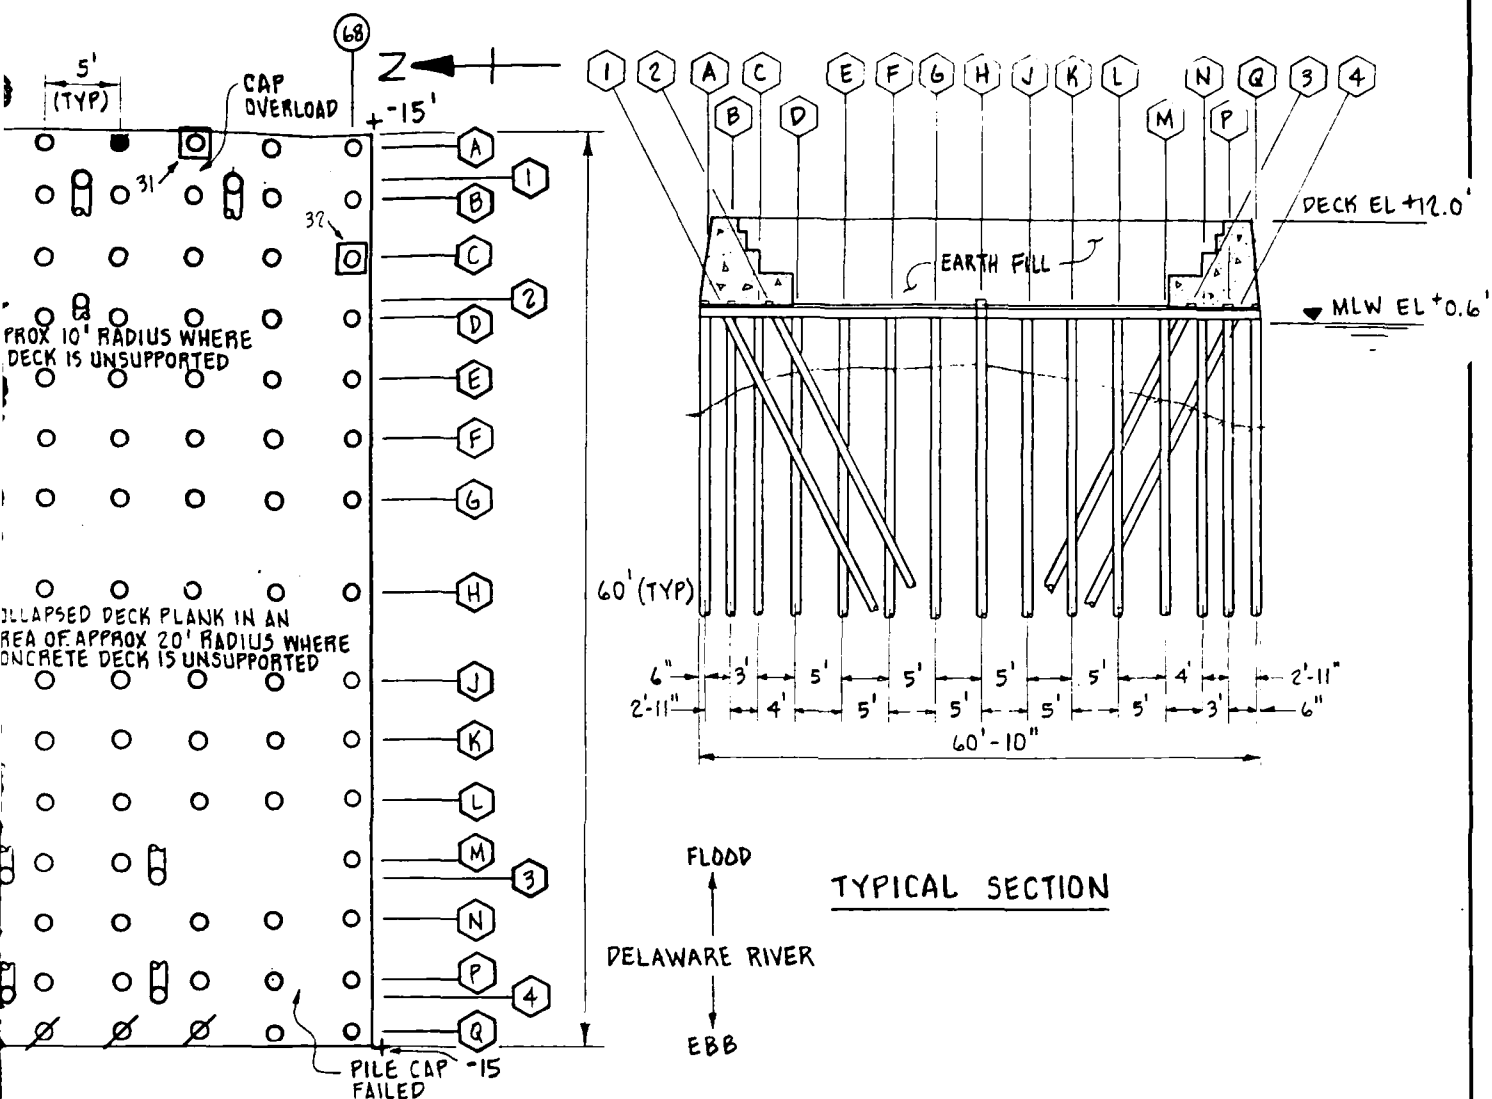
PROX 10' RADIUS WHERE DECK IS UNSUPPORTED

COLLAPSED DECK PLANK IN AN AREA OF APPROX 20' RADIUS WHERE CONCRETE DECK IS UNSUPPORTED

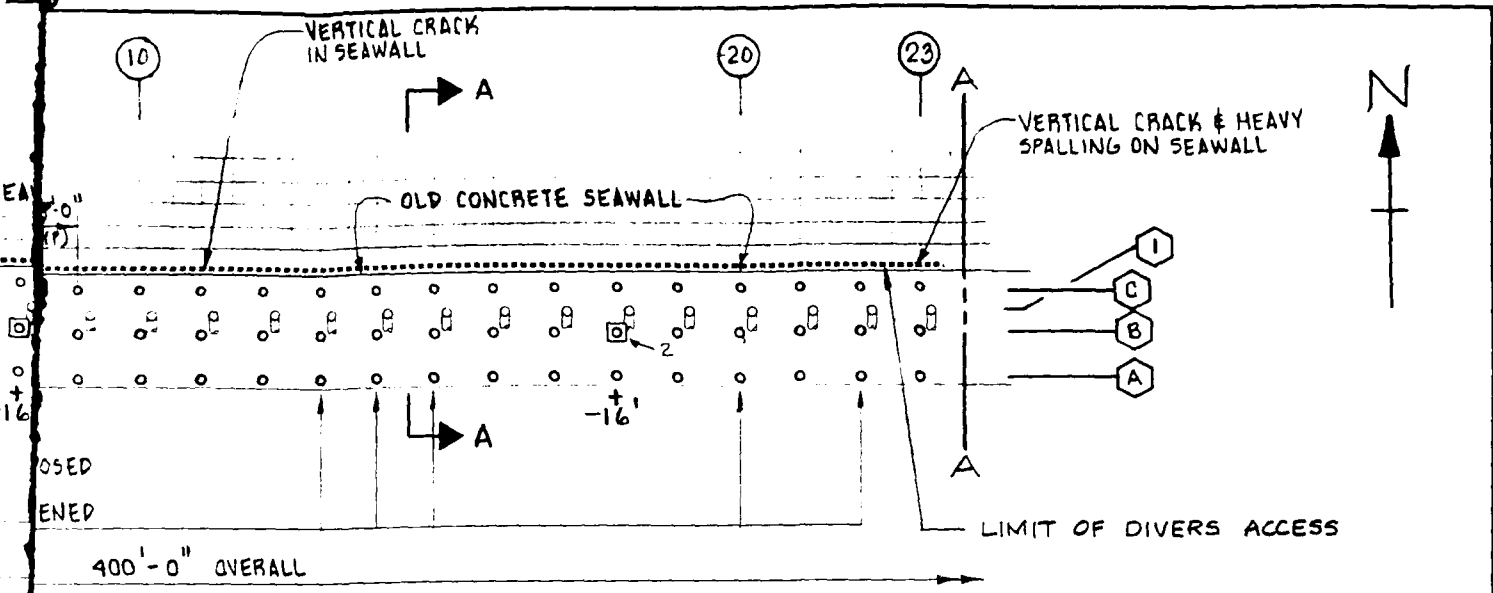
NOTE :
 MANY CONCRETE COLUMNS HAVE BEEN REPAIRED BY GUNNITE.
 LEVEL 1 INSPECTION ON ALL PILES -
 HIGHER LEVELS OF INSPECTION WHERE NOTED.
