# UNDERWATER FACILITIES INSPECTIONS & ASSESSMENTS

PIERS 2, 7 AND 9

U. S. NAVAL STATION,  
SAN DIEGO, CALIFORNIA

FPO-1-84(23)

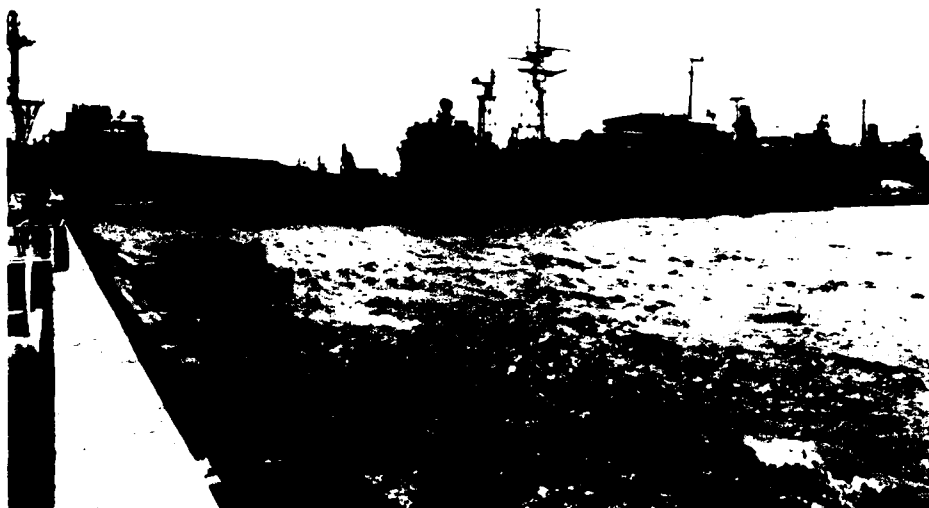
1. Pier 2 at Naval Station, San Diego, California. Picture is taken to the south.

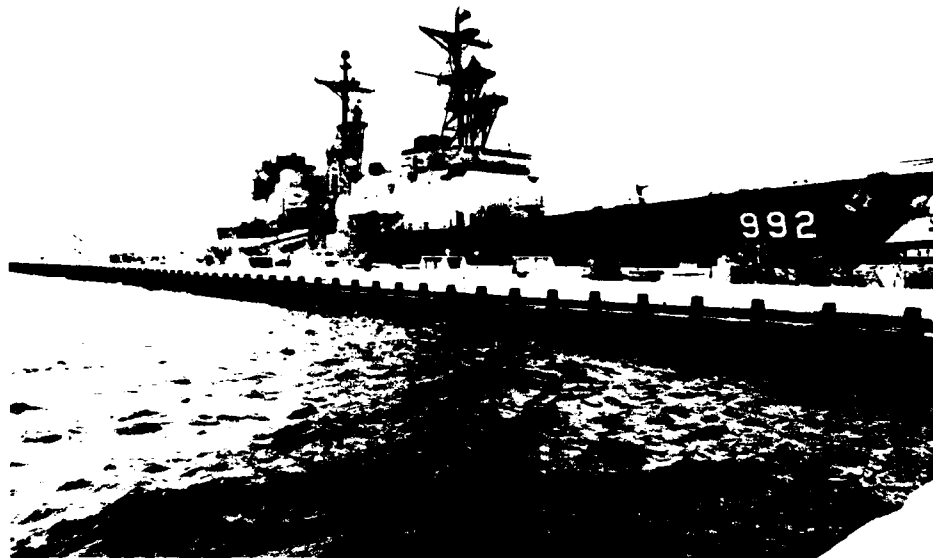
3. Pier 7 at Naval Station, San Diego, California. Picture is taken to the northwest.
