**UNDERWATER FACILITIES  
INSPECTION AND ASSESSMENT  
AT**

**MAGNETIC SILENCING FACILITIES  
NAVAL STATION  
CHARLESTON, SOUTH CAROLINA**

**FPO-1-84(39)**

**NOVEMBER 1984**

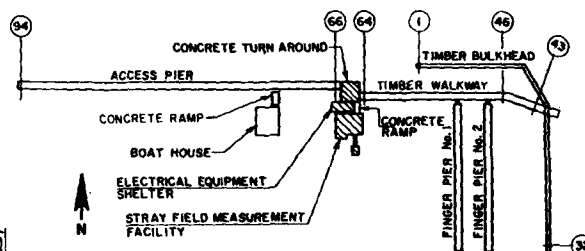
4.1-3

1. Crack  $\frac{1}{8}$  in wide on northwest corner from +4 to 0
2. Rust stained area 6 in. wide x 2 in. high, 2 ft. below pile cap.
3. Crack  $\frac{1}{8}$  in. wide on northwest corner from pile cap to mudline.

| Facility | Year Built/<br>Reconstructed | No. of<br>Piles | Facility Size<br>Length by Width | Structure Type | Recommendations* | Estimated Cost<br>of<br>Recommendations |
|---|---|---|---|---|---|---|
| Stray Field Measurement Building | 1965/1981 | 43 | 52'-0" x 68'-7" | 18" square prestressed concrete piles & Timber piles | Repair piles 1A, 1C, & 31 with epoxy grout..... | \$12,000 |

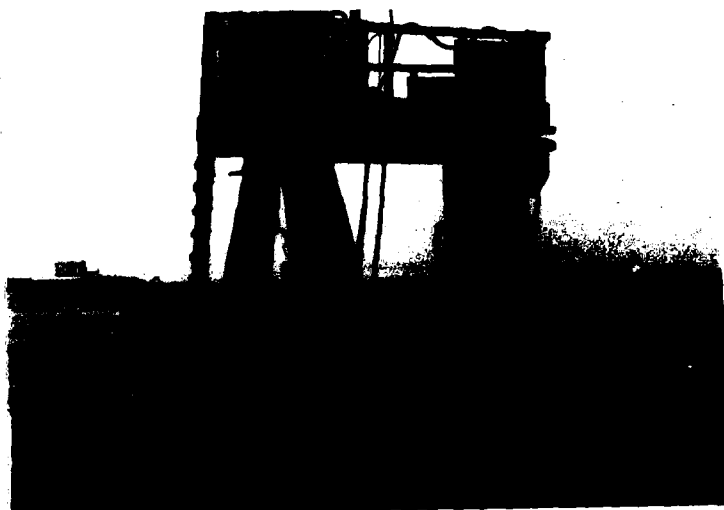
PHOTOGRAPH 4.2-3 Platform Dolphin 1.

| Facility | Year Built/<br>Reconstructed | No. of<br>Piles | Facility Size<br>Length by Width | Structure Type | Recommendations** | Estimated Cost<br>of<br>Recommendations |
|---|---|---|---|---|---|---|
| Platform<br>Dolphin 1 | Unknown | 7 | 15'± x 6'-0" | Timber and<br>prestressed<br>concrete piles | Repair concrete<br>pile cap with<br>formed concrete;<br>jacket timber piles<br>with concrete<br>and replace bracing... | \$30,000 |

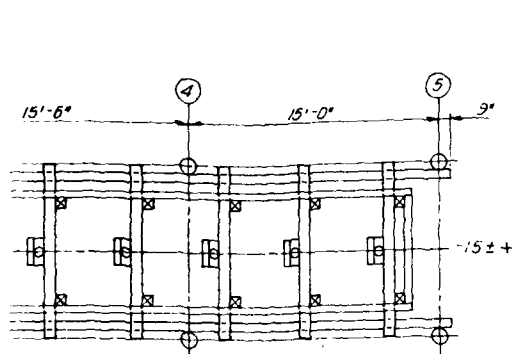
- NOTES:**
1. All instrument tubes in good condition; vertical within  $\pm 1^\circ$ ; no tags on tubes.
  2. Crib generally in good condition; minor holes in sheeting near east end of crib.
  3. No undermining of crib.
  4. Top timbers displaced  $6'' \pm$  at joint.

| Facility | Year Built/<br>Reconstructed | No. of<br>Piles | Facility Size<br>Length by Width | Structure Type | Recommendations** | Estimated Cost<br>of<br>Recommendations |
|---|---|---|---|---|---|---|
| Rock Crib | 1969 | — | 63'-0" x 11'-0" | Rock-filled<br>timber crib | Repair holes in<br>sheeting with grout-<br>filled bags..... | \$25,000 |

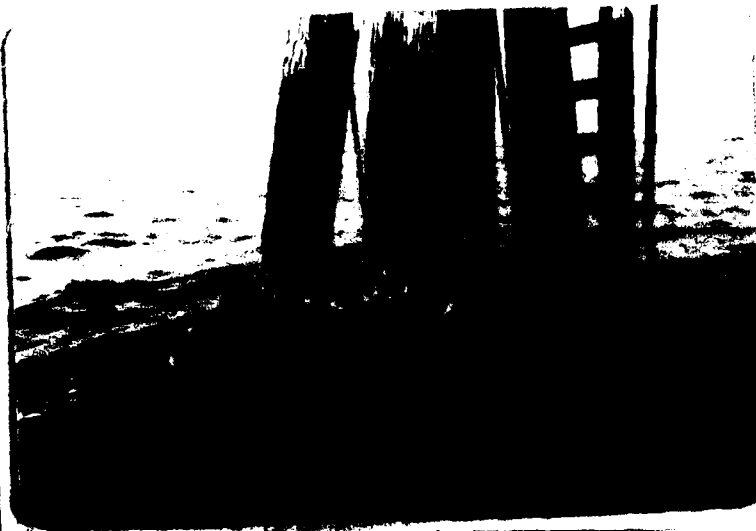
PHOTOGRAPH 4.2-13 Platform Dolphin 3 at Waterline, MSF Downtown.

| Facility | Year Built/<br>Reconstructed | No. of<br>Piles | Facility Size<br>Length by Width | Structure Type | Recommendations** | Estimated Cost<br>of<br>Recommendations |
|---|---|---|---|---|---|---|
| Platform<br>Dolphins 2-5 | Unknown | 16 | 6'-0" x 6'-0" | Timber piles | Jacket piles with<br>concrete and<br>replace bracing..... | \$50,000 |

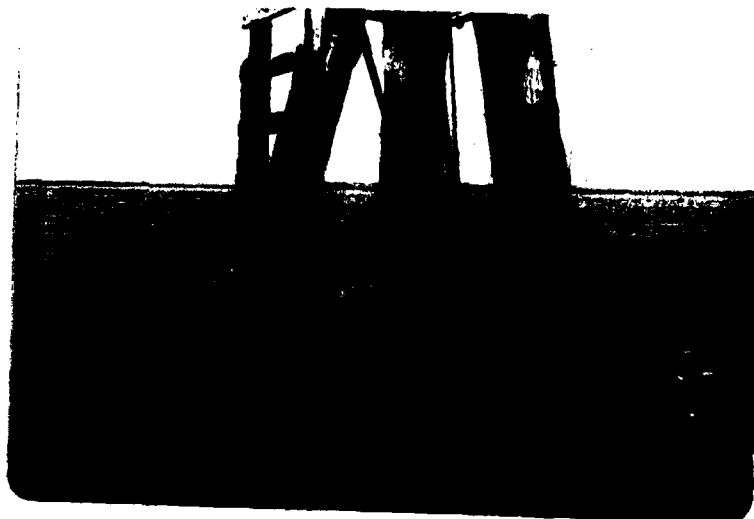
PHOTOGRAPH 4.2-14 Platform Dolphin 4 at Waterline,  
MSF Downtown.
