UNDERWATER FACILITIES INSPECTIONS AND ASSESSMENTS AT  
NAVAL TRAINING CENTE. (U) BLAYLOCK-HILLIS AND  
ASSOCIATES SAN DIEGO CA OCT 84

# UNDERWATER FACILITIES INSPECTIONS & ASSESSMENTS

FPO-1-84(21)

OCTOBER 1984

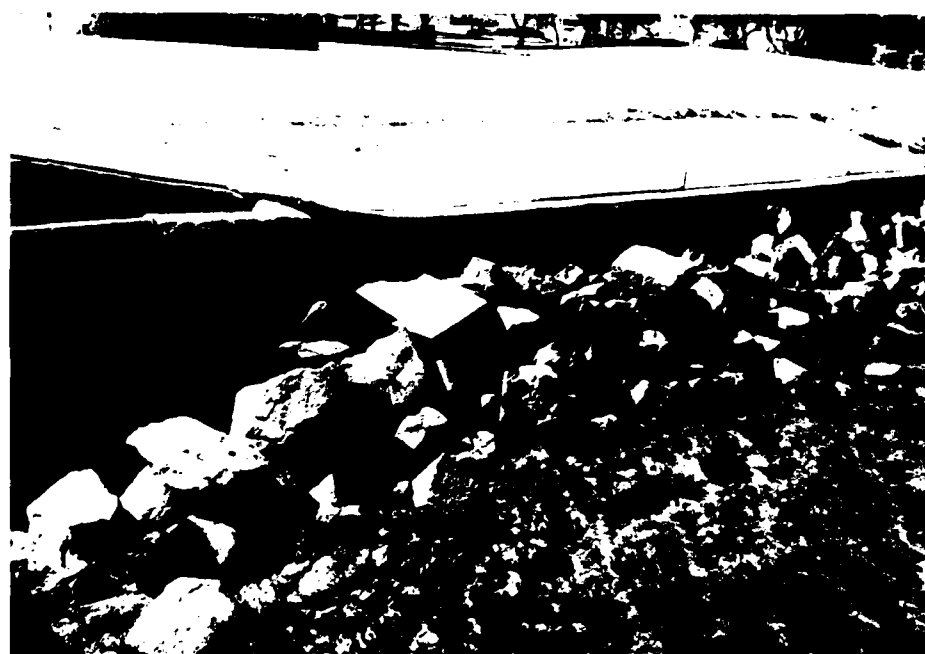
12. South Boundary Bulkhead. Picture is taken from the base of Pier 9. View is to the northwest.

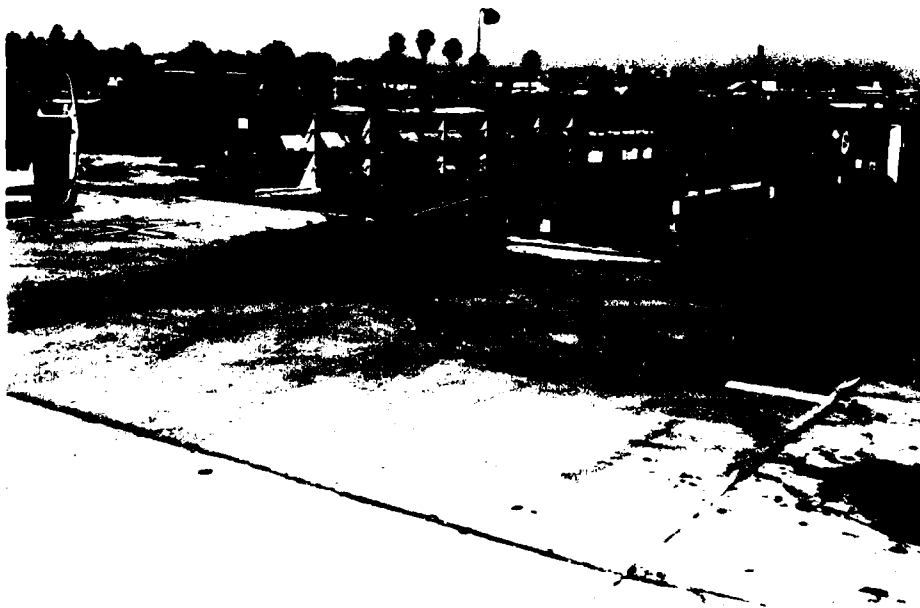
18. Pier 445. View is of surface depression above deteriorated Bulkhead.

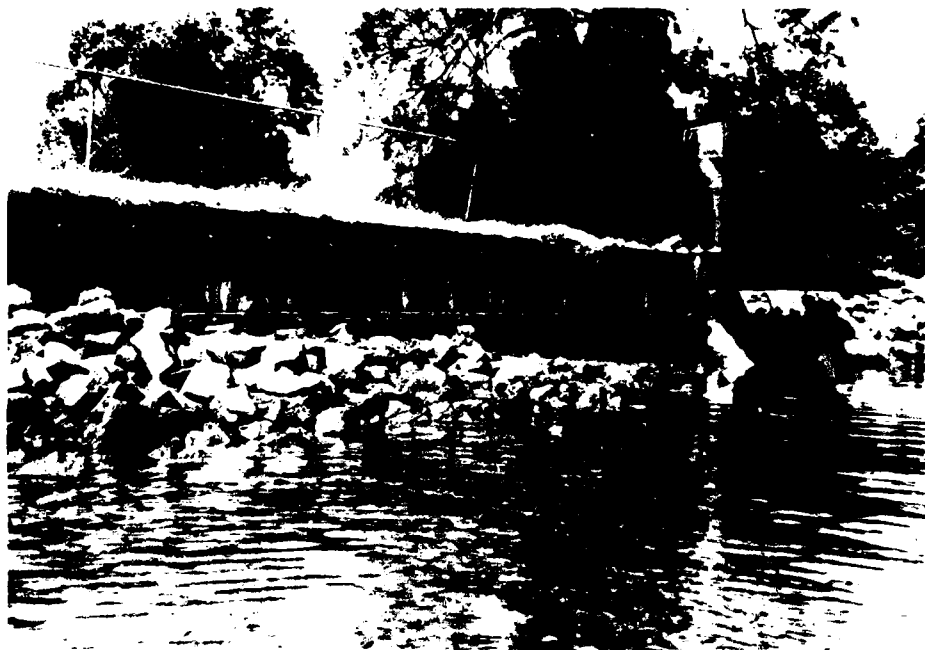
At the North Boundary, the wall exhibits similar deterioration to the Bulkhead at Pier 445. The bottom of the wall is in water at high tide and has suffered dry rot damage to both lagging and wales. A large void has occurred in the backfill at the north end of the wall.

19. North Boundary Bulkhead. Fence in the right foreground is the boundary with Marine Corps Recruit Depot. The wood has deteriorated from dry rot.

5. The North Boundary Bulkhead be replaced if the condition of the shoreline is a concern of the Training Center. No threat to life or property (except shoreline) is represented by this deteriorating wall. The cost of replacement is estimated to be \$62,800 (See Section 5 for a detailed cost estimate). It is recommended that the wall be inspected when completed.
