UNDERWATER FACILITIES
INSPECTIONS
AND
ASSESSMENTS
AT

NAVAL AIR
STATION
NEW ORLEANS, LA.

FPO-1-85-(18)

JUNE 1985

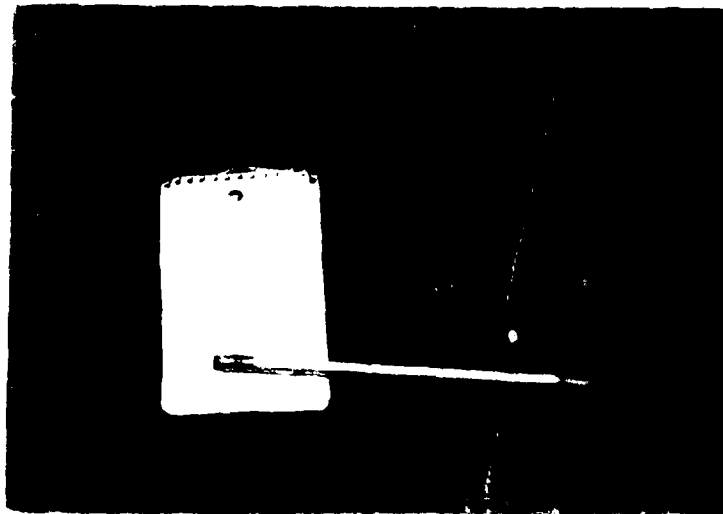
PHOTO 6

The underwater portions of all structural piling were in good condition. No evidence of marine borer activity or significant fungal decay was detected on the surface of any piles or in the extracted cores (See Photos 1, 2, 3, 4, 5 and 6). A water sample collected during the inspection indicated virtually no salinity, a condition in which marine borers cannot survive (See Appendix, Testing Laboratory Report). No significant impact or mechanical damage was detected at any structural pile. There was no evidence to suggest that an impact of sufficient magnitude to fracture a structural pile below the mudline had occurred, although 10 fender piles were broken from impact damage.

Showing cores extracted from Wharf 3, Pile 1A.

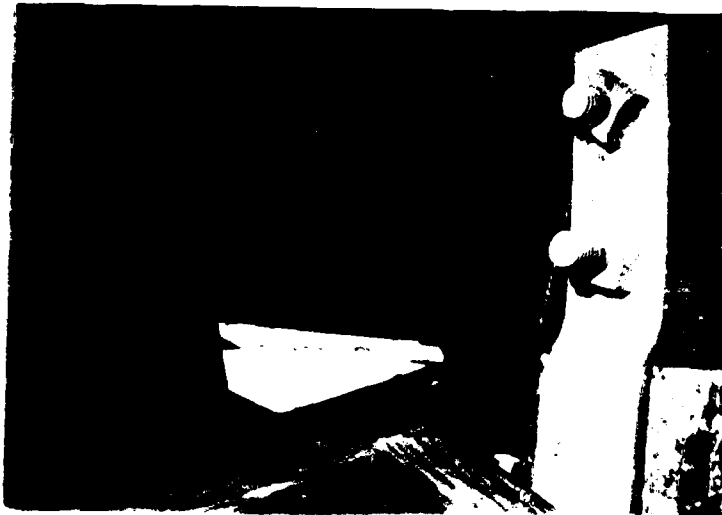
PHOTO 12

Decayed cap at Wharf 1, Bent 3 between Rows C and D.

Replacing cap members would require virtual disassembly of the superstructure. Therefore, depending on the extent of the decay, it would be desirable to repair the damaged sections by removing decayed material and refilling the voids with filler material such as epoxy grout. In some cases, where decay has not destroyed more than 50% of a section, or where decay is limited to an isolated area of a particular member, a decayed section may be spanned by spliced sections (See Figure 6). Application of moisture barriers and preservative to exposed locations would prolong the structural integrity. Top rot in timber piles should be repaired by a similar procedure. Rotten material should be removed, the void refilled and the top sealed to prevent moisture intrusion. Diagonal and horizontal braces indicated on Figure 3 should be replaced. It is often convenient to utilize the removed damaged member as a pattern for cutting the bolt holes in the replacement member. It is expected that most existing connection hardware can be re-used, but some hardware replacement will be necessary. Estimated cost to repair or replace damaged structural timbers is \$36,000 (See Appendix, Cost Estimate Calculations).
