# **INDIAN ISLAND MOORING PROJECT PHASE II COMPLETION REPORT**

**FPO - 1 - 84 (2)  
MARCH 1984**

**ROBERT TAGGART INCORPORATED  
FAIRFAX, VIRGINIA**

Phase II of the Indian Island Mooring Project is the continuation and completion of an effort initiated in June 1978 to provide a set of six fleet moorings off the west coast of Indian Island in Puget Sound. The purpose of this mooring facility is to provide a means of securing ammunition storage barges while the ships from which ammunition has been offloaded are undergoing repair or overhaul at the Puget Sound Naval Shipyard (PSNS). The facility is operated by the Naval Undersea Warfare Engineering Station (NUWES) in Keyport, Washington.

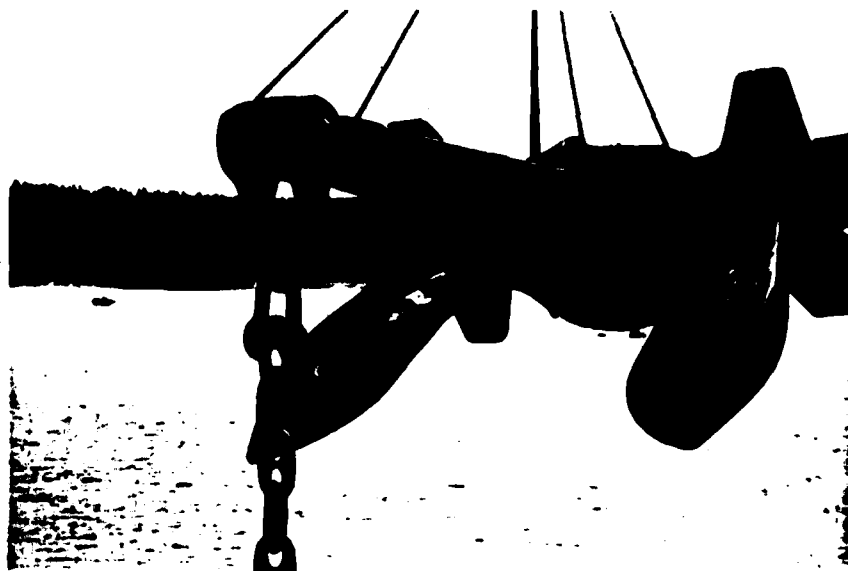
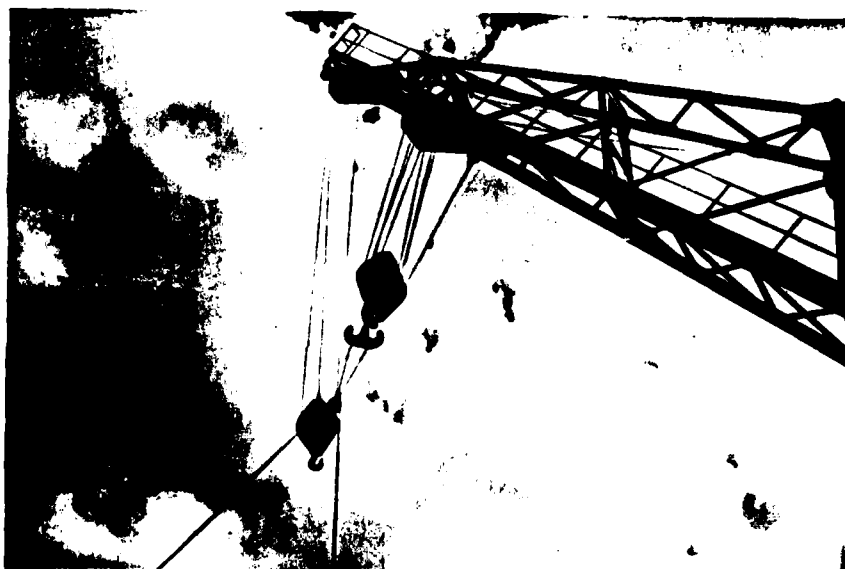
FIGURE 4-35

DAMAGED CRANE BLOCK ASSEMBLY  
ANCHOR STILL SUSPENDED

On 30 August, the Army BD crane barge was towed to Puget Sound Naval Shipyard for repairs to the damaged rigging. Fortunately, a Navy YD crane barge with operator was available at PSNS to be used as a substitute for the Indian Island mooring project. The Finger Eater was transferred from the BD to the YD and the YD was towed to Indian Island so that operations could be resumed.

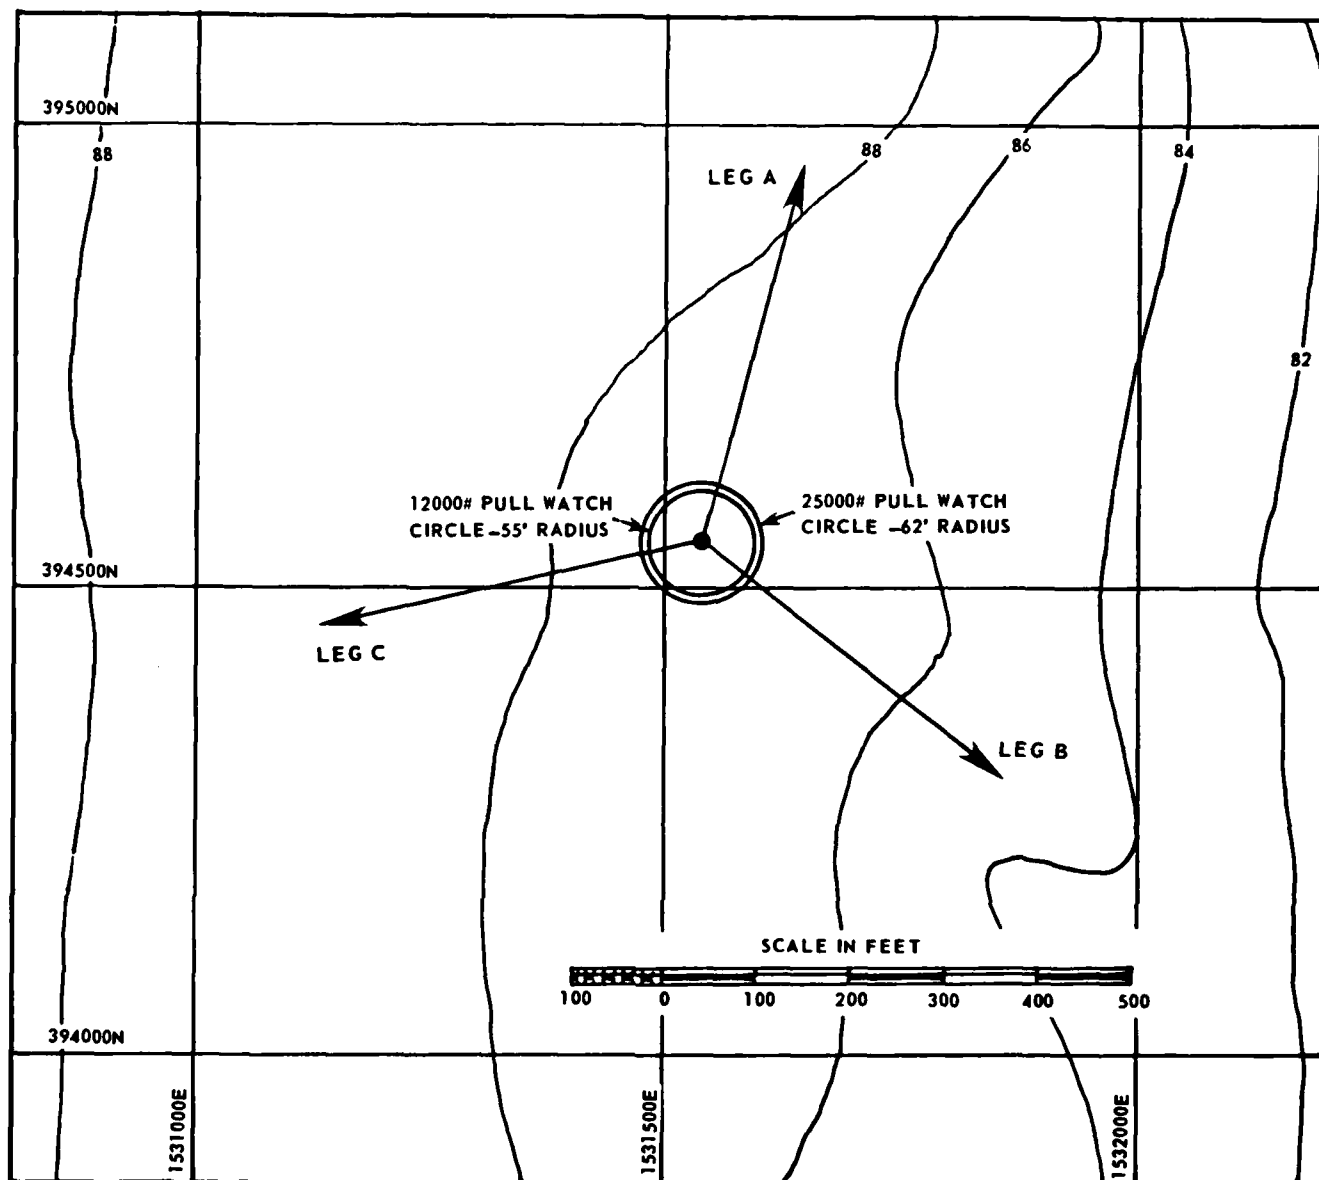
FIGURE 4-38

FINAL LOCATION OF MOORING BUOY #1 RELATIVE TO  
WASHINGTON STATE LAMBERT NORTH ZONE COORDINATES
