**UNDERWATER FACILITIES
INSPECTION AND ASSESSMENT
AT**

**ARDM
NAVAL SUBMARINE BASE
KINGS BAY, GEORGIA**

FPO-1-85(19) JUNE, 1985

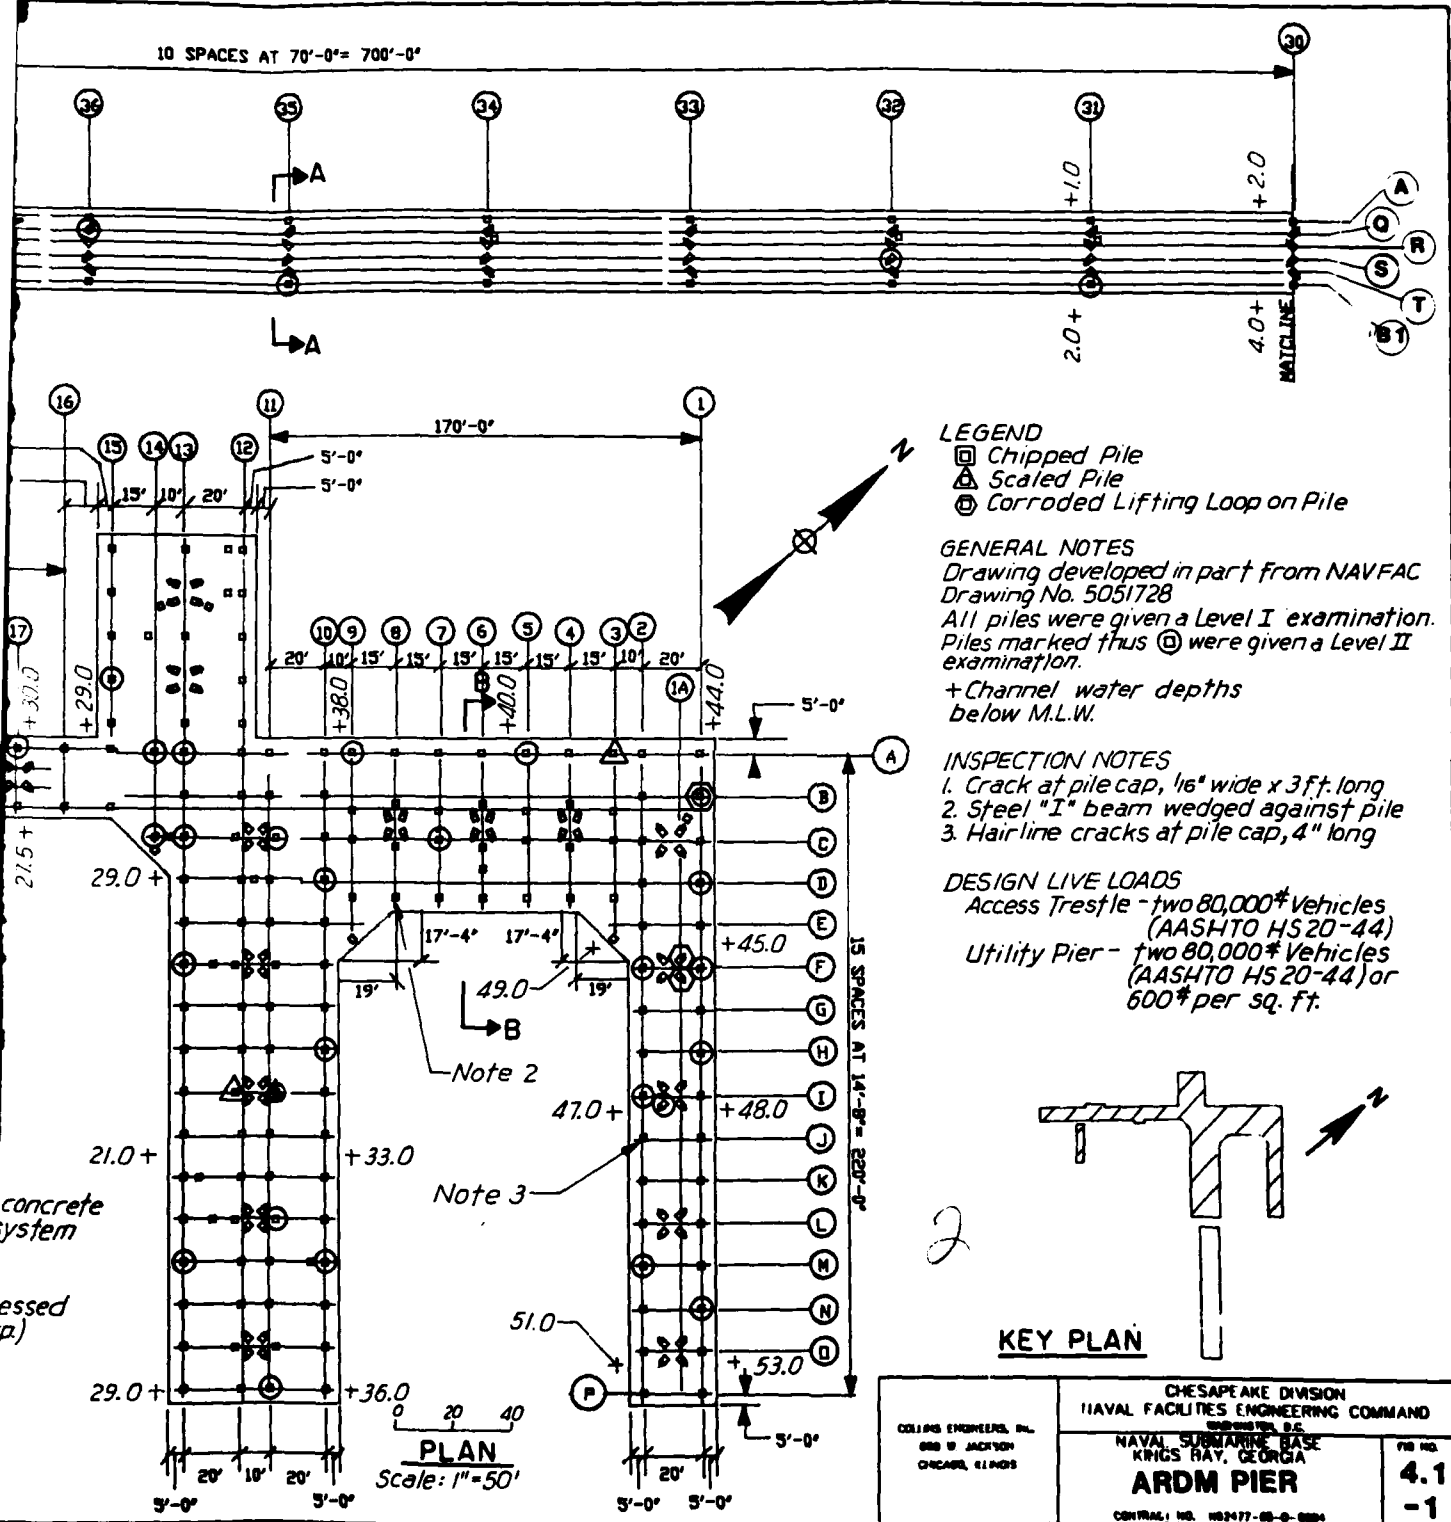
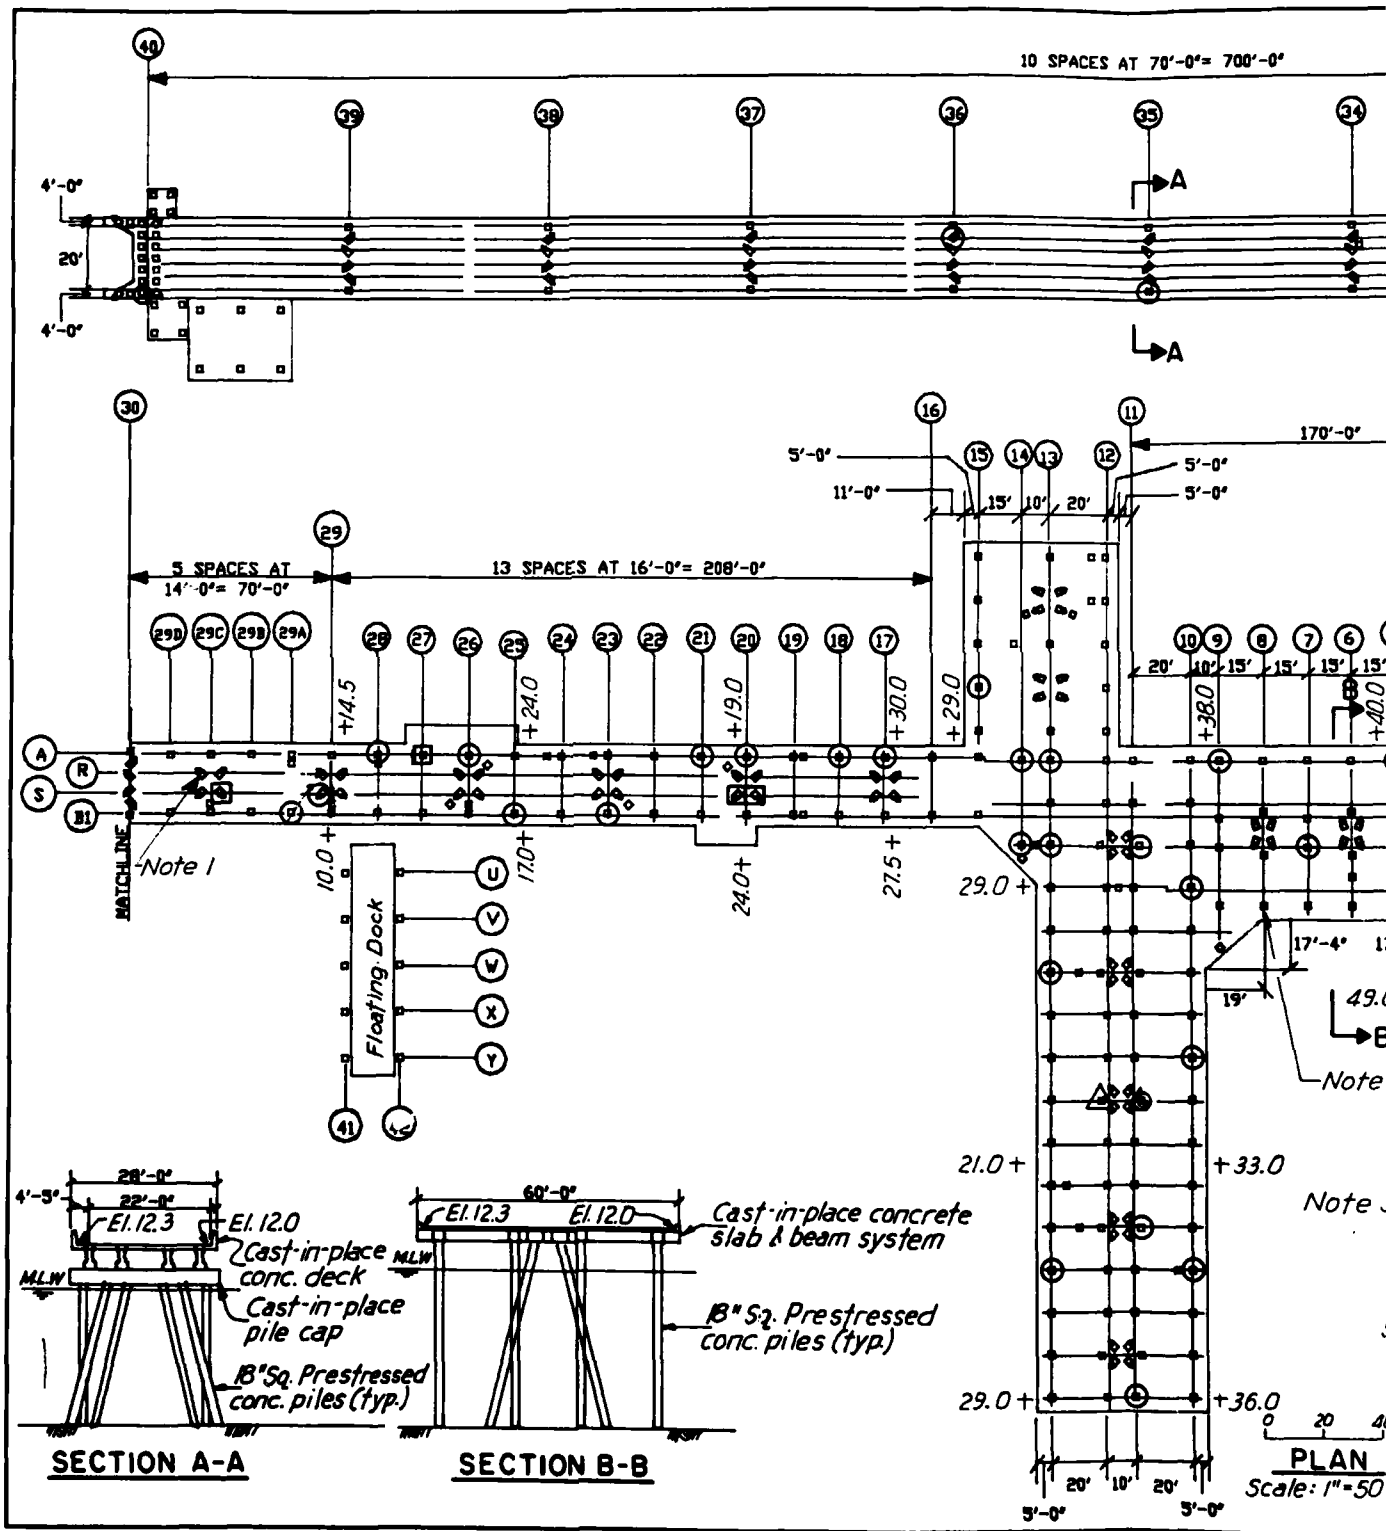
COLLINS ENGINEERS, INC. 888 W JACKSON CHICAGO, ILLINOIS	CHESAPEAKE DIVISION NAVAL FACILITIES ENGINEERING COMMAND WASHINGTON, D.C.	
	NAVAL SUBMARINE BASE KRIGS BAY, GEORGIA	
	ARDM PIER	
	FIG. NO. 4.1 -1

- Chipped Pile
- △ Scaled Pile
- ⊕ Corroded Lifting Loop on Pile

1. Crack at pile cap, 1/16" wide x 3 ft. long
2. Steel "I" beam wedged against pile
3. Hairline cracks at pile cap, 4" long

Above water, the piles were also generally found to be in excellent condition. There were, however, a few minor areas of cracking of the piles near the underside of the deck as shown in Photographs 4.1-16 and 4.1-17. These areas of distress are generally very minor and randomly located. Six piles, 29C-S outboard, 29C-R inboard, 27A, 20S inboard, 20S outboard, and 12I have minor, but measurable areas of cracking and scaling. Refer to Page A-1 in the Appendix for a summary of the defects found during the inspection.

It is recommended that the areas of scaling and minor cracking on Piles 29C-S outboard, 29C-R inboard, 27A, 20S inboard, 20S outboard, and 12I be repaired by patching with surface applied epoxy mortar. Prior to applying the mortar, any loose concrete should be removed and any exposed reinforcing steel should be cleaned. The estimated cost of these repairs is approximately \$5,000. Refer to the Appendix (Page A-3) for a breakdown of the cost estimate.

It is also recommended that the corrosion of the submerged lifting loops be investigated further. NSB personnel indicated that some of the piles of the facility would be removed in the future as part of planned construction at the ARDM. NSB personnel suggested and it is recommended that these piles be examined to determine if the corrosion of the lifting loops is progressing into the pile, and to ascertain if the lifting loops were cast in contact with the mild steel reinforcement or the prestressing strands of the piles. After that inspection of the

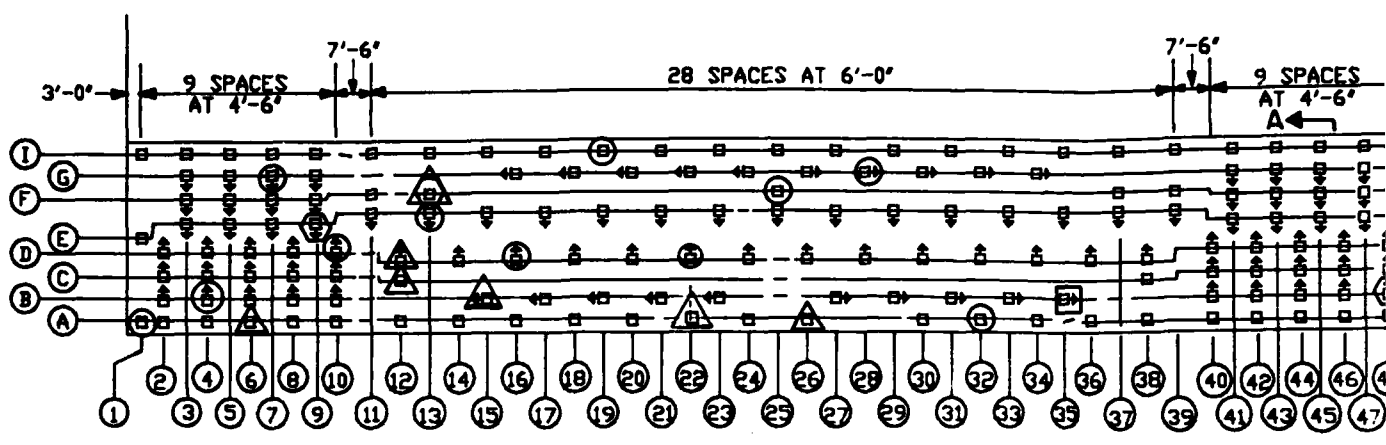
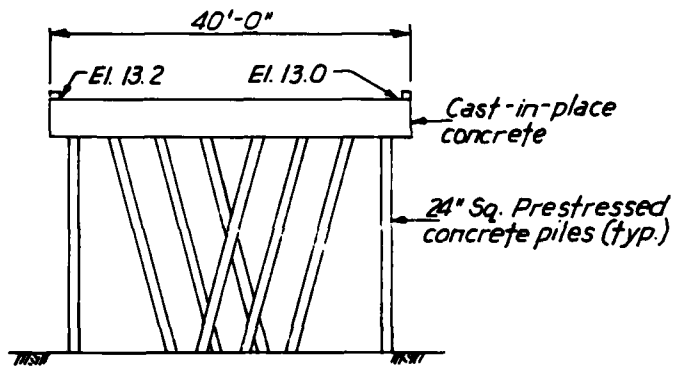
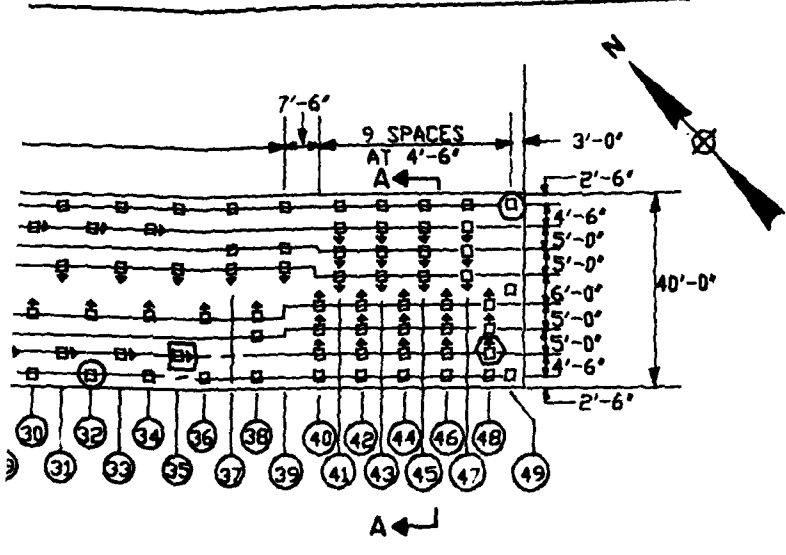
CEDINGS ENGINEERS, INC. 800 N. JACKSON CHICAGO, ILLINOIS	CHESAPEAKE DIVISION NAVAL FACILITIES ENGINEERING COMMAND <small>WASHINGTON, D.C.</small>	
	NAVAL SUBMARINE BASE KINGS BAY, GEORGIA SPUD DOLPHIN <small>CONTRACT NO. 492477-00-0-0004</small>	FIG. NO. 4.2 -1

Above water, the piles were generally found to be in excellent condition. There were, however, a few minor areas of chipped corners and localized scaling. Eight piles, 6A, 12C, 12D, 13B, 15A, 22A, 26A, and 35B had minor, but measurable areas of chipped and scaled concrete. Refer to Page A-2 in the Appendix for a summary of the defects found during the inspection. Refer to Photographs 4.2-2 through 4.2-4 and 4.1-5 through 4.1-15 for underwater views of piles which are typical of conditions at the spud dolphin.

- ⊠ Chipped Pile
- △ Scaled Pile
- ⊙ Corroded Lifting Loop on Pile

It is recommended that the areas of scaling and chipping on Piles 6A, 12C, 12D, 13B, 15A, 22A, 26A, and 35B be repaired by patching with surface applied epoxy mortar. Prior to applying the mortar, any loose concrete should be removed and any exposed reinforcing steel should be cleaned. The estimated cost of these repairs is approximately \$5,000. Refer to the Appendix (Page A-3) for a breakdown of the cost estimate.

It is also recommended that the corrosion of the submerged lifting loops be investigated further. NSB personnel indicated that some of the piles of the facility would be removed in the future as part of planned construction at the ARDM. NSB personnel suggested and it is recommended that these piles be examined to determine if the corrosion of the lifting loops is progressing into the pile, and to ascertain if the lifting loops were cast in contact with the mild steel reinforcement or the prestressing strands of the piles. After that inspection of the interior of the piles is completed, an evaluation can be made as to whether cleaning of the piles, removal of the lifting loops and patching of the piles is required. It is recommended that, in the future, lifting loops be removed and the surface of the pile be patched during the construction period.
