POTABLE WATER STORAGE FACILITIES INSPECTIONS AND ASSESSMENTS

NAVAL AMPHIBIOUS BASE
LITTLE CREEK
NORFOLK, VIRGINIA

FPO-1-84(41) OCTOBER 1984

19. ABSTRACT (Continue on reverse if necessary & identify by block number)
In October of 1984, an underwater inspection was conducted at the Naval
Amphibious Base, Little Creek, Norfolk, Virginia to assess the condition of
seven potable water storage facilities.

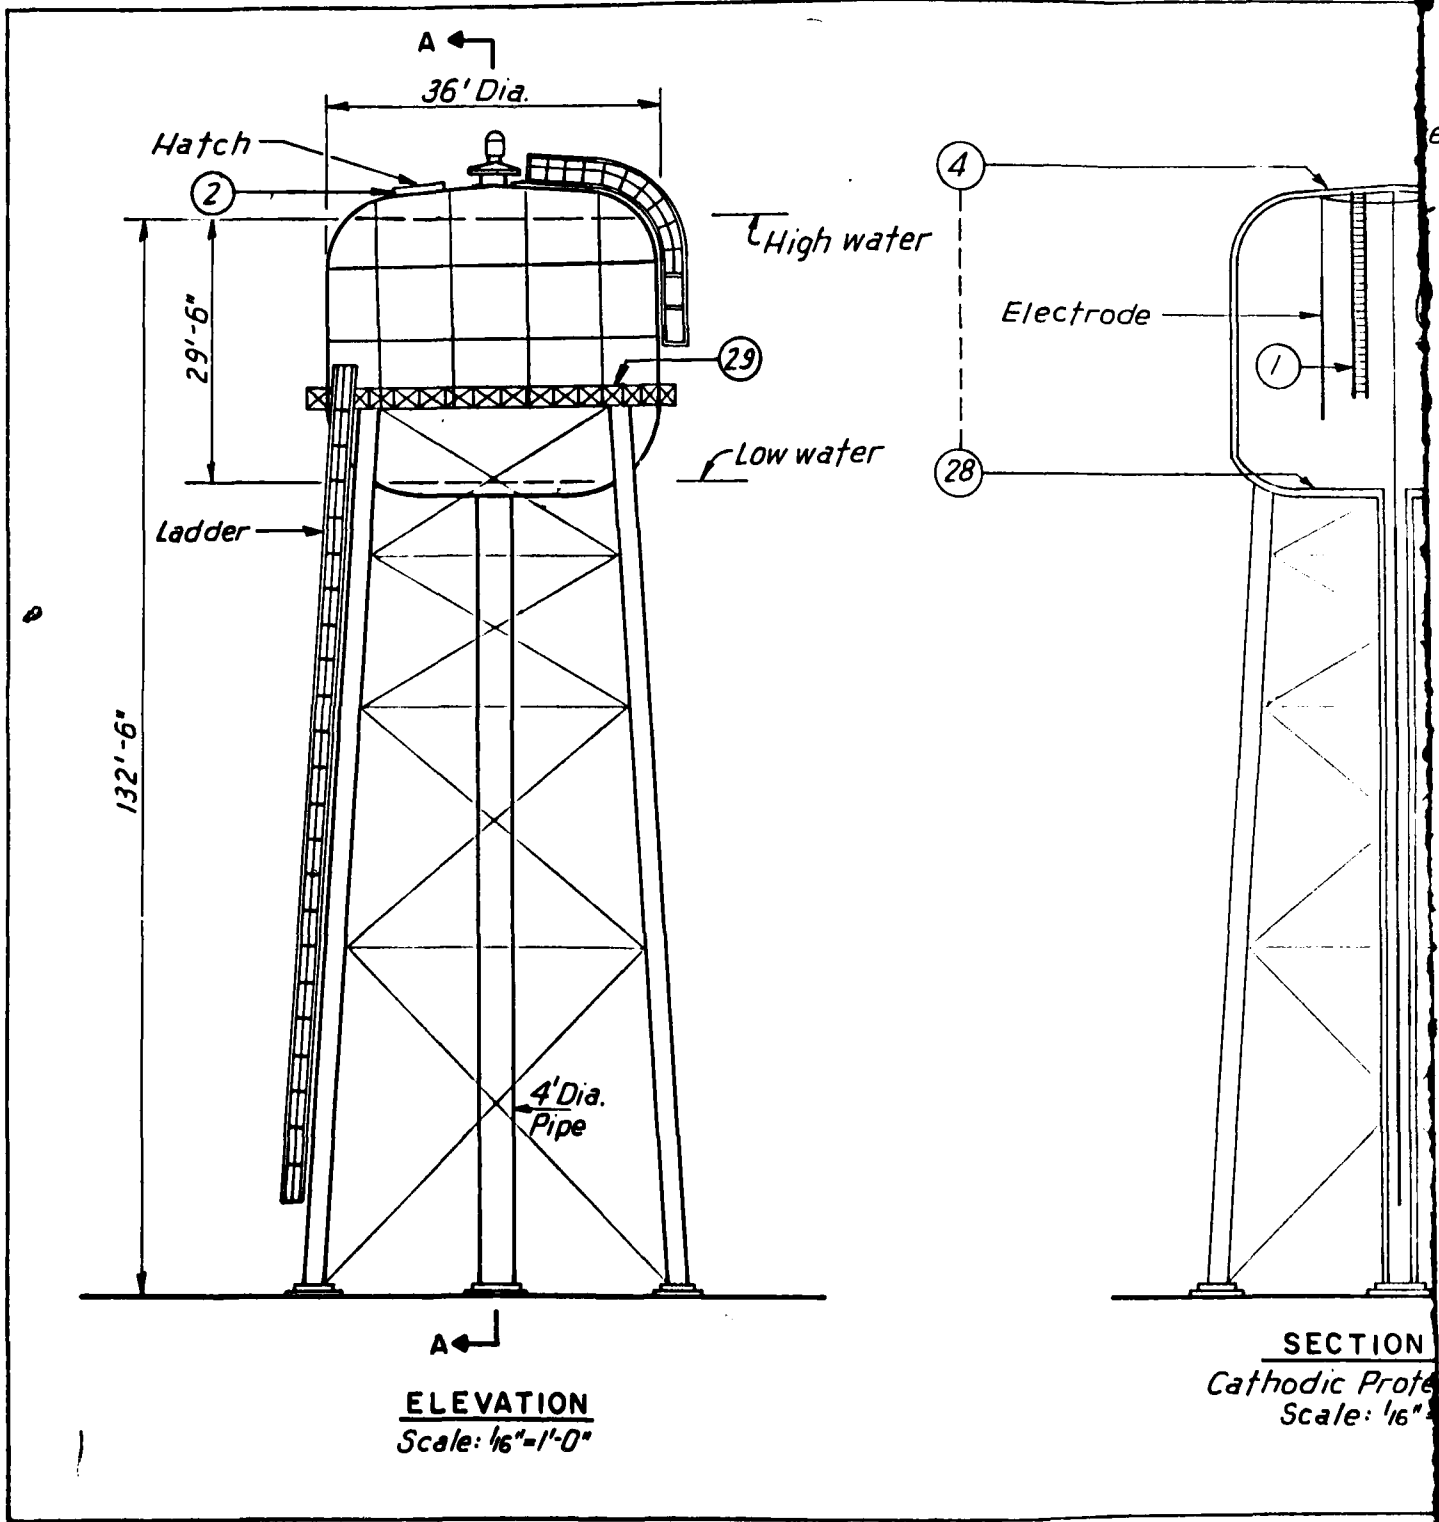
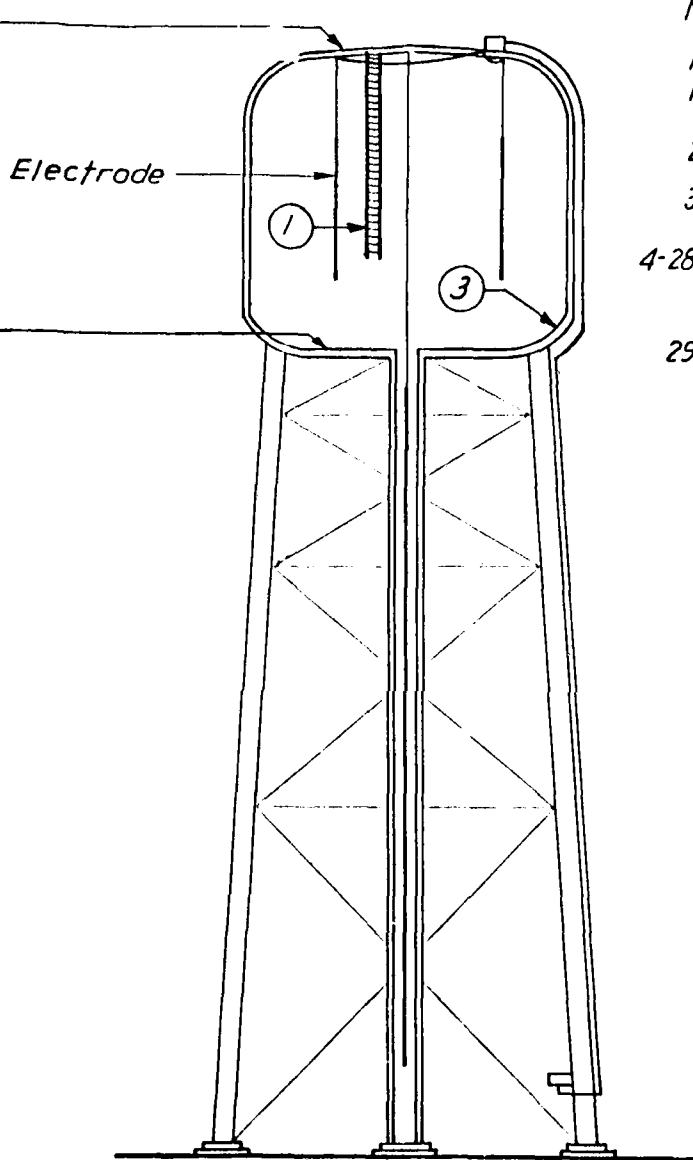
ELEVATION
Scale: 1/16"=1'-0"

1. Ladder on interior of facility is severely corroded at top.
2. Holes due to corrosion in hatch
3. Areas of light to moderate corrosion on interior.
- 4-28. Ultrasonic thickness measurements. Measurements taken at approximately 2" intervals. Values given in table below.
29. Minor areas of corrosion on floor plate of balcony.

ULTRASONIC THICKNESS MEASUREMENTS			
4	0.30"	16	0.44"
5	0.29"	17	0.40"
6	0.29"	18	0.41"
7	0.29"	19	0.40"
8	0.29"	20	0.36"
9	0.29"	21	0.38"
10	0.31"	22	0.37"
11	0.28"	23	0.36"
12	0.31"	24	0.36"
13	0.31"	25	0.37"
14	0.28"	26	0.37"
15	0.29"	27	0.40"
		28	0.40"

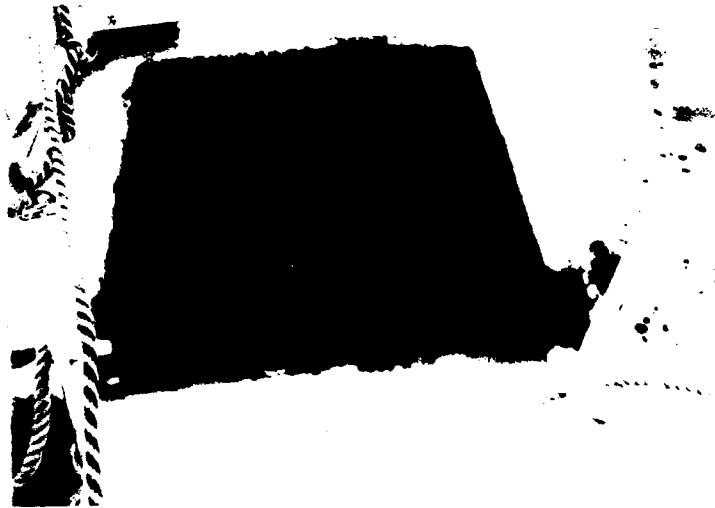
The paint on the exterior of the tank was generally in good condition. The cover for the access opening on the top of the tank has a broken hinge as shown in Photograph 4.2-6. Several of the anchor bolts at the base of the structure have nuts which are corroded with approximate losses of section of 50 percent. Refer to Photograph 4.2-7 for a picture of a typical anchor bolt. The inspection opening at the base of the standpipe shows evidence of seepage as can be seen in Photograph 4.2-8. On the ladder from

PHOTOGRAPH 4.2-6
Facility 3266, Exterior. Note Upper Hinge On
Cover for Access Hole is Broken.

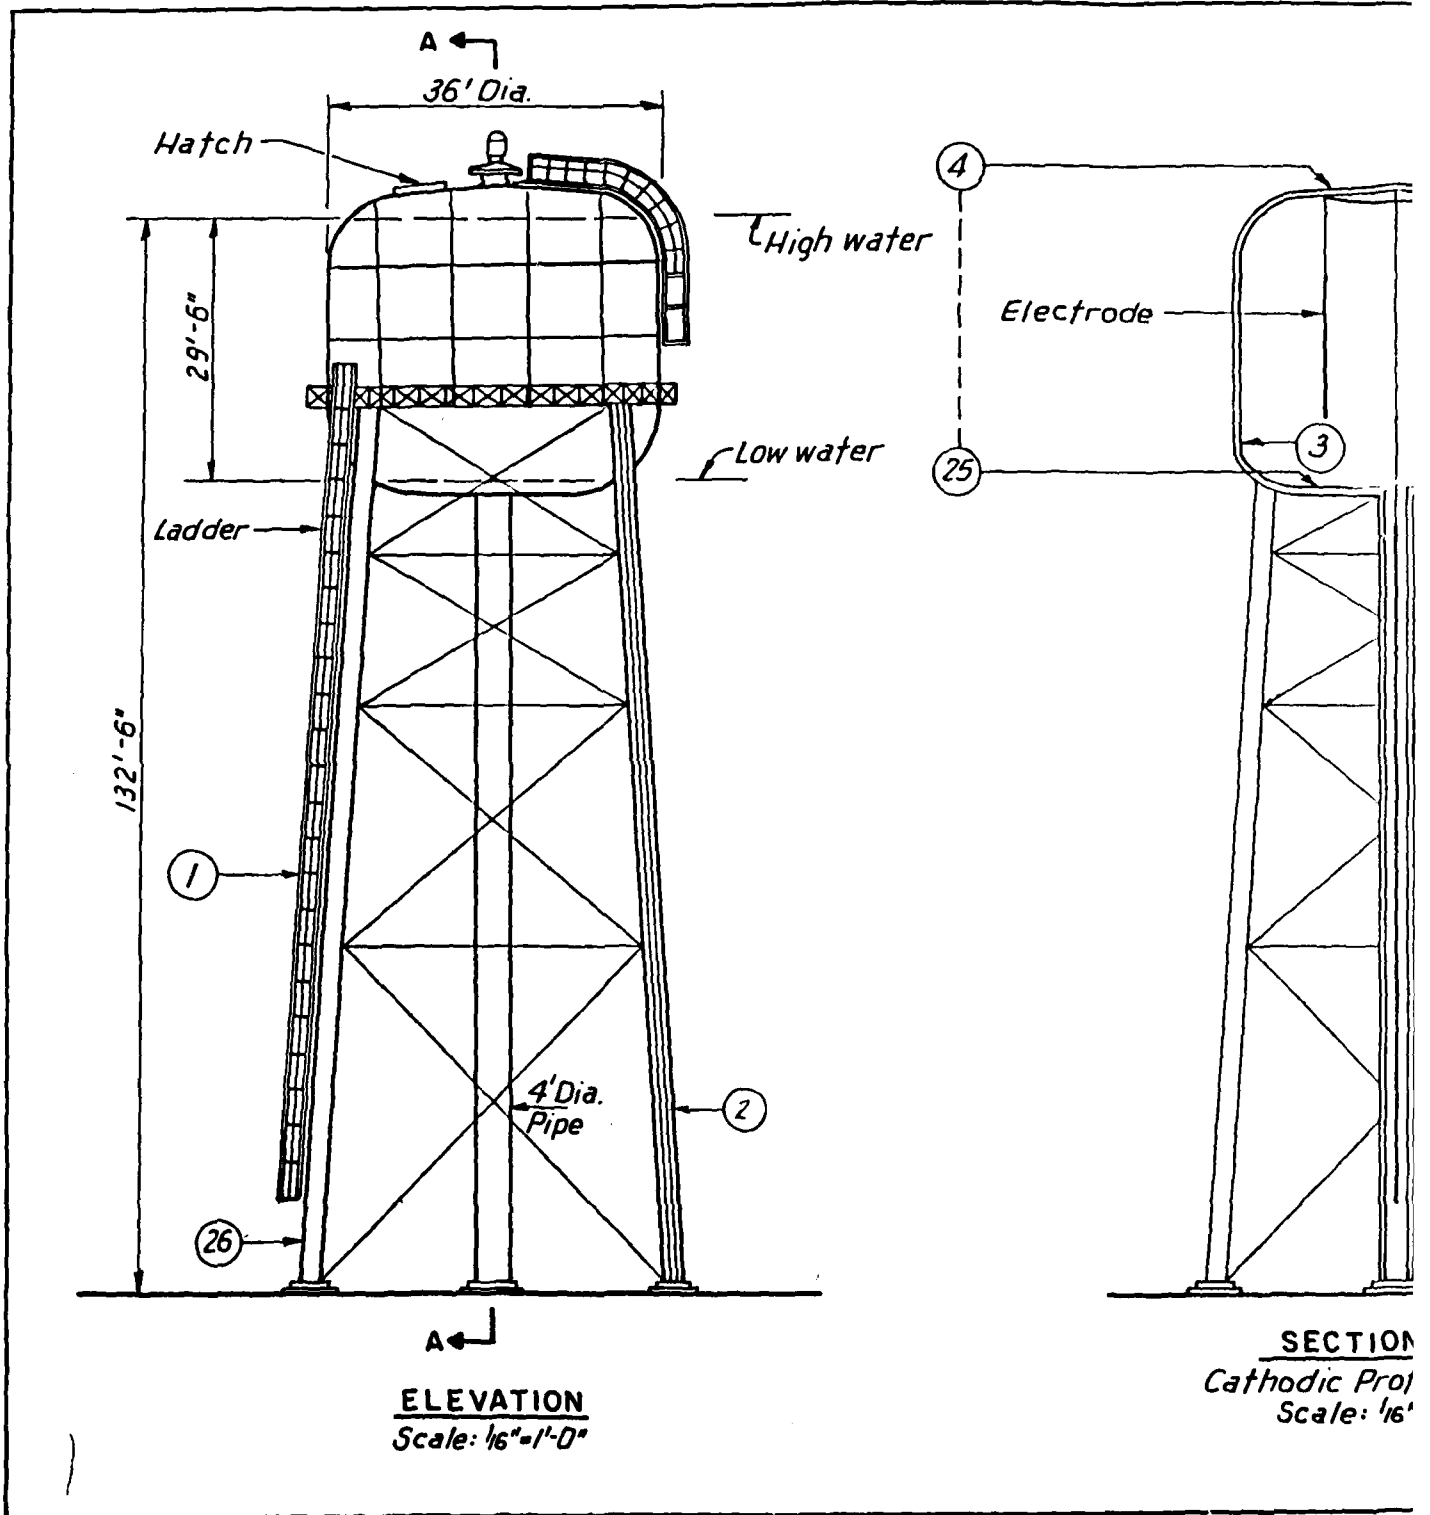
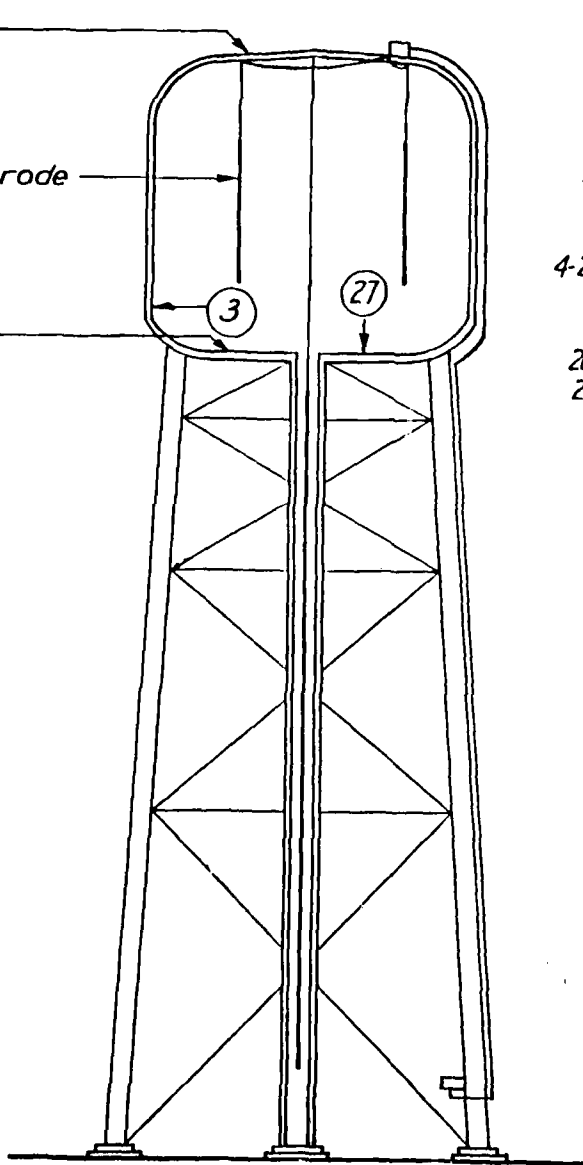
1. Ladder and safety cage are heavily pitted and several of the rungs are bent.
2. Crack in weld of pipe support.
3. Areas of light to moderate corrosion on interior
- 4-25 Ultrasonic thickness measurements. Measurements taken at approximately 2" intervals. Values given in table below.
26. Pitted areas on column.
27. Approximately 3 inches of sediment on bottom.

ULTRASONIC THICKNESS MEASUREMENTS			
4	0.30"	16	0.34"
5	0.27"	17	0.32"
6	0.29"	18	0.33"
7	0.28"	19	0.35"
8	0.28"	20	0.33"
9	0.28"	21	0.44"
10	0.27"	22	0.52"
11	0.29"	23	0.46"
12	0.28"	24	0.44"
13	0.41"	25	0.50"
14	0.40"		
15	0.39"
