UNDERWATER FACILITIES
INSPECTION AND ASSESSMENT

**DEPERMING PIER
TRIDENT REFIT FACILITY
BANGOR, WASHINGTON**

FPO-L-85 (6)

January, 1985

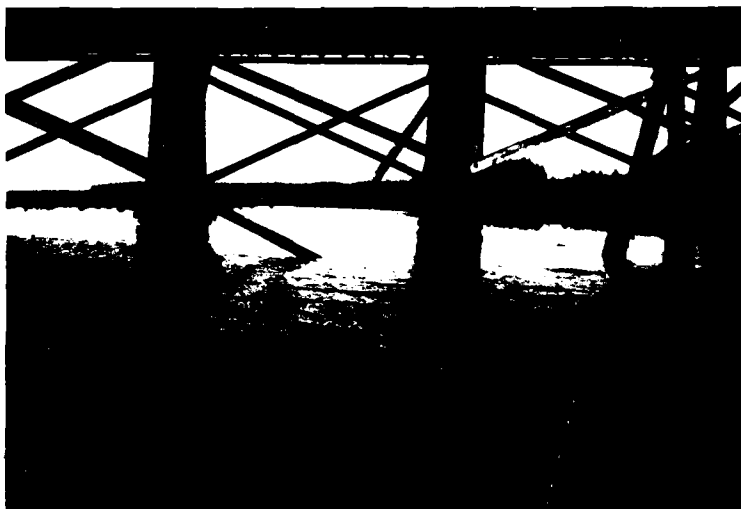
PHOTOGRAPH NO. 4

Broken diagonal brace timber - Row 3, Bent 23-24 South Diagonal of Approachway. All other braces are undamaged.
