FPO-1-85 (14)

NAVAL SUBMARINE
BASE
KINGS BAY
FLEET MOORINGS
UNDERWATER
INSPECTION
REPORT

MAY 1985

OCEAN ENGINEERING
AND CONSTRUCTION PROJECT OFFICE
CHESAPEAKE DIVISION
NAVAL FACILITIES ENGINEERING
COMMAND
WASHINGTON, D.C. 20374

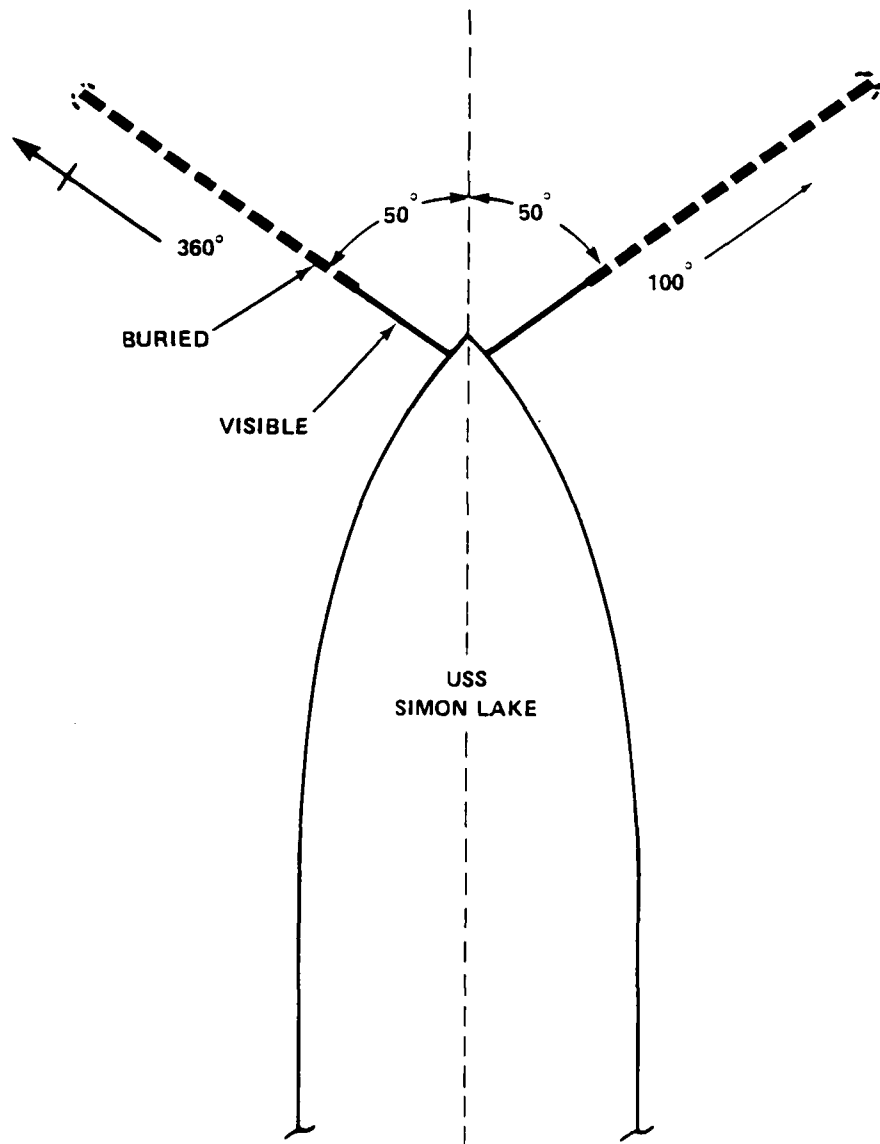
Figure A-1. USS SIMON LAKE Bow Legs

The retriever buoys are connected to the bow leg chains by 1 3/4-inch chain. Measurements of this chain near the mudline were between 80 and 90 percent of

their original wire diameter. Although design drawings indicate that the 1 3/4-inch chain is attached to the bow leg chains at the first sinker, this could not be verified since the leg chain and sinker were both buried in the mud.

- o Overall, the Mediterranean mooring is in good condition and satisfactory for continued fleet use.
- o Due to measurements between 80 and 90 percent near the mudline, the retriever buoy chain should be refurbished during the next scheduled mooring overhaul.
- o In its current configuration, the northern stern leg contains 12 consecutive detachable links. During the next scheduled overhaul, this unusual and nonstandard configuration should be replaced with a comparable length of 3 1/2-inch common "A" links.

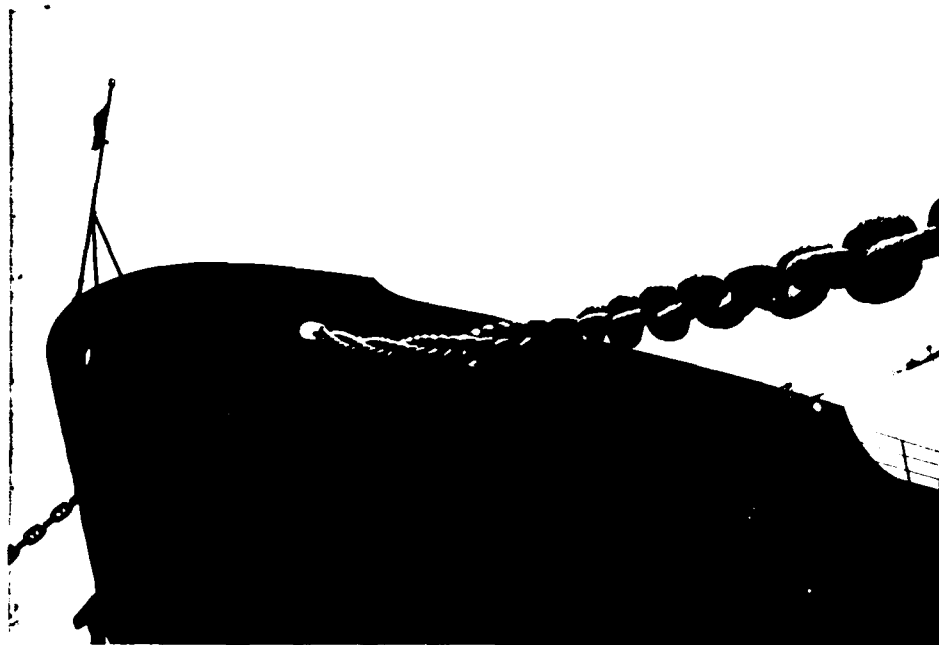
Mediterranean Mooring Bow Legs - Note Twisting.

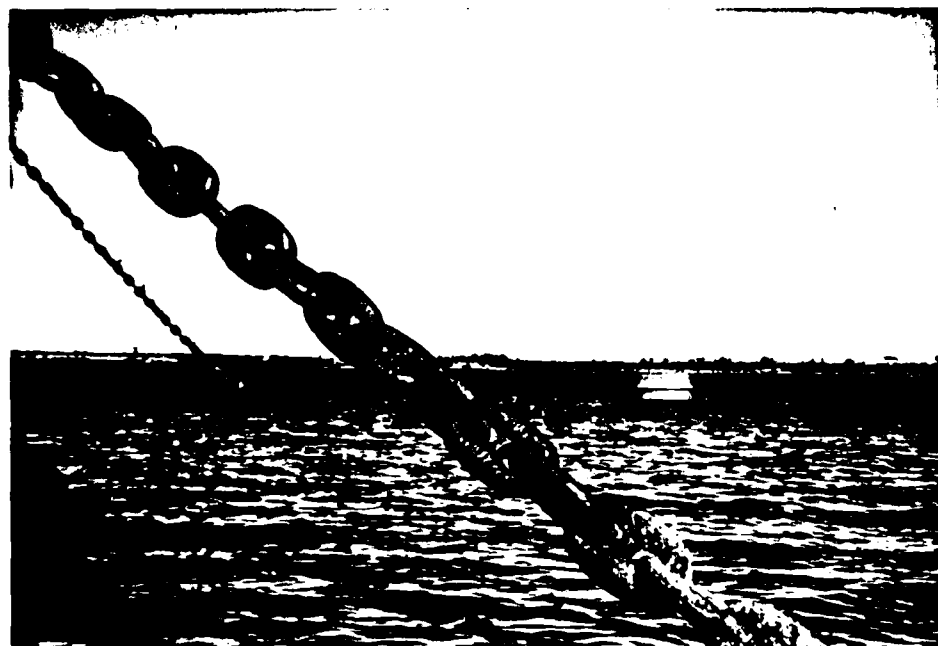
Bow Anchor Chain Subassemblies. The two legs consist of 3 1/2-inch Dilok chain. All double-link measurements of these legs indicated over 90 percent of the original wire diameter. The port leg bears approximately 360 degrees magnetic from the bow of the ship, and the starboard leg bears approximately 100 degrees (see Figure A-1). Both legs are under tension. Inclinator readings were recorded on each leg as shown below.

Mediterranean Mooring - Note The Configuration Of The Bow Legs And Condition Of The Chain.

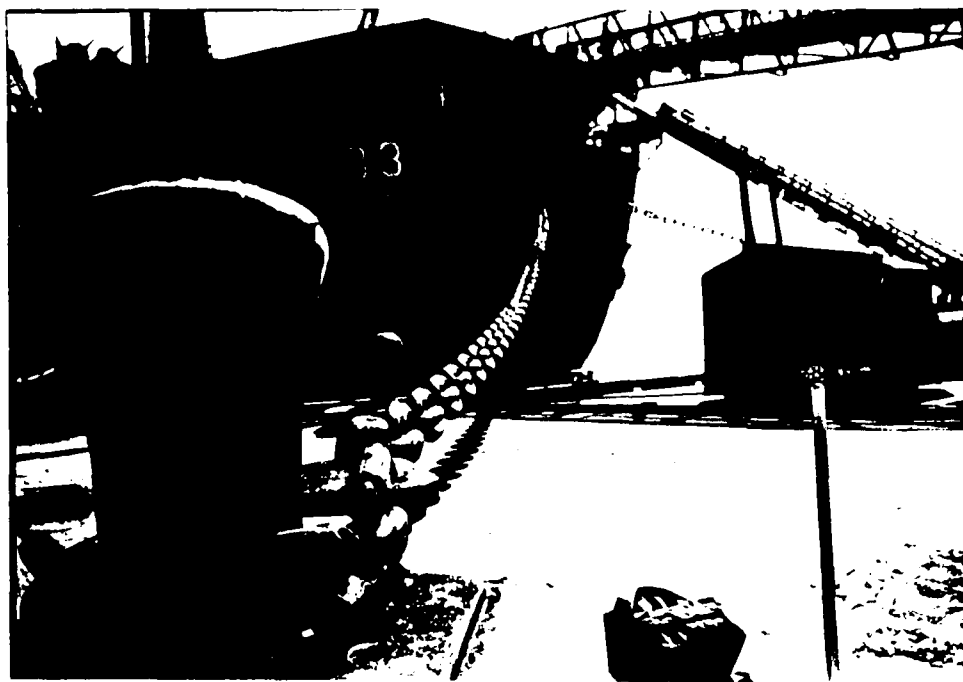
Stern Legs. Two 3 1/2-inch Dilok chain legs secure the stern of the Tender to the eastern end of the wharf at SUBASE Kings Bay. Both legs are rusting and the paint on them is blistering. Double- and single-link measurements were all above 90 percent of the original wire diameter. A schematic diagram of the Mediterranean mooring's stern legs is contained in Figure A-2.

Mediterranean Mooring Stern Leg To Bollard
