REPORT  
MRL-R-984

INVESTIGATION OF COATING PERFORMANCE AND  
CORROSION OF COMPRESSOR COMPONENTS IN THE TF30-P-3  
ENGINE OF F111C AIRCRAFT

L.V. Wake & P.S. Smith

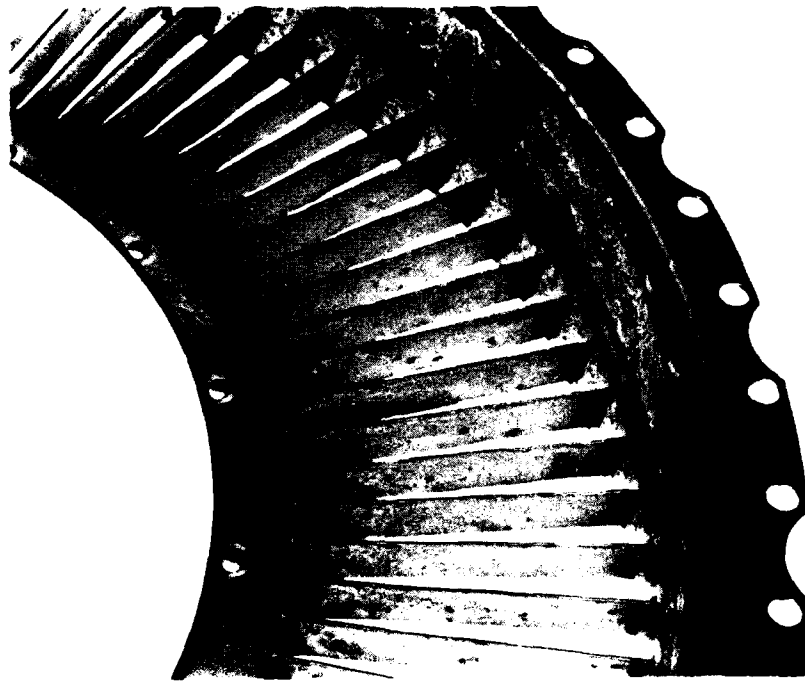
vanes. These areas had the dark steely grey appearance of the diffusion coating rather than the glossy dark green of the glazed top coat. The conversion coating had been eroded from the concave surfaces of the vanes and from two-thirds of the convex surface. The conversion coating remained intact on the leading edge, on the leading area of the convex surface and in a thin line along the trailing edge. The brown corrosion spots on the vanes were restricted to the eroded areas (see Fig. 1) and were present on both convex and concave vane surfaces.

Figure 1. Section of the 7th stage of the compressor from RAAF TF30-P-3 engine after 427 h operation.

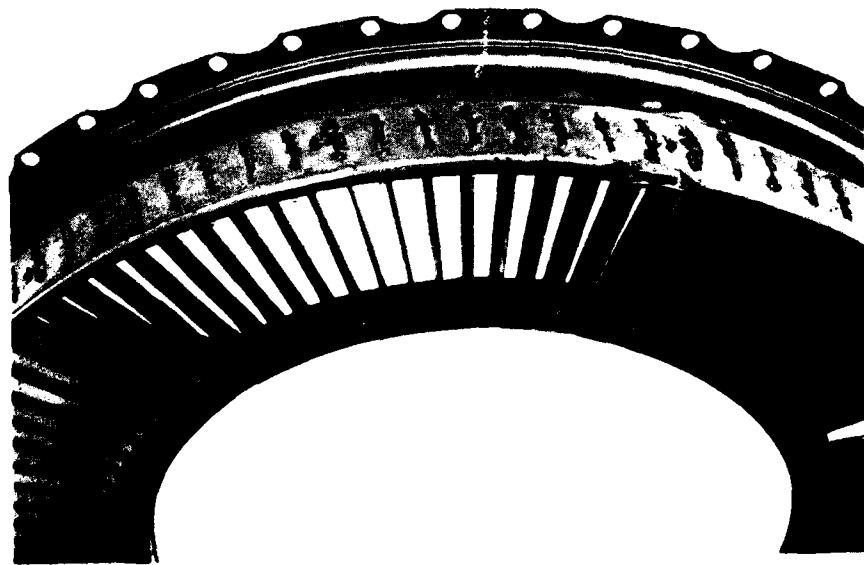
A clearly defined arc of corrosion of approximately 150° was present on the shroud or outer ring of the stage and on components associated with it. The outer ends of 40 stator vanes were corroded adjacent to the point where they pass through the shroud along this corroded arc (Fig. 2). The most heavily corroded section on this arc was the area below the 'rub strip' (Fig. 3). This area was corrosively pitted resulting in the 'rub strip' lifting and partially detaching. The air-seal around the leading edge of the shroud also showed this arc of corrosion (Fig. 4) as did the inner and outer surfaces of the shroud (the blades missing in Figs. 2 & 4 were removed for analysis). (It will be seen later Sections 4.2 & 4.3 that corrosion present on the stator was generally the result of breakdown of the metallic diffusion coating rather than corrosion of the stator itself, except for the area under the 'rub strip').

Figure 2. Coating failure and corrosion on the outer ends of the stator vanes where they pass through the shroud.

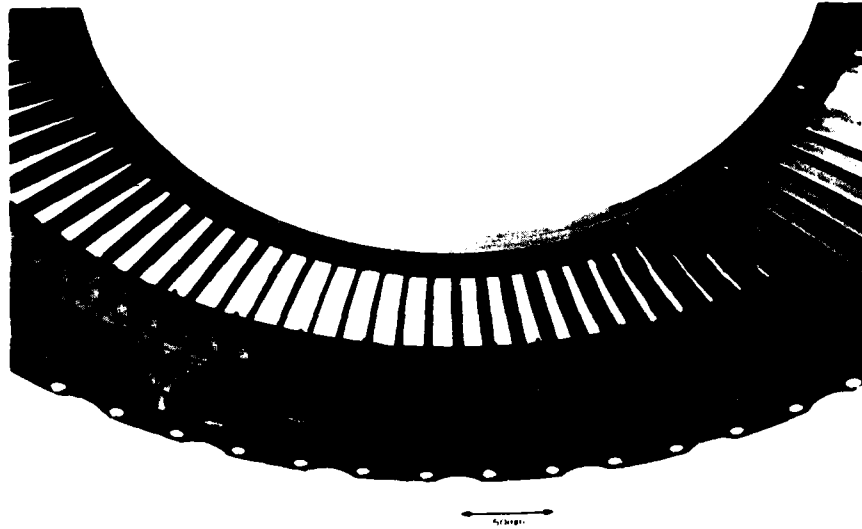
This attack differs from that in other areas on the stage in that no protective coating is present on the steel substrate of the compressor stator under the 'rub strip'. Corrosion in this region is occurring directly into the stator assembly and represents the most serious problem to the stage.

Figure 3. Failure of the rub strip and corrosion along the shroud.

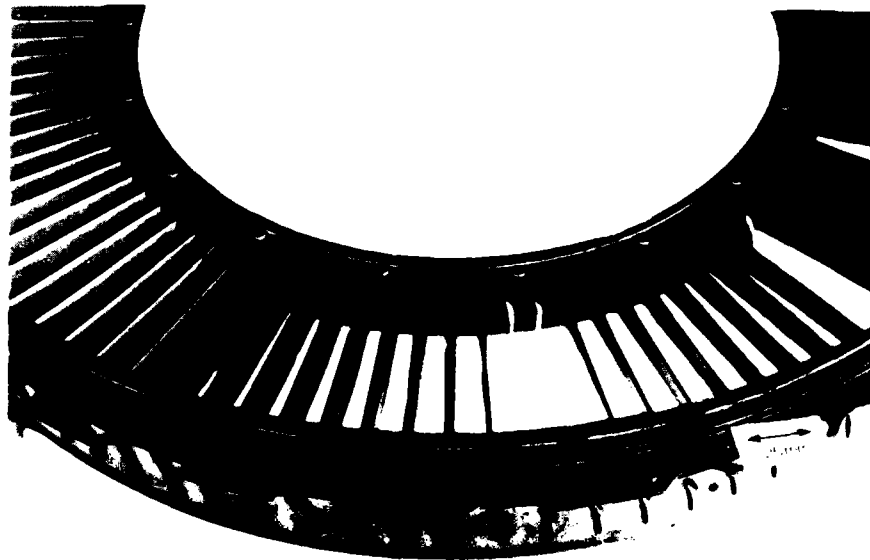
Figure 4. Coating failure along the air seal around the outside of the compressor stage.

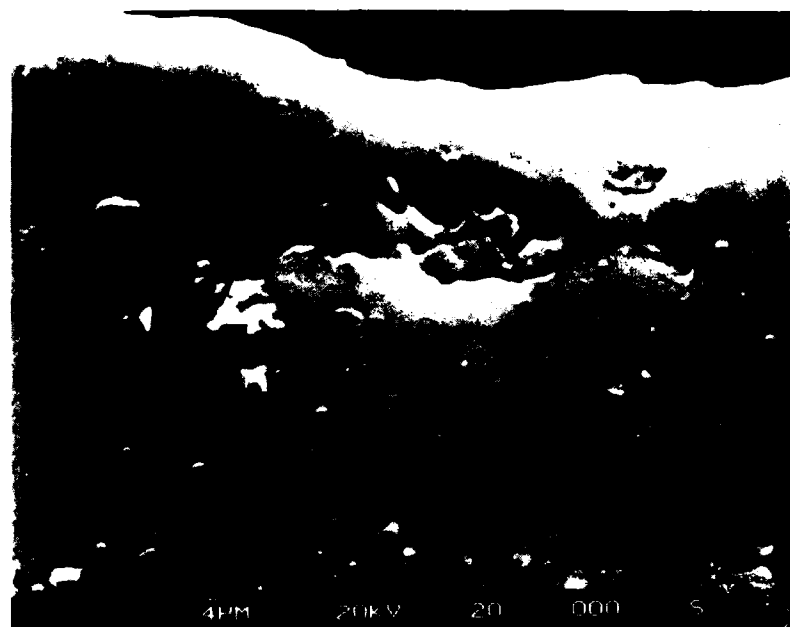
Figure 6. Scanning electron micrograph showing oxide formation and pit initiation in S-A12 coating.

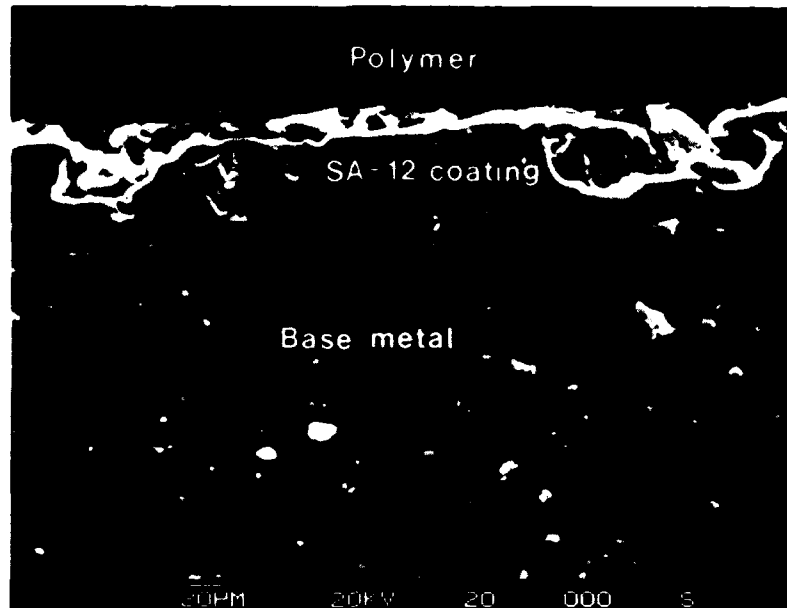
Examination of cross sections through the vanes showed that coating degradation was extremely severe in certain areas. Total or partial coating failure could be seen adjacent to areas of uncorroded coating (Fig. 7). There was only minimal corrosion of the steel substrate of the vanes (Fig. 8) suggesting that the coating had acted sacrificially until failure. Small cracks were apparent in some areas of the coating leading to chipping (Fig. 9) and pinhole corrosion (Fig. 10). Following pore formation (Fig. 11), the coating oxidised and formed deposits over the existing surface. Continued breakdown caused further surface deposition of the oxidation products forming raised surface nodules. The fully oxidised coating in the corrosion nodules

Figure 7. Scanning electron micrograph of S-Al2 coating showing corroded and uncorroded areas.

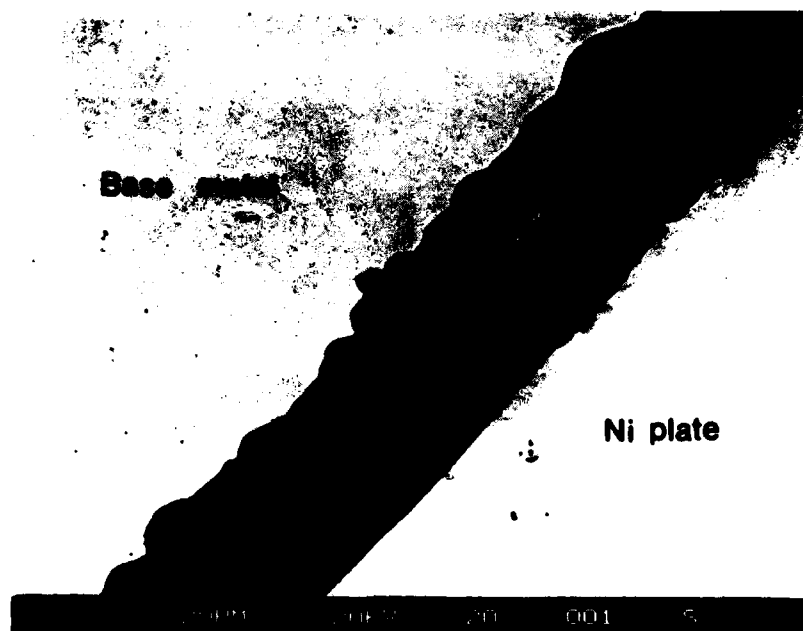
Figure 8. An oxidized section of coating which exhibited considerable pitting. Failure of the oxidized coating to stop base metal attack can be seen at one point in this scanning electron micrograph.

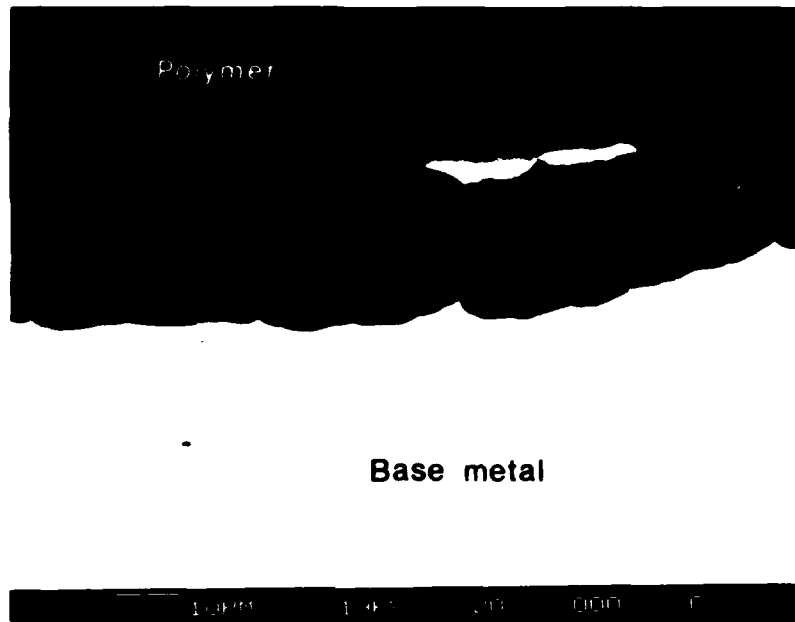
Figure 9. Occasional cracking and chipping of the coats are seen in cross sections under the scanning electron microscope.

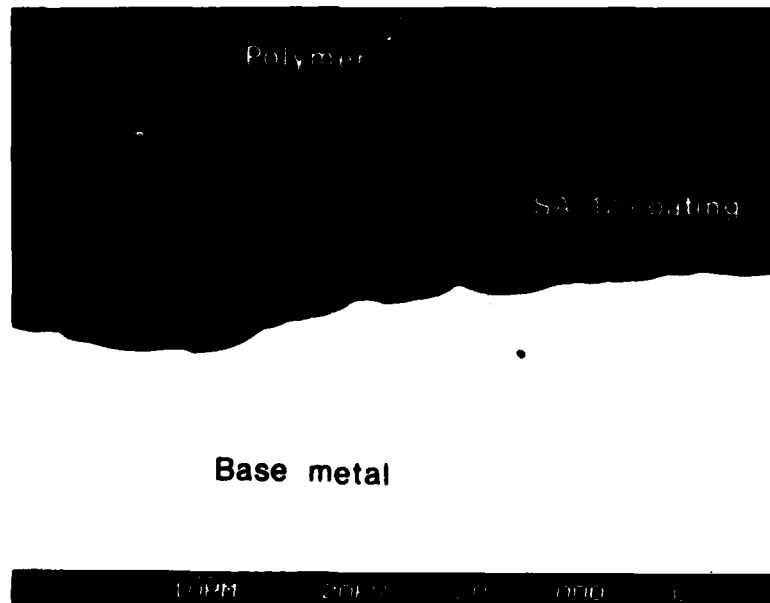
Figure 10. Scanning electron micrograph showing pinhole corrosion through the coating.

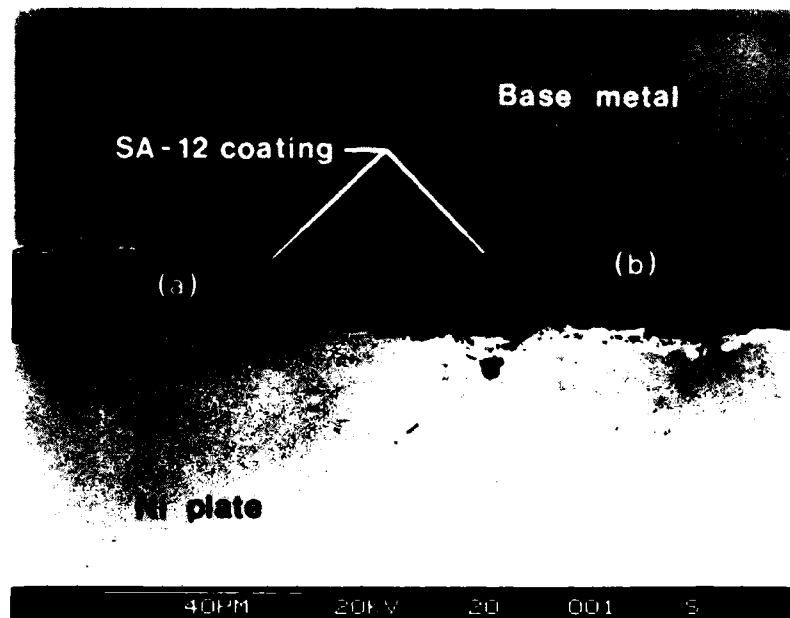
Figure 11. Scanning electron micrograph showing oxidized coating adjacent to intact coating areas.

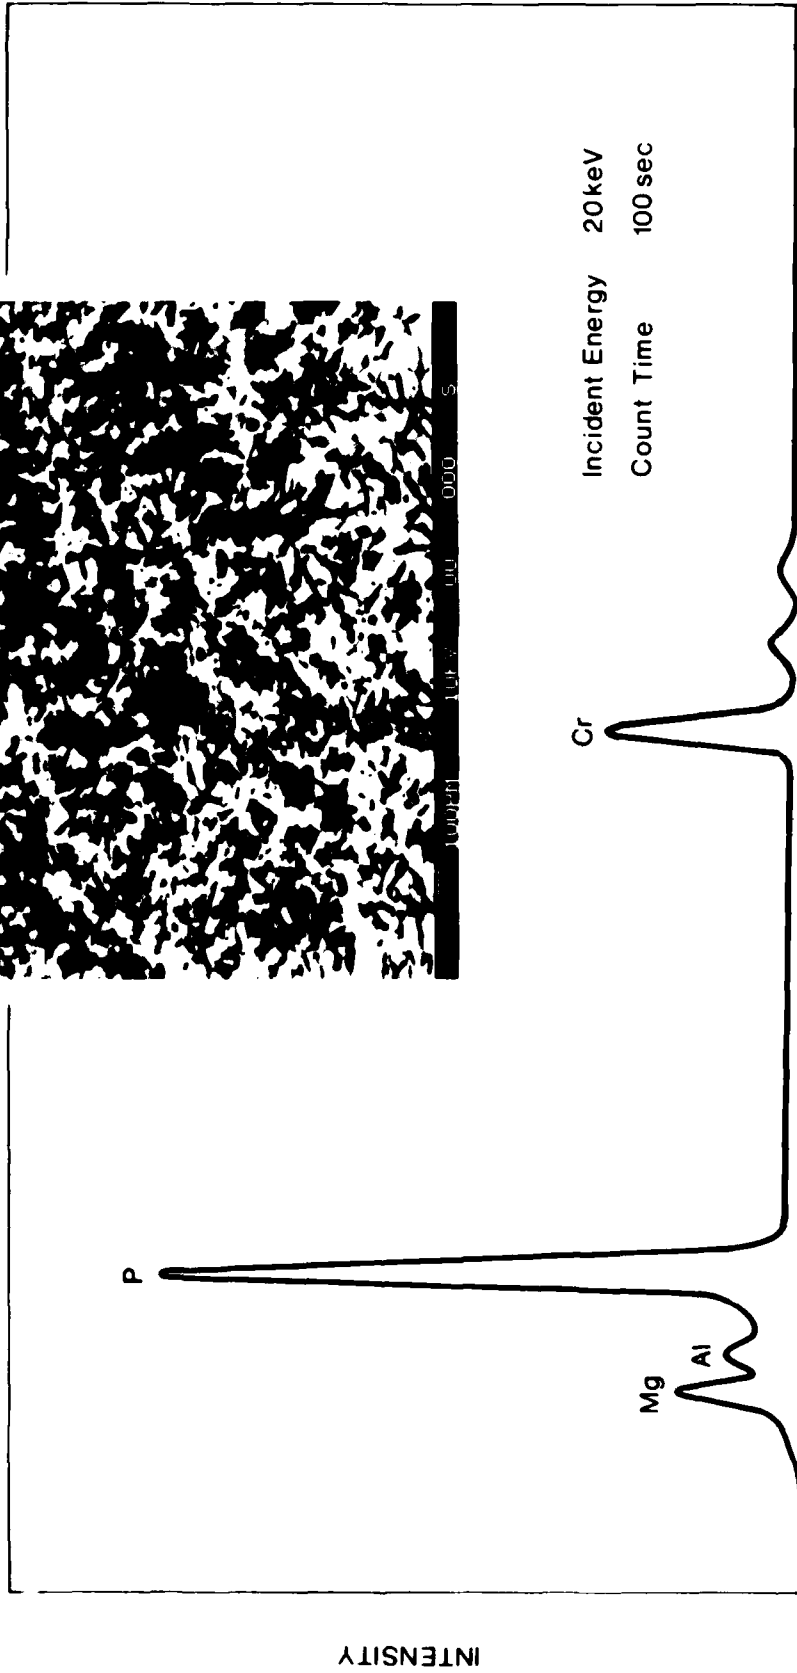
Figure 13. EDXRA surface analysis of unused blade showing the presence of the phosphate/chromate/magnesium top coat.

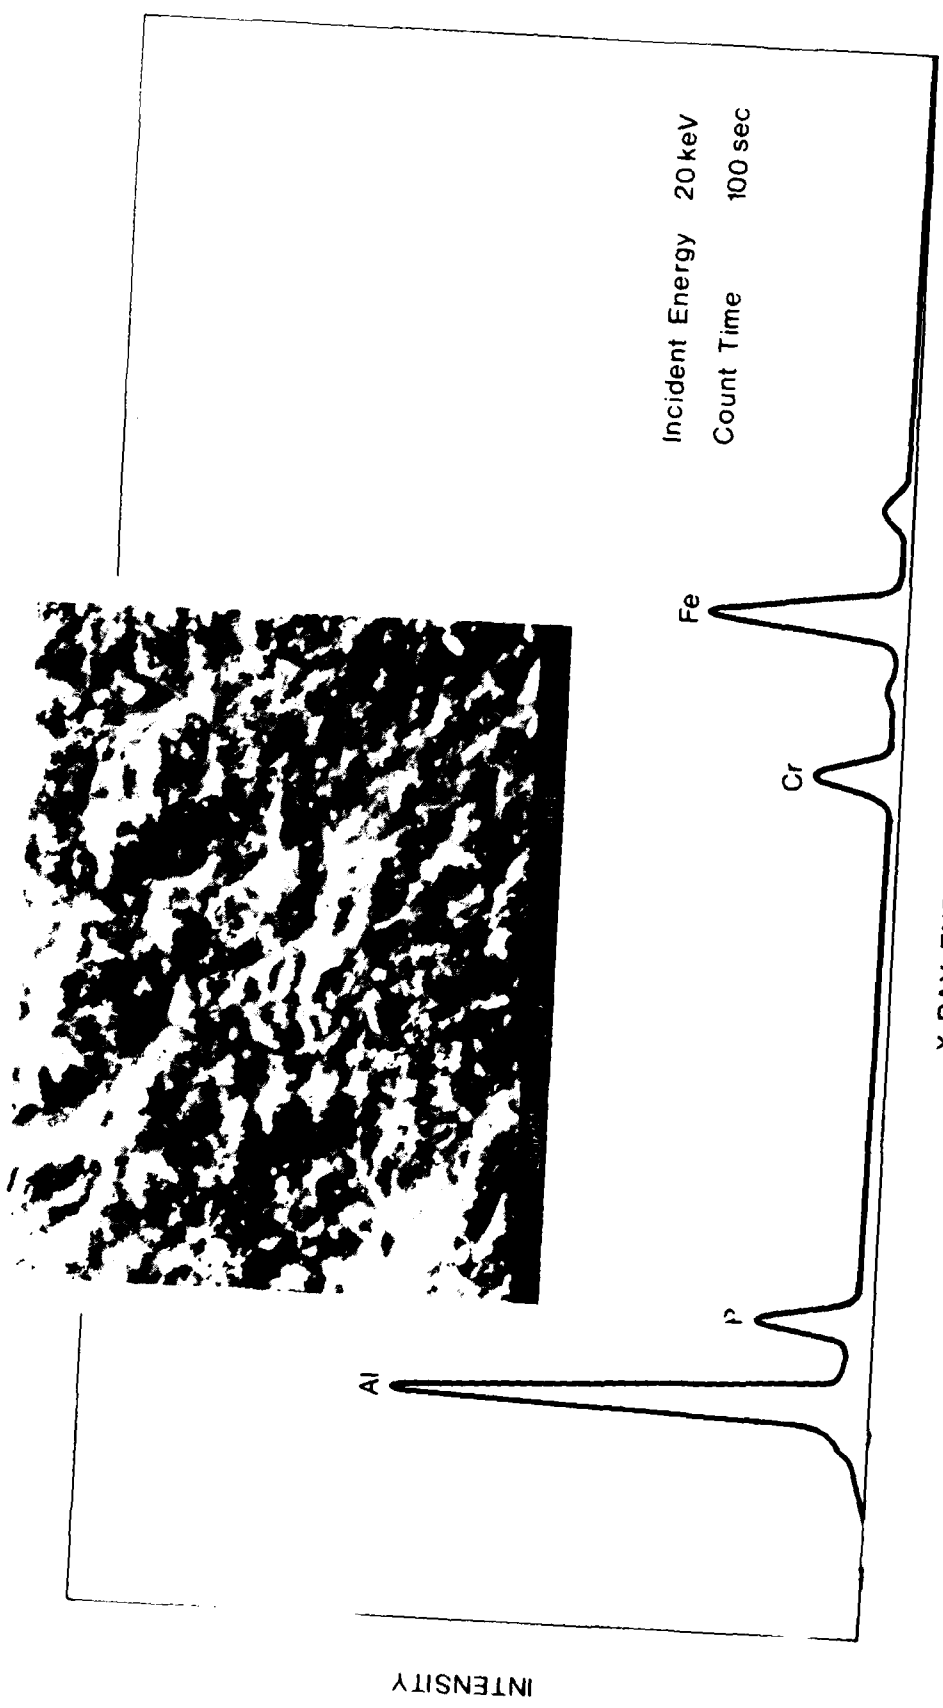
Figure 14 EDXRA surface analysis of eroded blade surface dominated by aluminate/iron components in base coat.

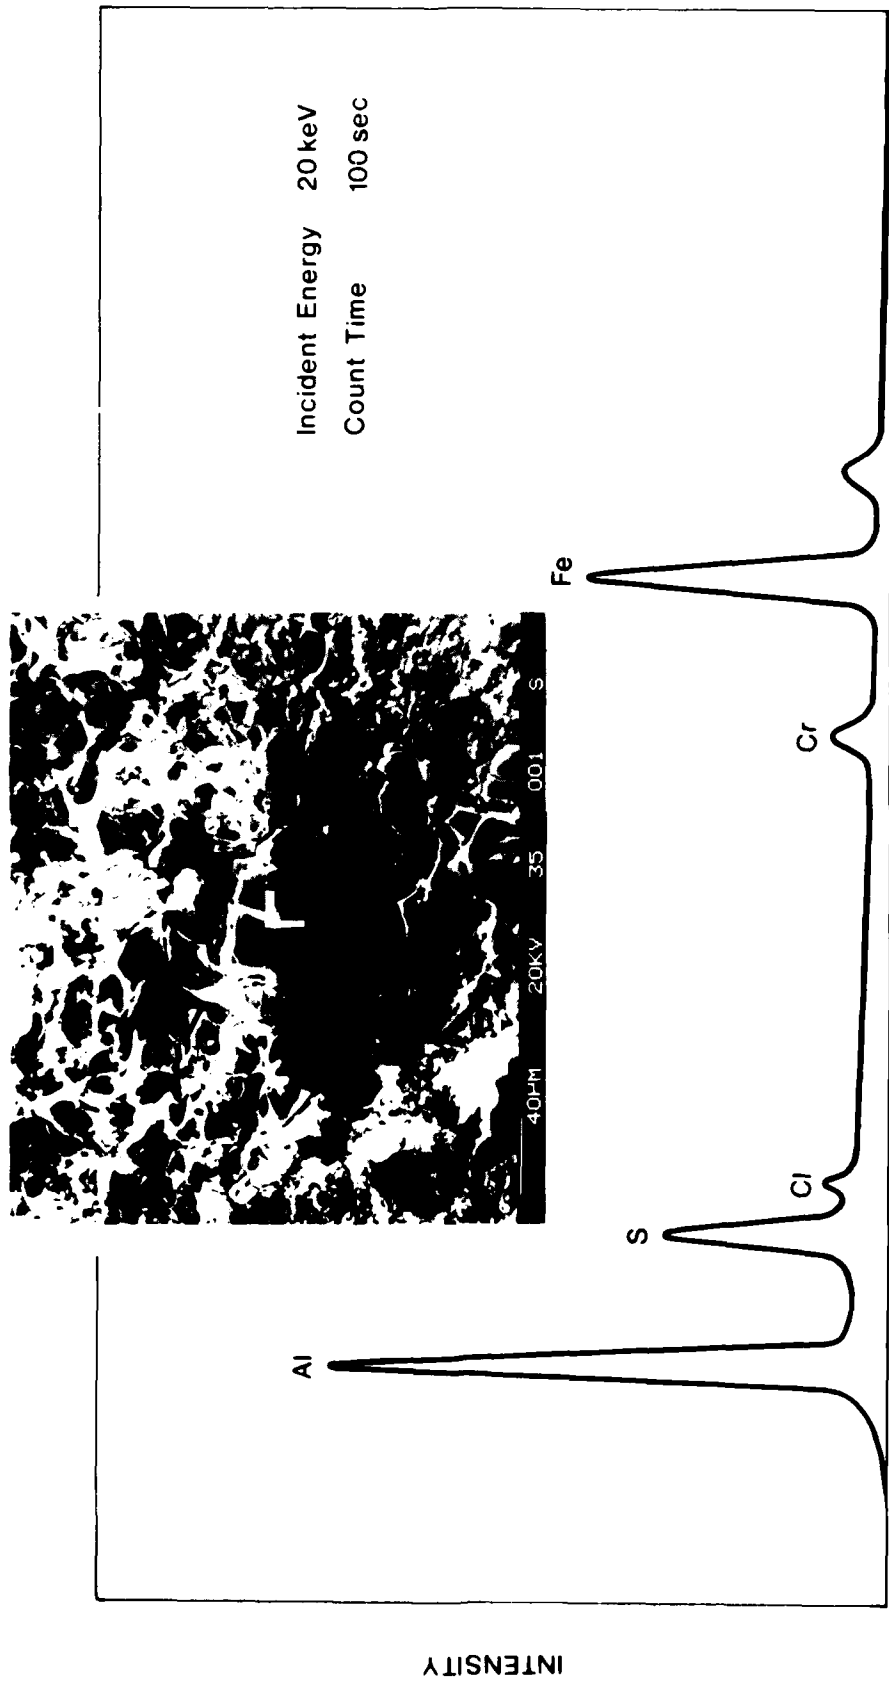
The surface composition of the corrosion products on the vanes, as determined by EDXRA, showed variation throughout the corrosion sites. As well as the corrosion products of aluminium, chromium and iron, the deposits also contained the contaminant elements sulphur, chlorine, potassium and calcium. Of these, sulphur was the most common, while chlorine and calcium were frequently present. Analysis of the central surface area of the nodules showed high levels of sulphur (Fig. 15).

Figure 15 EDXRA surface analysis of a corrosion nodule in which high levels of sulphur materials were present

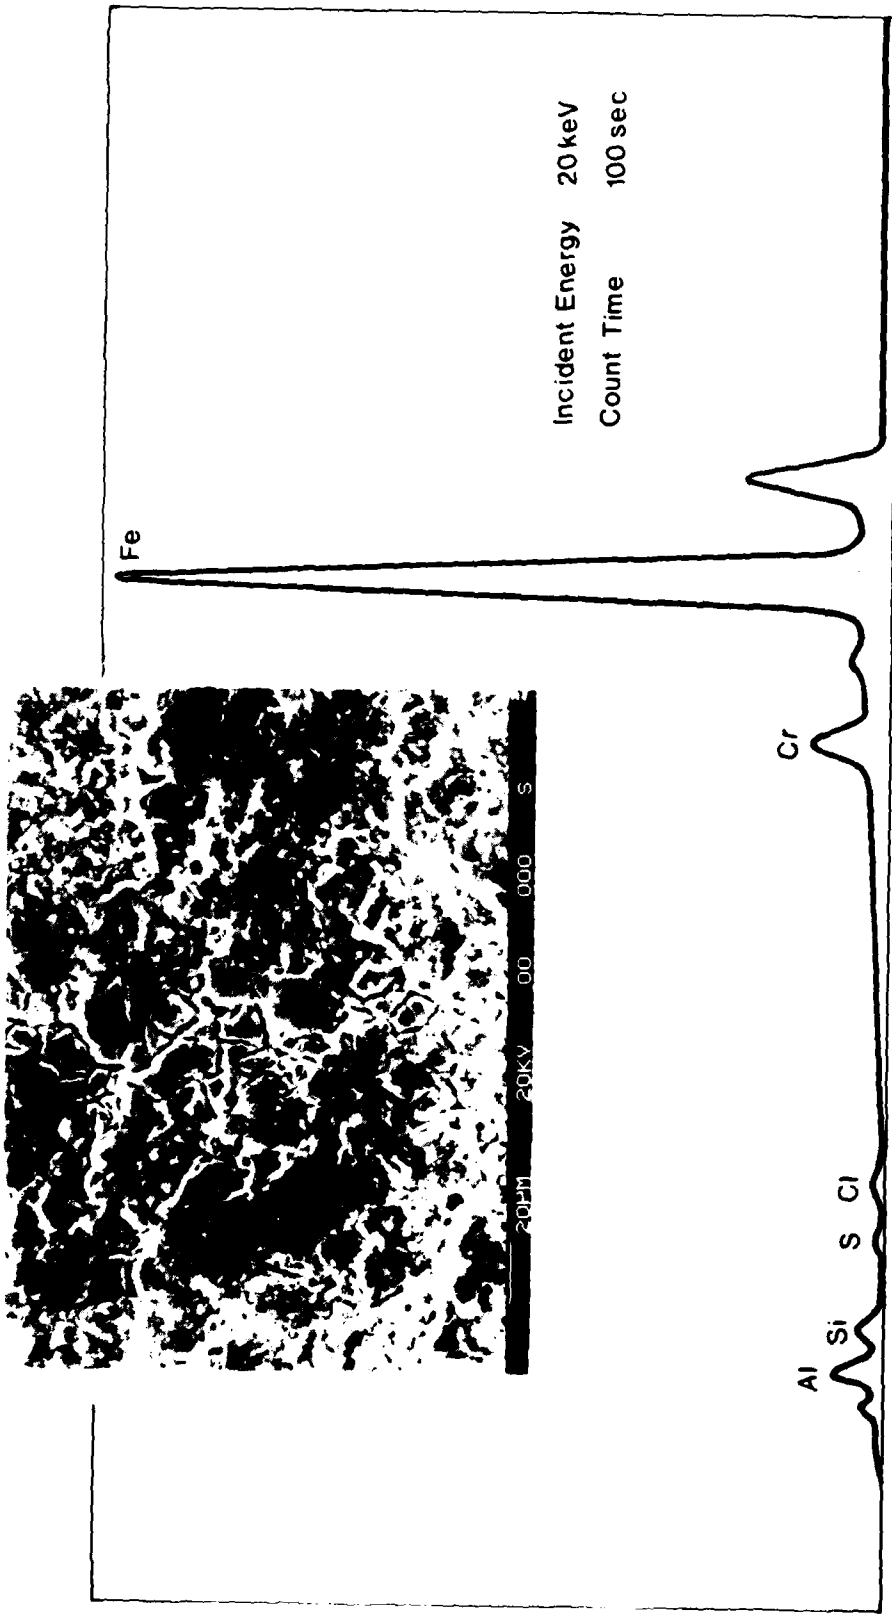
The cracked areas of the coating around the periphery of the nodules also varied in composition. In some places iron compounds predominated (Fig. 16) whereas in others, calcium, potassium, sulphur or chlorine containing materials were present. Analysis at discontinuities in the coating were richer in iron and chromium products as might be expected.

Figure 16 EDXRA surface analysis of cracked coating showing the presence of high levels of iron compounds

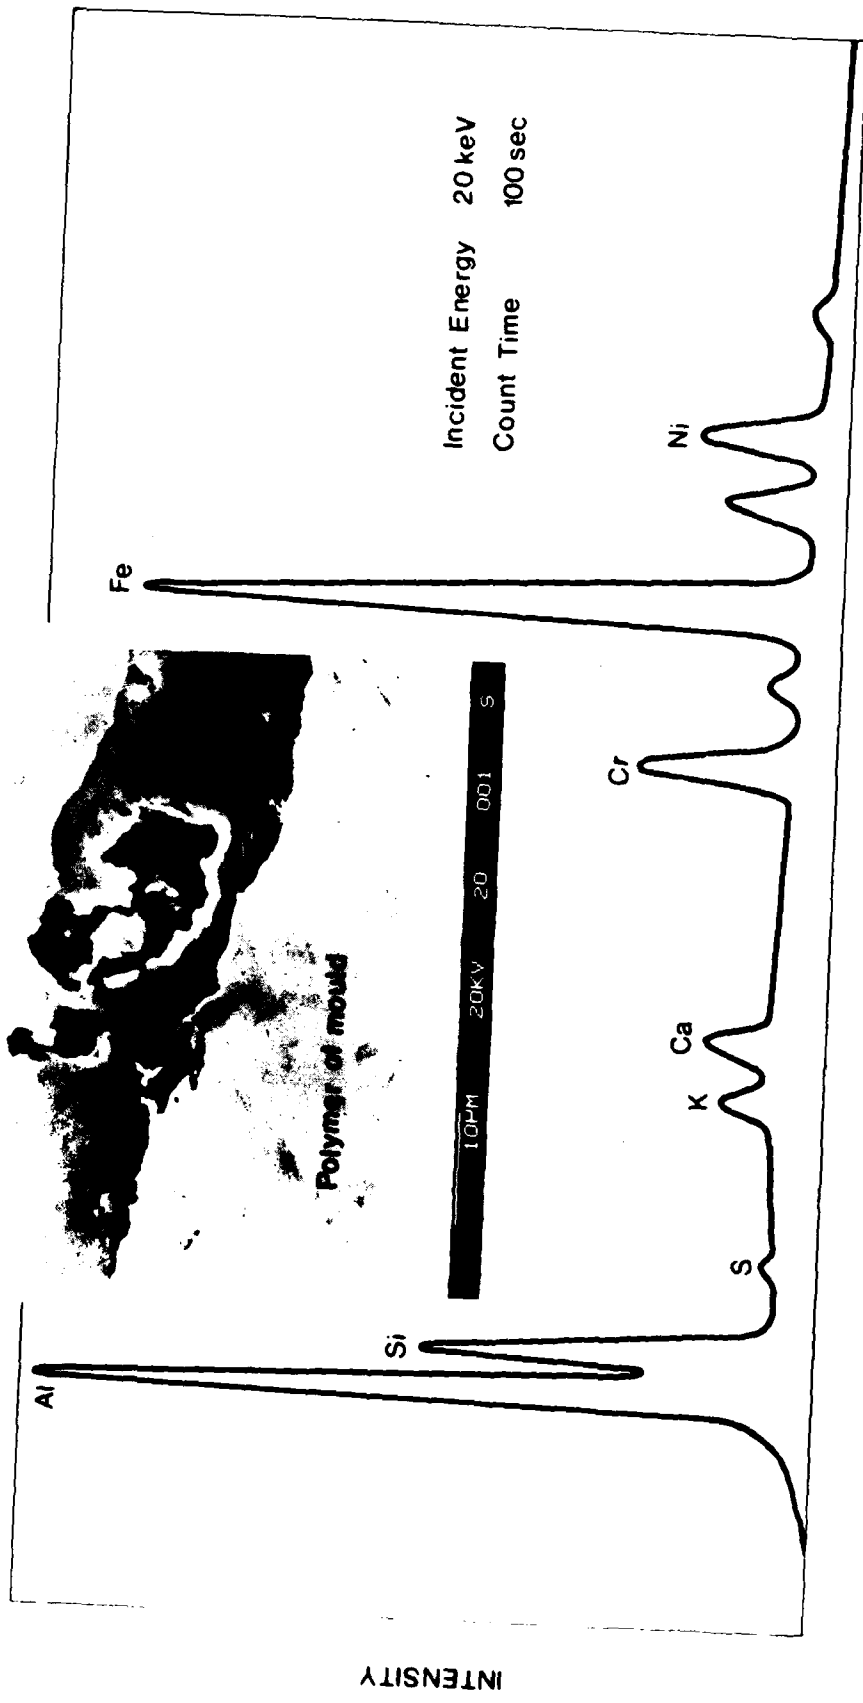
Analysis of cross sections through failed areas of the coating also showed compositional variation depending on the section of the failure, e.g. pores in the coating (Fig. 17) were found to be associated with the cationic contaminants calcium and potassium whereas the poorly reflective oxidation products were found to have high levels of the anionic contaminants, sulphur and chlorine. Attack on the base metal of vanes can be seen in some of the badly failed areas (Fig. 18).

Figure 17 EDXRA of cross section through pore in coating. Calcium and potassium compounds are apparent.

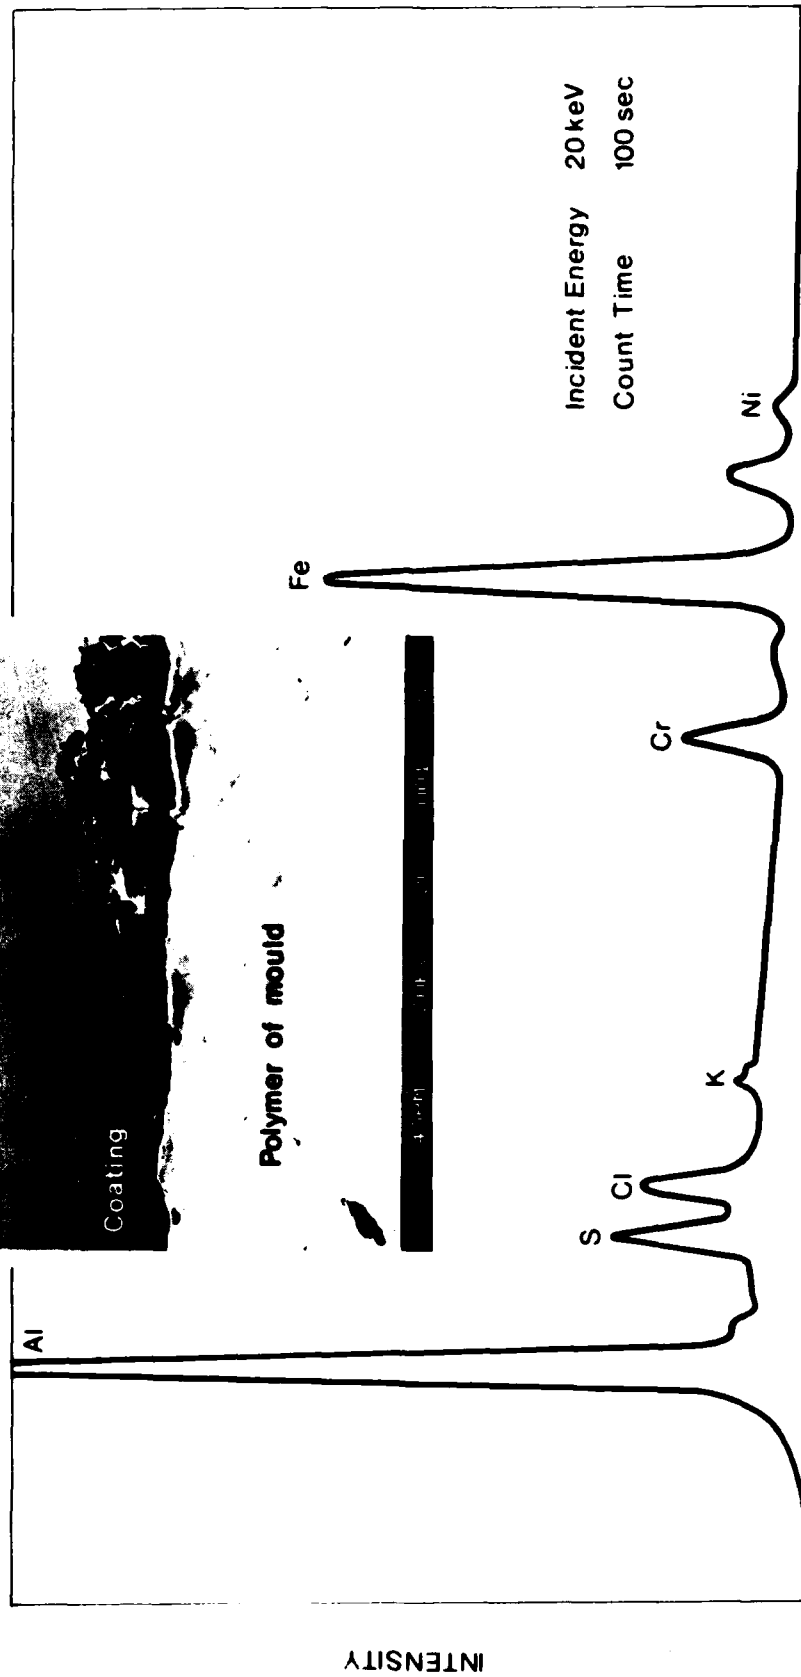
Figure 18. EDXRA of cross section through cracked and corroded coating. Sulphur and chlorine compounds are apparent. Note pitting of substrate.

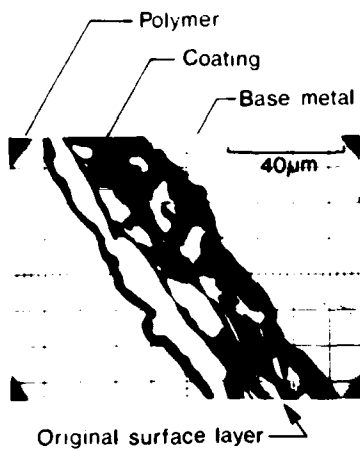
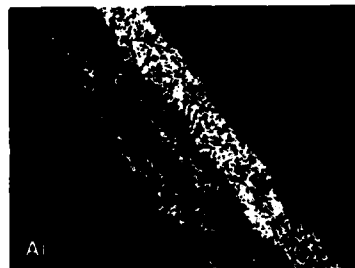
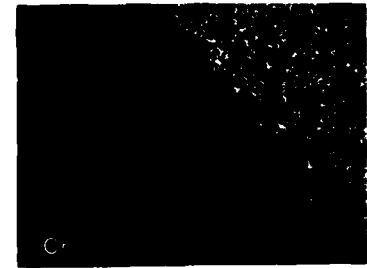
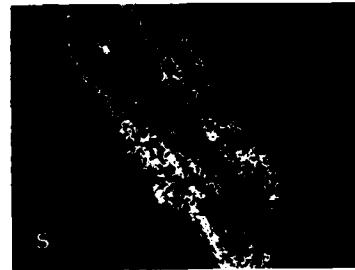
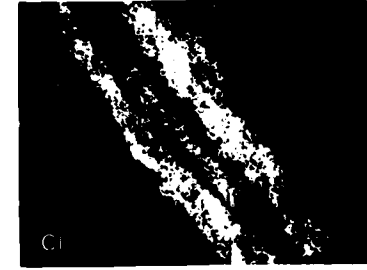
EPMA of cross sections through corroded areas of the coating showed that an oxidised deposit containing an aluminium product was present in a layer over components of the original ceramic top coat. Also present in this layer were oxygen, chlorine, and sulphur. This oxidised layer resulted in a cross sectional coating thickness much greater than that of the original protective system (Fig. 19). EPMA maps around the mouth of a pit in the coating showed the presence of oxide and sulphur materials (Fig. 20).

Figure 19. EPMA area scans of a degraded section of the surface coating. The corroded material lying over the original surface is composed of products rich in Al, O, Cl and S.

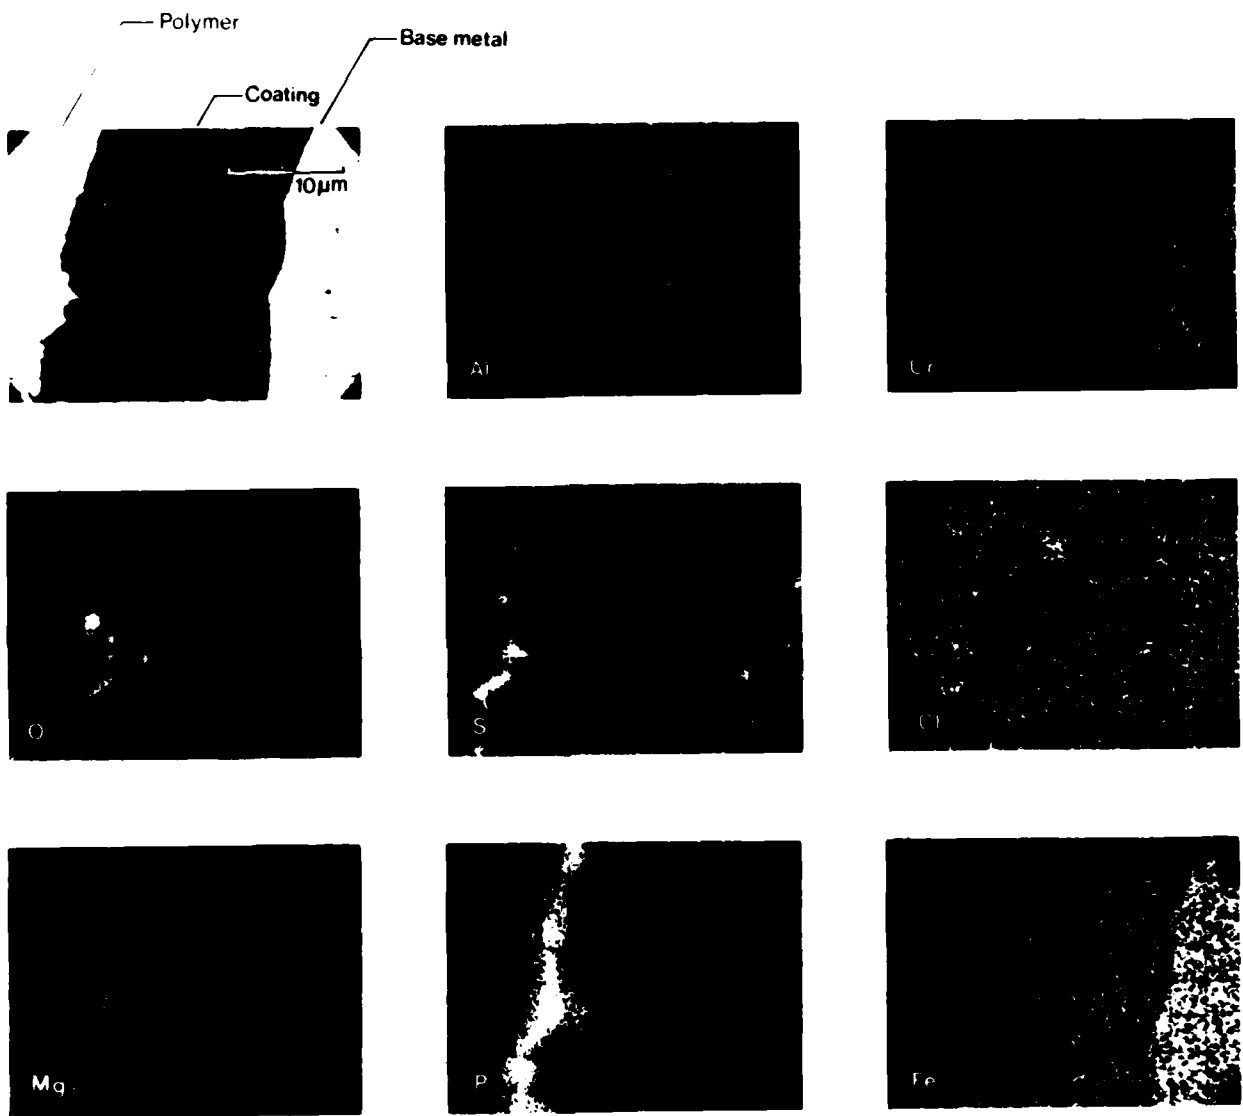
Figure 20. EPMA area scans of an oxidized crack in the surface coating.
