UNDERWATER FACILITIES INSPECTIONS & ASSESSMENTS

DEGAUSSING RANGE
NAVAL STATION
MAYPORT , FLORIDA

FPO-1-84(10)

MARCH 1984

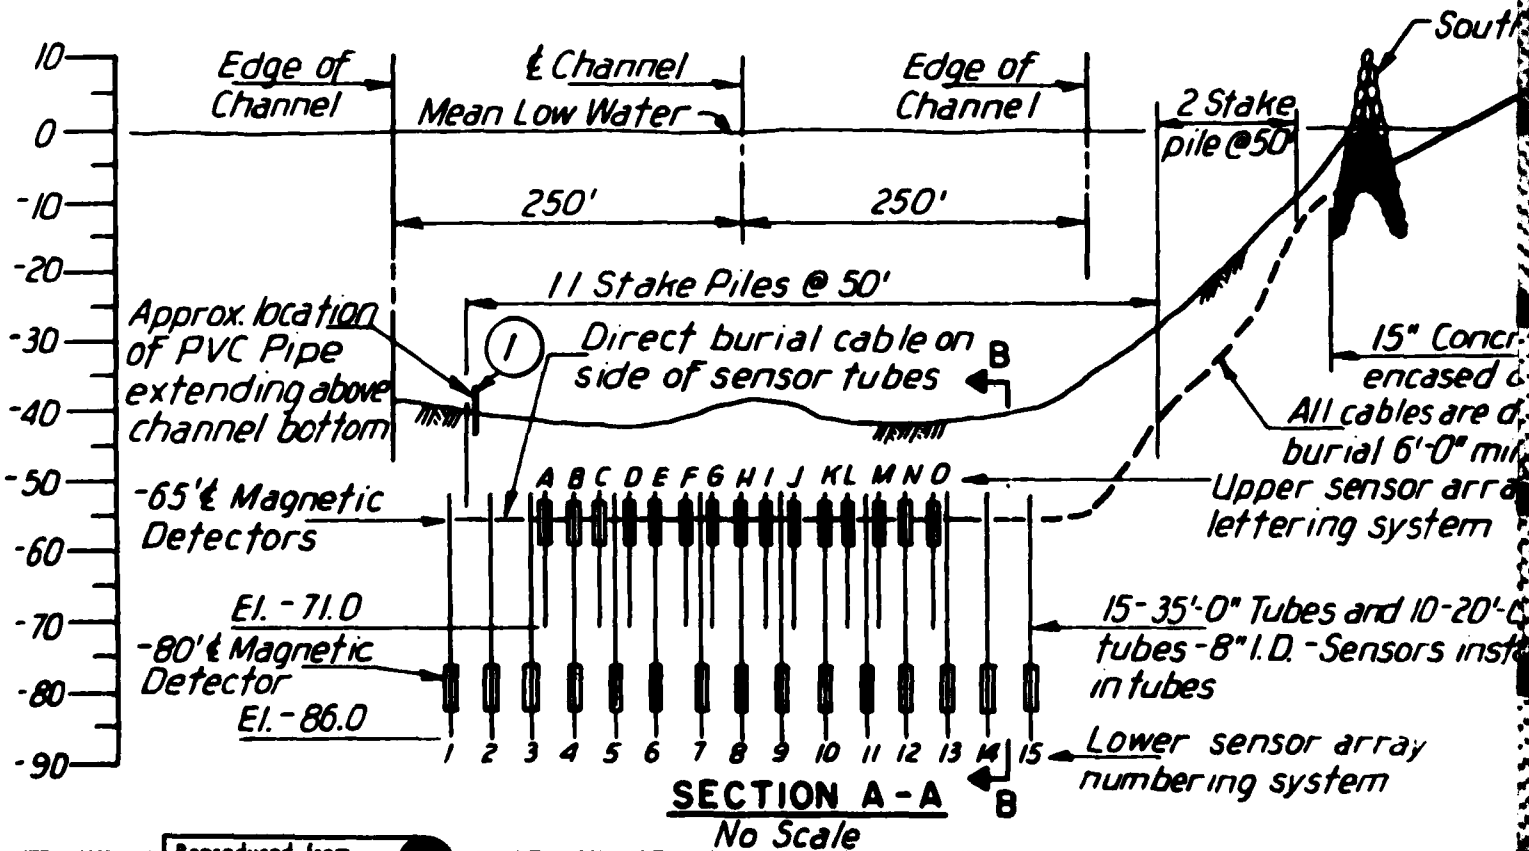
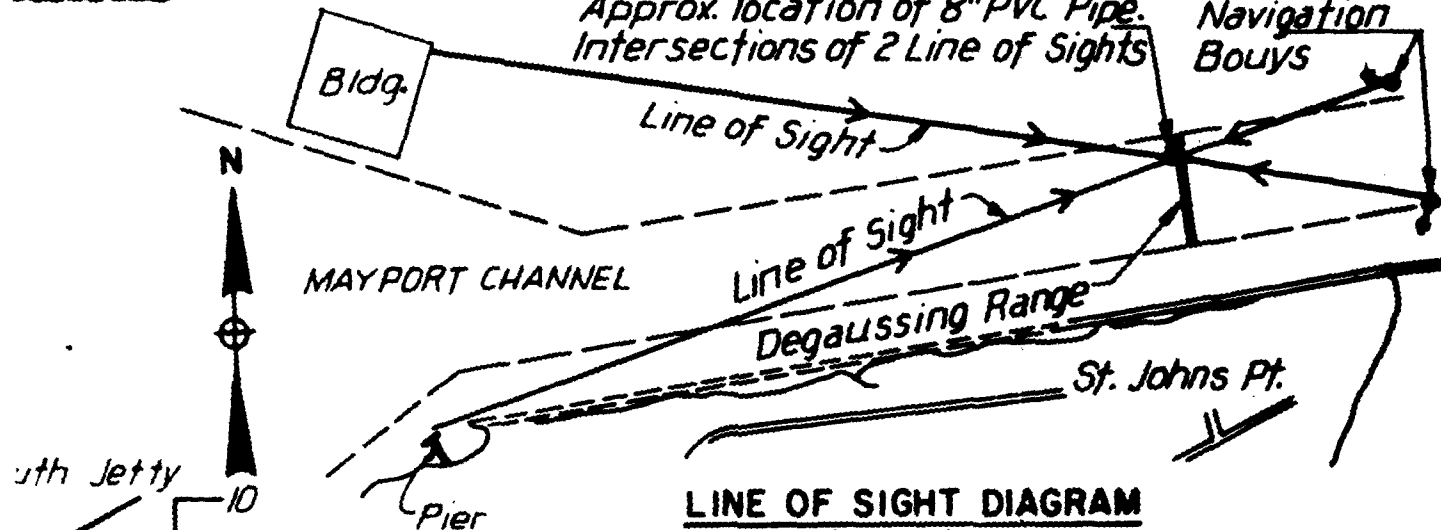
COLLINS ENGINEERS, INC. 600 W. JACKSON CHICAGO, ILLINOIS	CHESAPEAKE DIVISION NAVAL FACILITIES ENGINEERING COMMAND WASHINGTON, D.C.	
	NAVAL STATION DEGAUSSING FACILITY	MAYPORT, FL FILE NO. 4

The inspection of the area of the cable runs between the shore and the sensor tubes did not detect any scouring or unburying of the cables. The eleven degaussing range stake piles and thirty magnetic sensor tubes were also buried. One PVC pipe was found along the range but is not known if this is one of the stake piles. This pipe extended approximately two feet above the channel bottom, and nothing was attached to the exposed pipe. Refer to Figure 4 on page 4-2 for the location of this pipe and to Photograph 1 for a view from shore.

The tidal gauge to be inspected had been removed. Three new timber piles have been driven in order to construct a new tidal gauge. Refer to Photograph 2 for a view of the new timber piles. River soundings using a recording fathometer were made to document the river bed elevations. The soundings are shown on Figure 4.

- ① 8" PVC Pipe extending 2'± above channel bottom; No cables exposed

Correlation of the sounding data with the original design drawings for the facility indicate that the present channel bottom is above the cable runs and magnetic sensors.

It is recommended that future periodic reinspections of this facility be scheduled on 5 year intervals to monitor the long-term serviceability of these structures. No repairs are recommended at this time.
