DOT/FAA/CT-85/25

# Seat Experiment Results Full-Scale Transport Aircraft Controlled Impact Demonstration

Mark R. Cannon  
Richard E. Zimmermann

Final Report

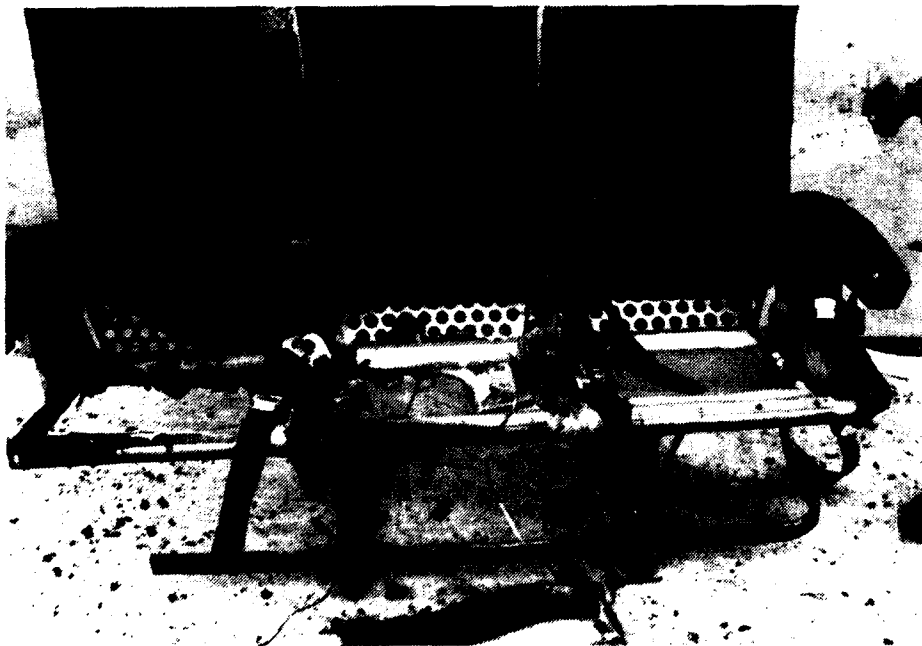
Figure 57. Damage to seat A/R.

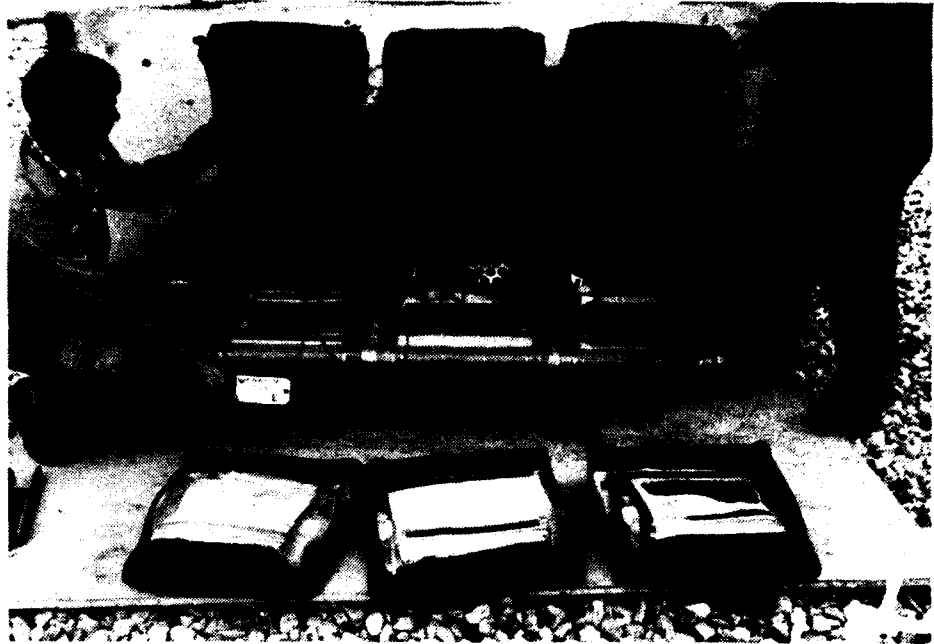
Figure 58. Damage to seat E/L.

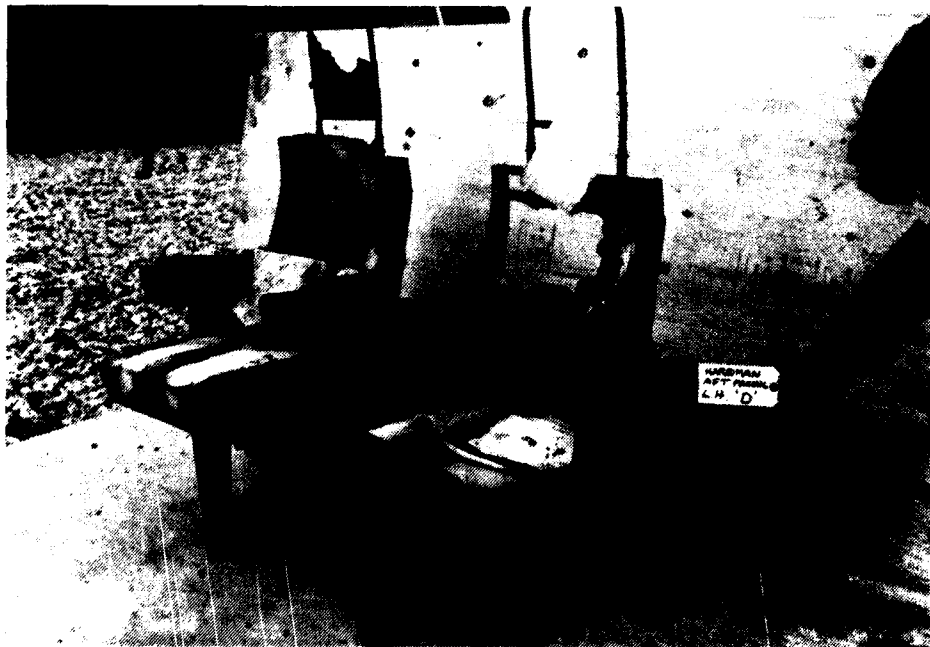
Figure 63. Damage to seat D/L.

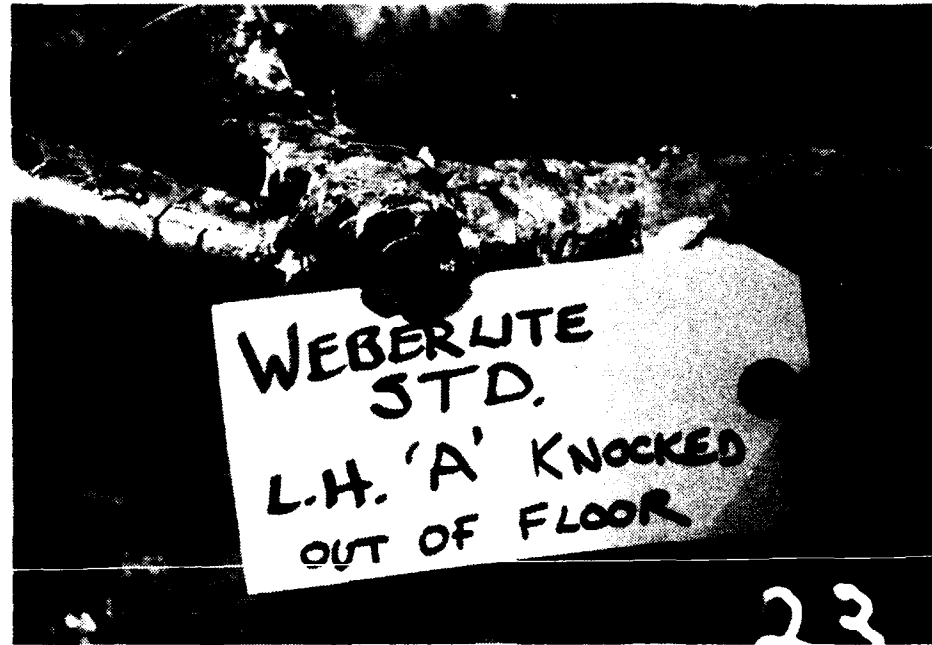
Figure 74. Seat A/L front inboard track button.
