US Army Corps  
of Engineers

REPAIR, EVALUATION, MAINTENANCE, AND  
REHABILITATION RESEARCH PROGRAM

TECHNICAL REPORT REMR-C.T-3

GEOTECHNICAL ASPECTS OF ROCK EROSION  
IN EMERGENCY SPILLWAY CHANNELS

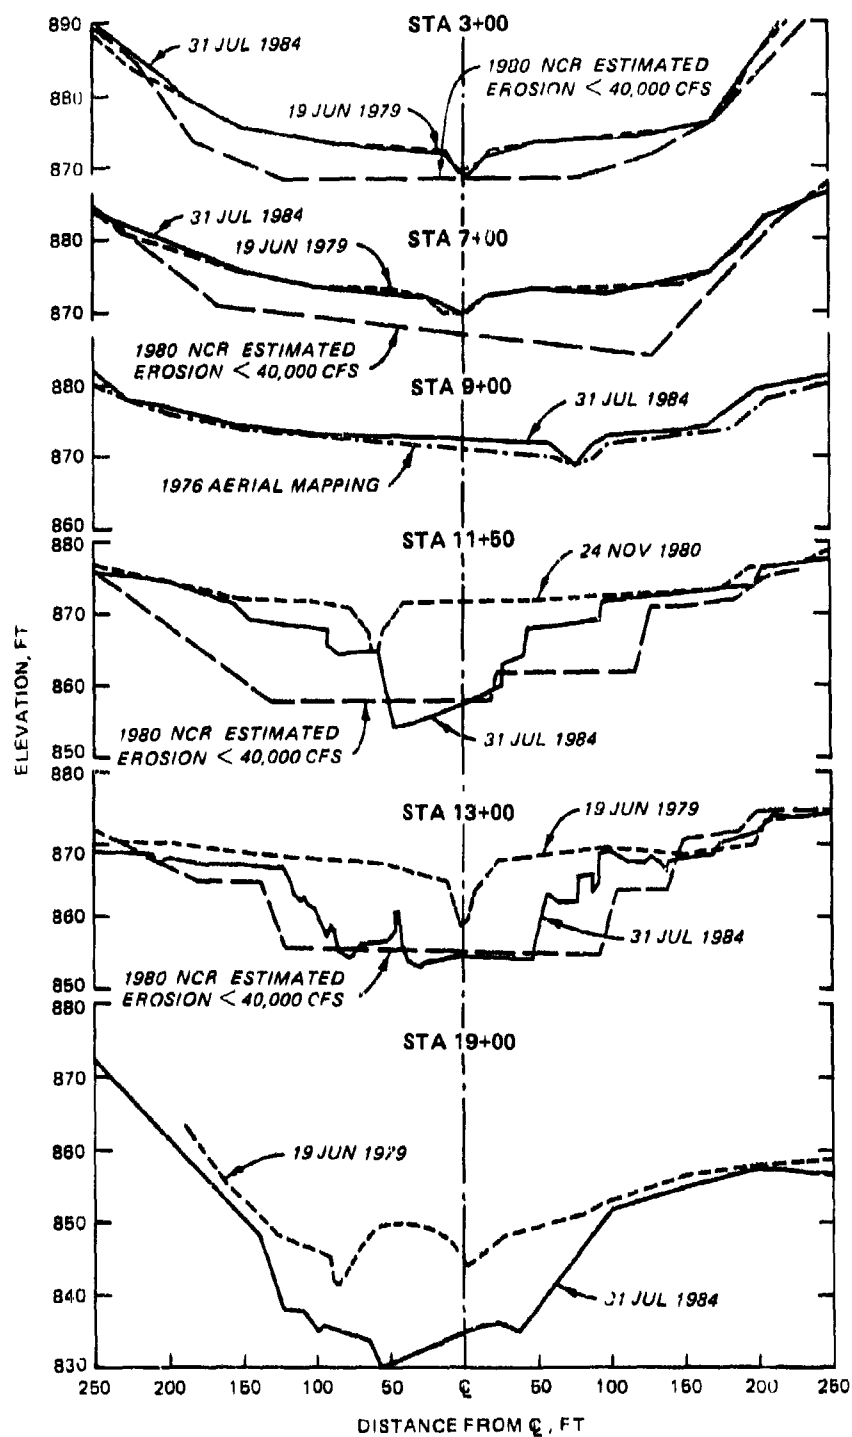
23. Emergency spillway overflow, which peaked at 17,000 cfs on 22 June 1984, produced the rock erosion predicted by the District's studies of 1981-82. District personnel observed the flow and erosion during the event as well as examined the before and after flood longitudinal geologic profiles (see Figure 7), and sections comparing preflood and postflood topography at twelve locations in the channel (Figures 10-12) revealed the following:

Figure 10. Saylorville emergency spillway discharge channel, cross sections from sta 3+00 to sta 19+00 showing preflood and postflood topography and the 1980 NCR erosion estimates for overflows less than 40,000 cfs

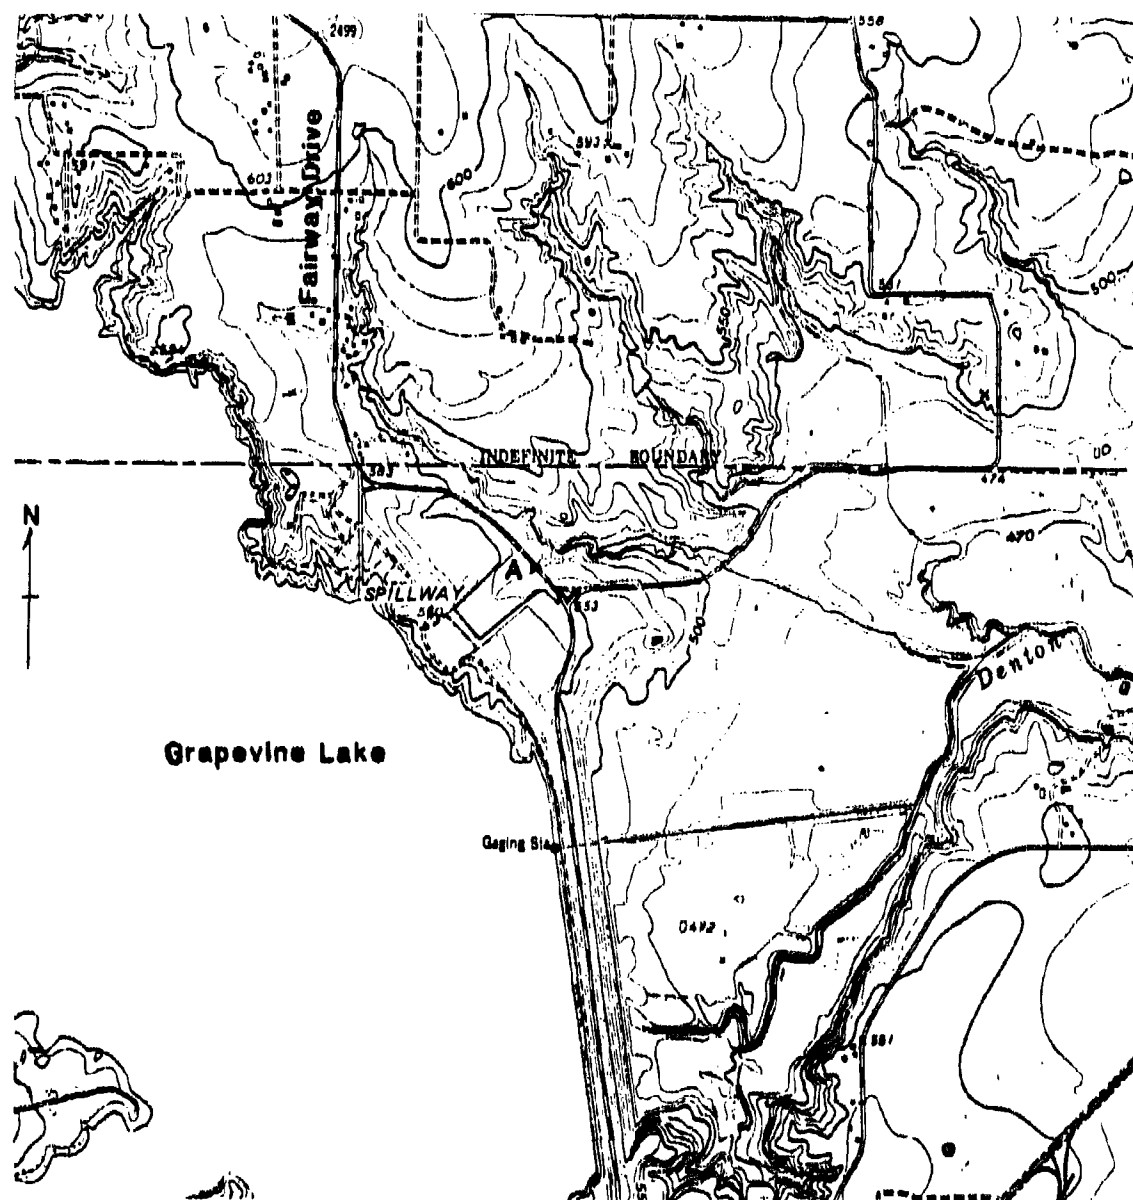
Figure 39. Spillway at Grapevine Lake, from Grapevine 7-1/2 min topographic quadrangle (1959), 10-ft contours. Spillway crest left center (Note the marked increase in gradient where the road crosses spillway channel (Point A)--severe erosion originated at this knickpoint)
