US Army Corps  
of Engineers  
Construction Engineering  
Research Laboratory

TECHNICAL REPORT M-86/14  
July 1986

# Field Test Results of Aluminum Standing-Seam Roofing

by  
Myer J. Rosenfield

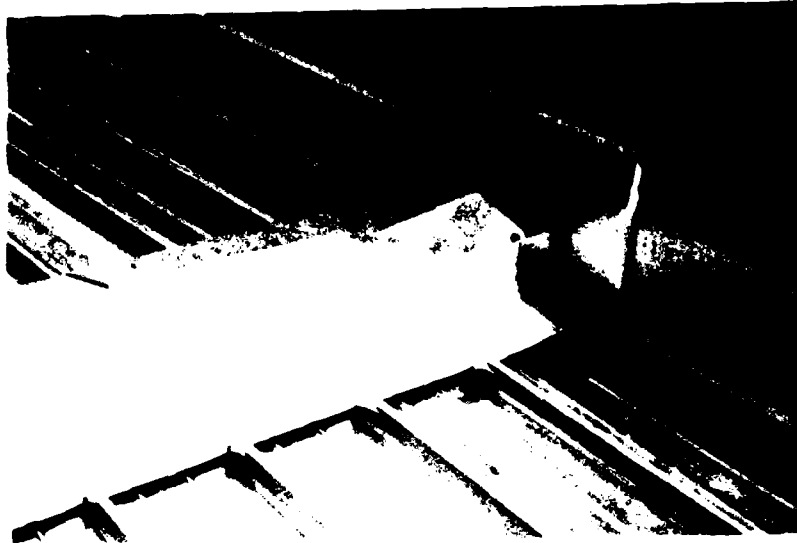
inadvertently stepped on, which probably caused the damage shown in Figure 17, it may not be possible to straighten the cap without first removing it. It is unlikely that the damage was caused by expansion. An expansion joint is visible in Figure 17 and its design is such that it should act as a slip joint between sections.

Figure 17. Damage to ridge cap (July 1983).

The ridge caps will be the easiest components of the roofing system to remove, repair, and replace. At the firewall ends, the ridge caps should be anchored to the walls by aluminum or stainless steel clip angles. The counterflashing could then incorporate a flange to cover the cap. Fasteners holding the ridge cap flanges to the panel closures should be removed and the holes sealed with closures similar to tinker's dams. Clip angles should be attached to the panel closures, and the ridge cap fastened to these clips through slotted holes. This recommendation is illustrated in Figure 34. Ridge cap expansion joints should be checked to determine if they are free to slide, and comply with the manufacturer's recommendation (Figure 19).

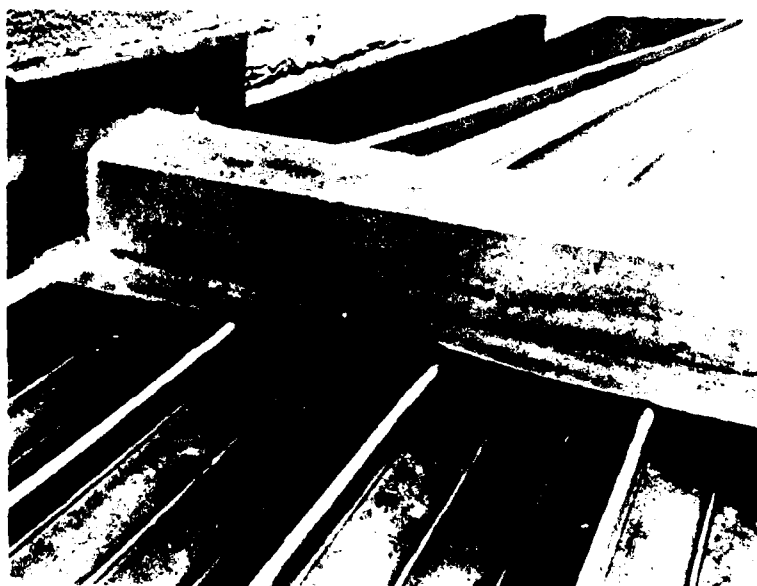
Figure 20. Buckled flange of ridge cap (July 1984).

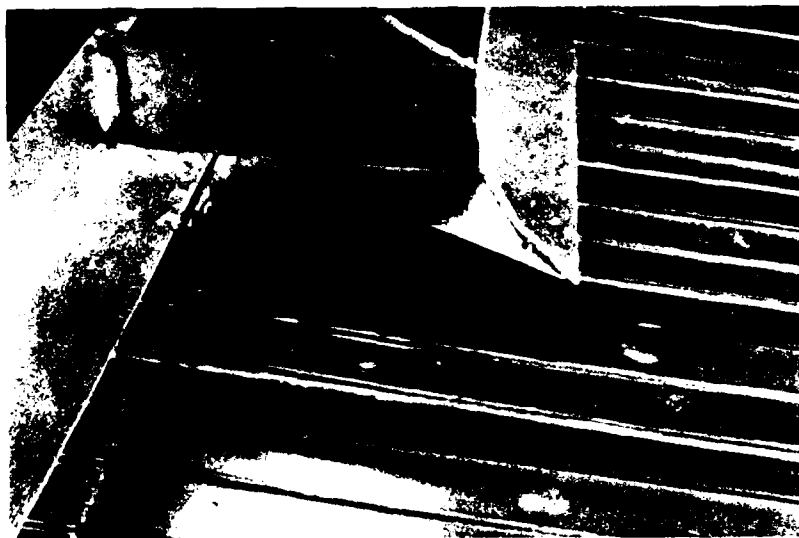
Figure 25. Buckled flange of ventilator flashing (July 1983).

A new cover should be fabricated to fit over the connections between the ridge cap and the ventilator flashings. This cover would divert any water from entering the split joints. The flanges of the ventilator flashings should be attached to the panel closures with clip angles, similar to those recommended for the ridge cap. This design will help prevent buckling.

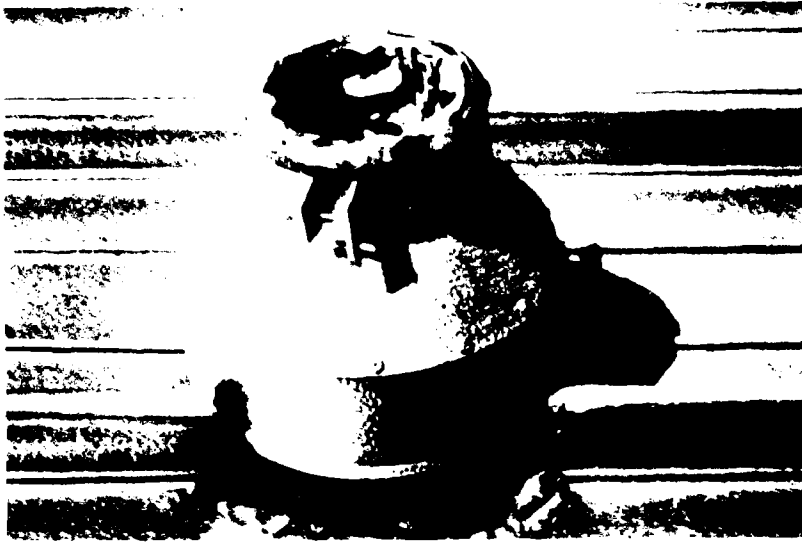
Figure 29. Close-up of plumbing stack flashing (July 1984).

Redesign of the plumbing stack flashing is not necessary. All that is required is to inspect all the opening seals, remove them if they are dried and shrunken, and replace with a new rubbery mastic.

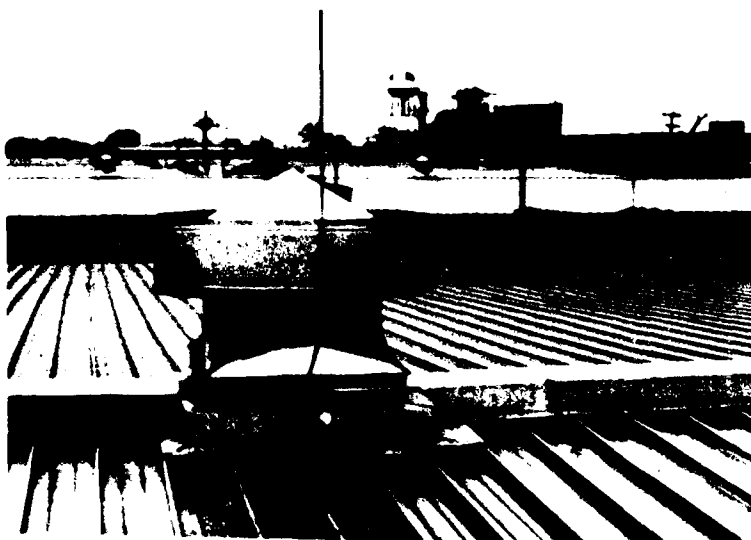
Figure 32. Lightning rod on ventilator (January 1984).

A flanged sleeve made from aluminum tubing should be fastened to the ridge cap around the lightning rod. An umbrella-type counterflashing of copper or a copper-bearing alloy should then be fastened to the rod to cover the sleeve. Alternatively, a prefabricated rubber boot could be installed. In addition, the whole roofing system should be grounded.

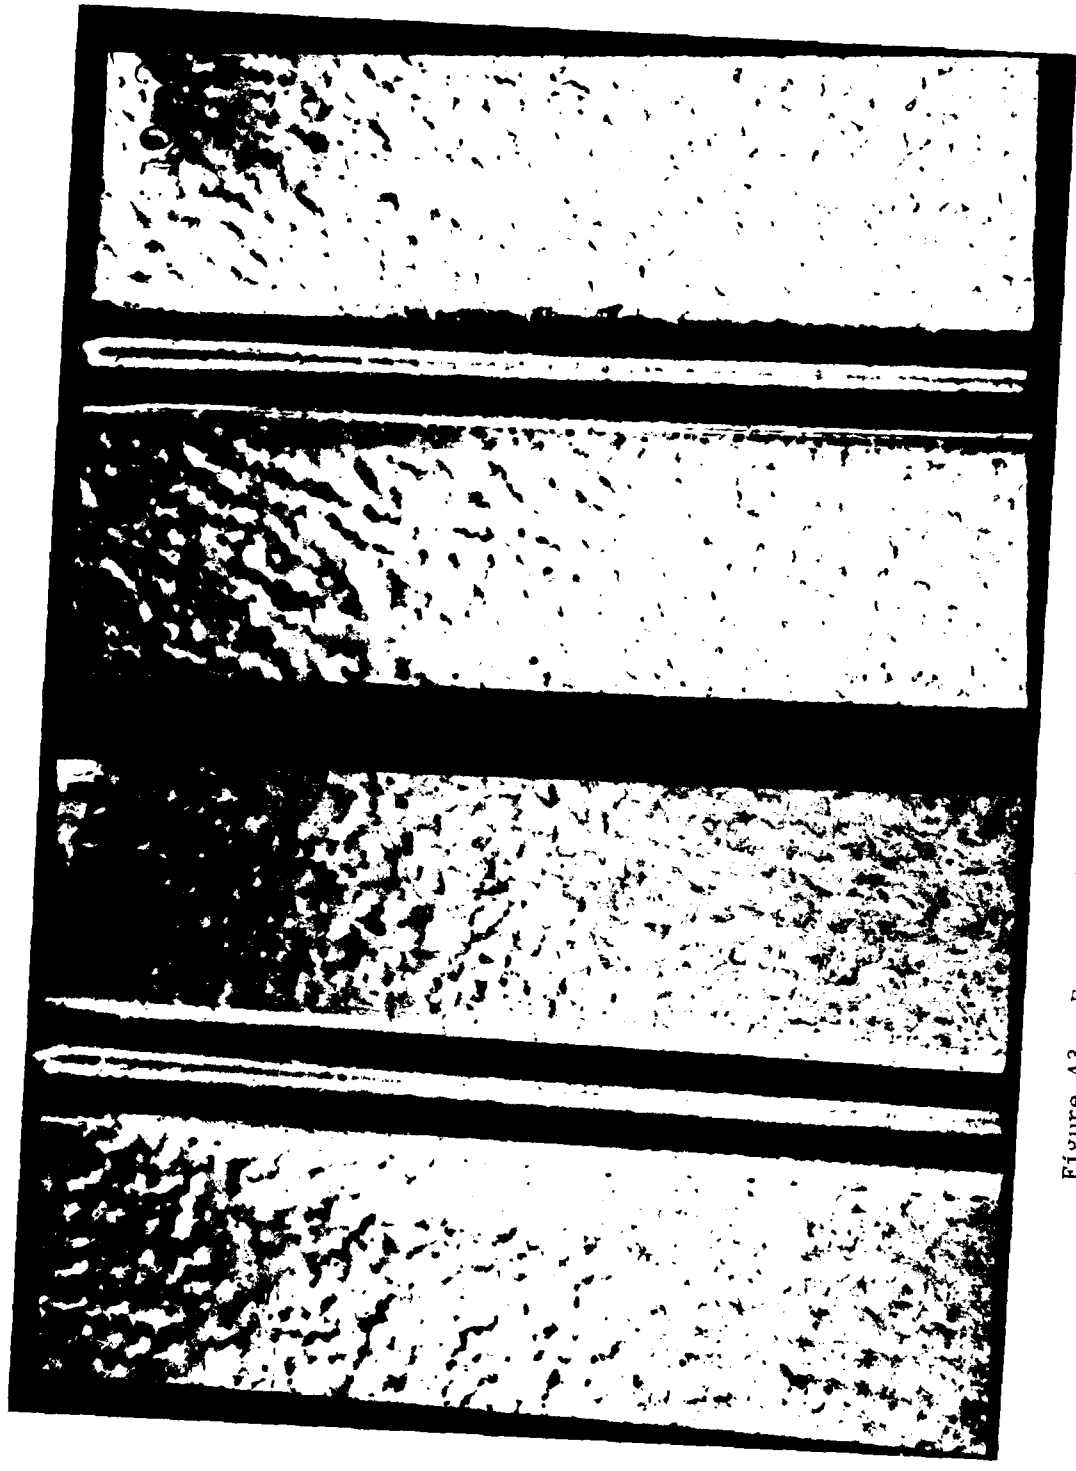
ASTM Standards G1-81 [4] and G48-76 [5] were considered in examining and determining the extent of corrosion. It can be seen from the photograph (figure A3) of a typical exposed and control sample, that the exposed sample on the left has less gloss and greater surface roughness than the control sample on the right. Also, it can be seen that the surface of the exposed sample contains many small dark spots. It is thought that these dark spots

Figure A3. Exposed (left) and control (right) specimens.
