Technical Note

September 1986  
By J. F. Jenkins  
Sponsored by Naval Facilities  
Engineering Command

## Corrosion and Corrosion Control of Hush House Interiors

This report is based on the inspection of a typical hush house at the Marine Corps Air Station (MCAS), El Toro and on laboratory investigations performed at the Naval Civil Engineering Laboratory (NCEL).

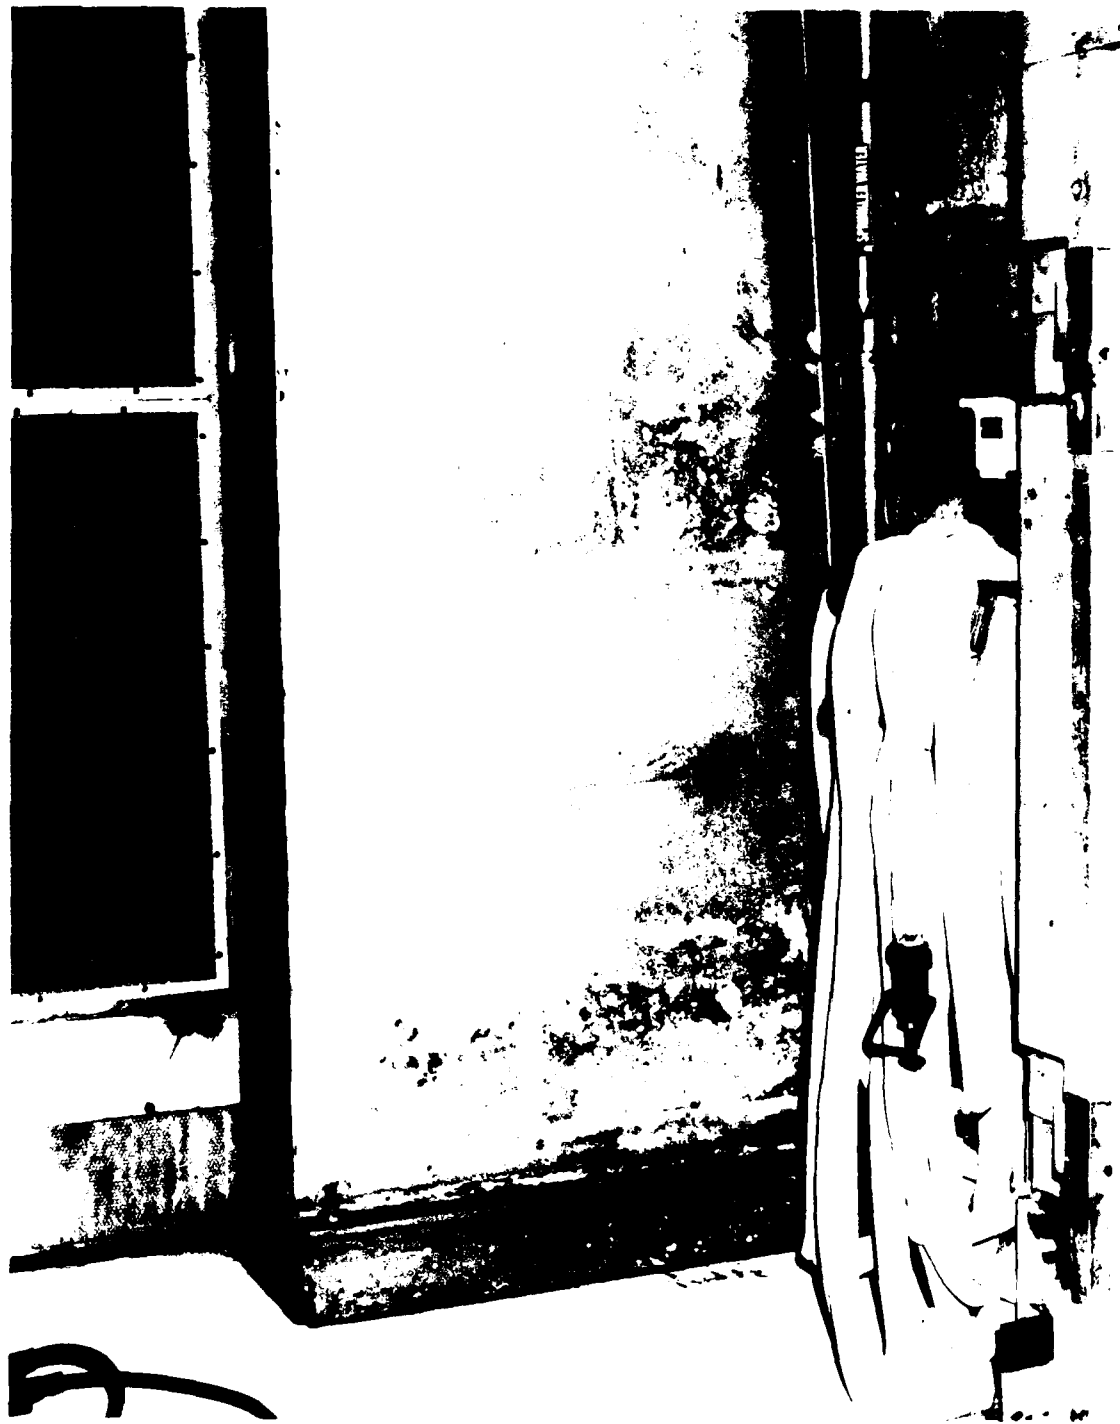
In June 1983, the exterior of the perforated liner plate was inspected. The corrosion damage was widespread. As shown in Figure 2, it was generally concentrated at the lower portions of the sections and, to a lesser extent, at an area approximately 4 feet above the bottom of the sections. The corrosion damage, which ranged from a light covering of white corrosion products to red rust, was typical of galvanized steel exposed to a rural-type exterior atmosphere. The areas of most severe corrosion damage were adjacent to the firefighting hose and to the hose bibs on the two lateral walls. Above the 8-foot level there were scattered areas with a very thin layer of white corrosion products.

Figure 2. Example of liner corrosion at lower section near fire hose.

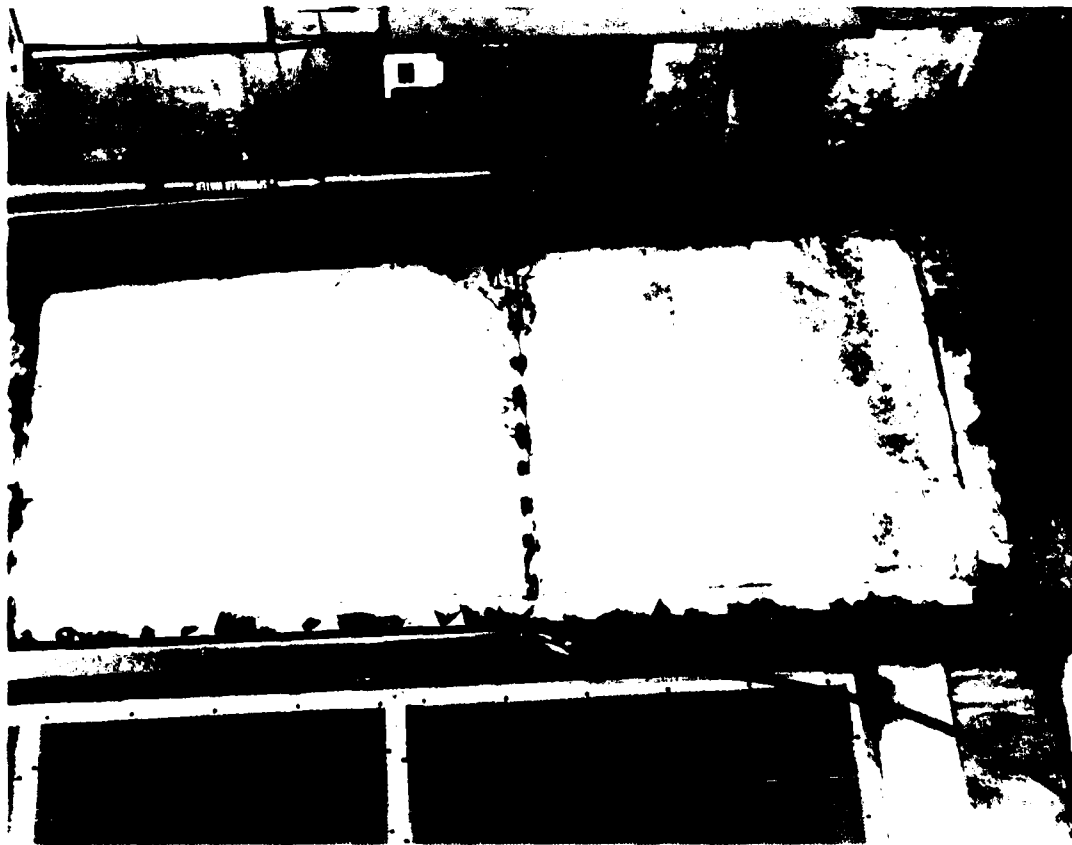
After all of the welds had been cut, the panel was removed and the acoustic material was exposed and inspected. As shown in Figure 6, the fiberglass material was stained. As shown in Figure 7, the material in the first layer of insulation was inspected for moisture before removal and was found to be dry to the touch. The fiberglass cloth covering the outer section of the acoustic material was, however, water stained. The outer section of the acoustic material was removed and unwrapped. The lower section of the material was significantly deteriorated, and it easily crumbled when handled as shown in Figure 8. The inner section of acoustic material was then removed. Portions of this material adhered to the interior plate of the section (see Figure 9) but were easily removed by light scraping. The acoustic material was retained for future evaluation in a separate work unit.

Figure 6. water stains on fiberglass covering.

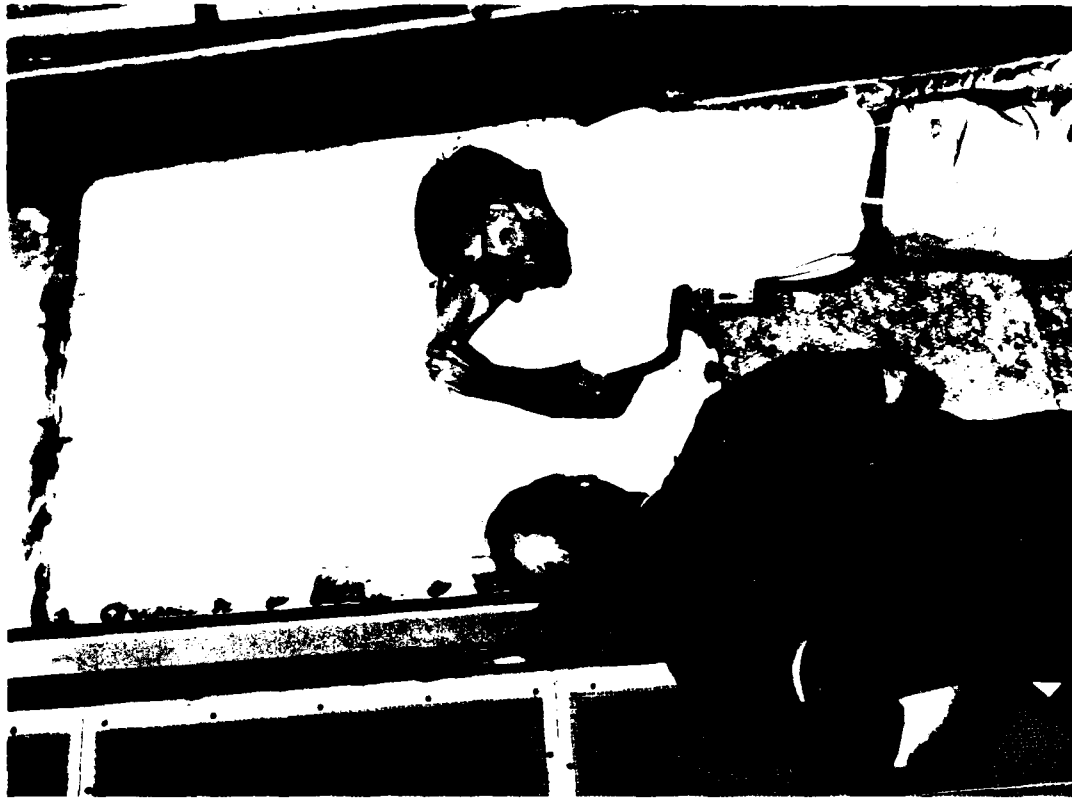
Figure 7. Inspection of acoustic material for moisture.

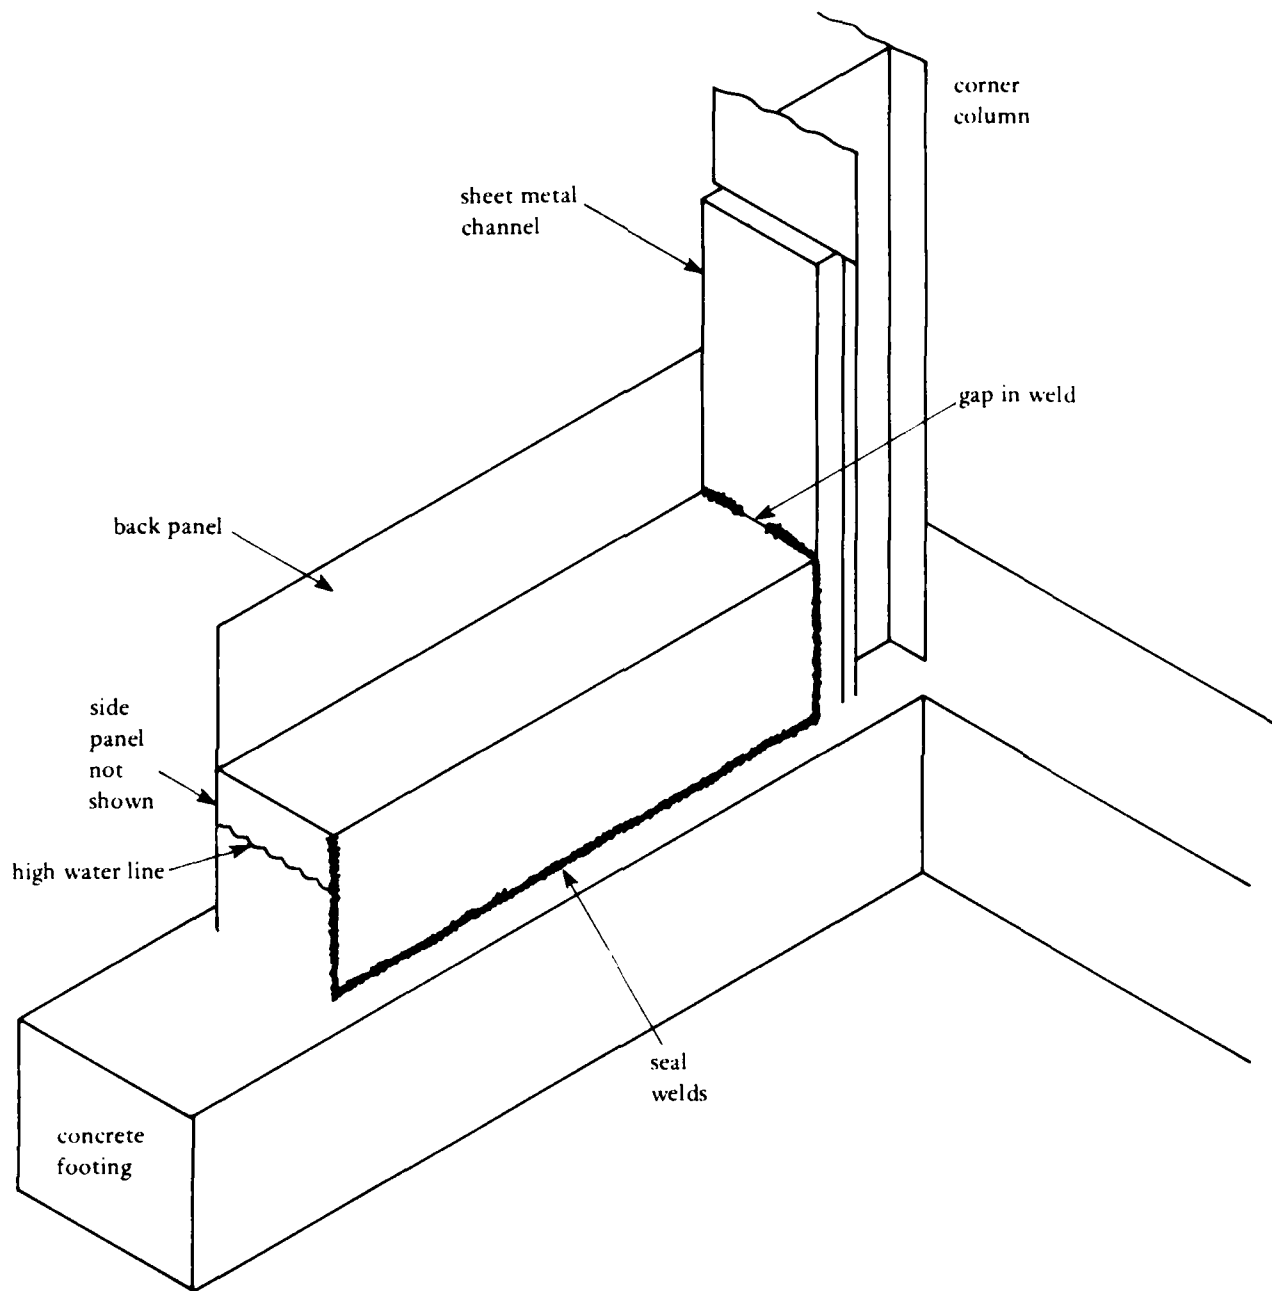
Figure 18. Sketch of lower support channel showing water entrapment mechanism.

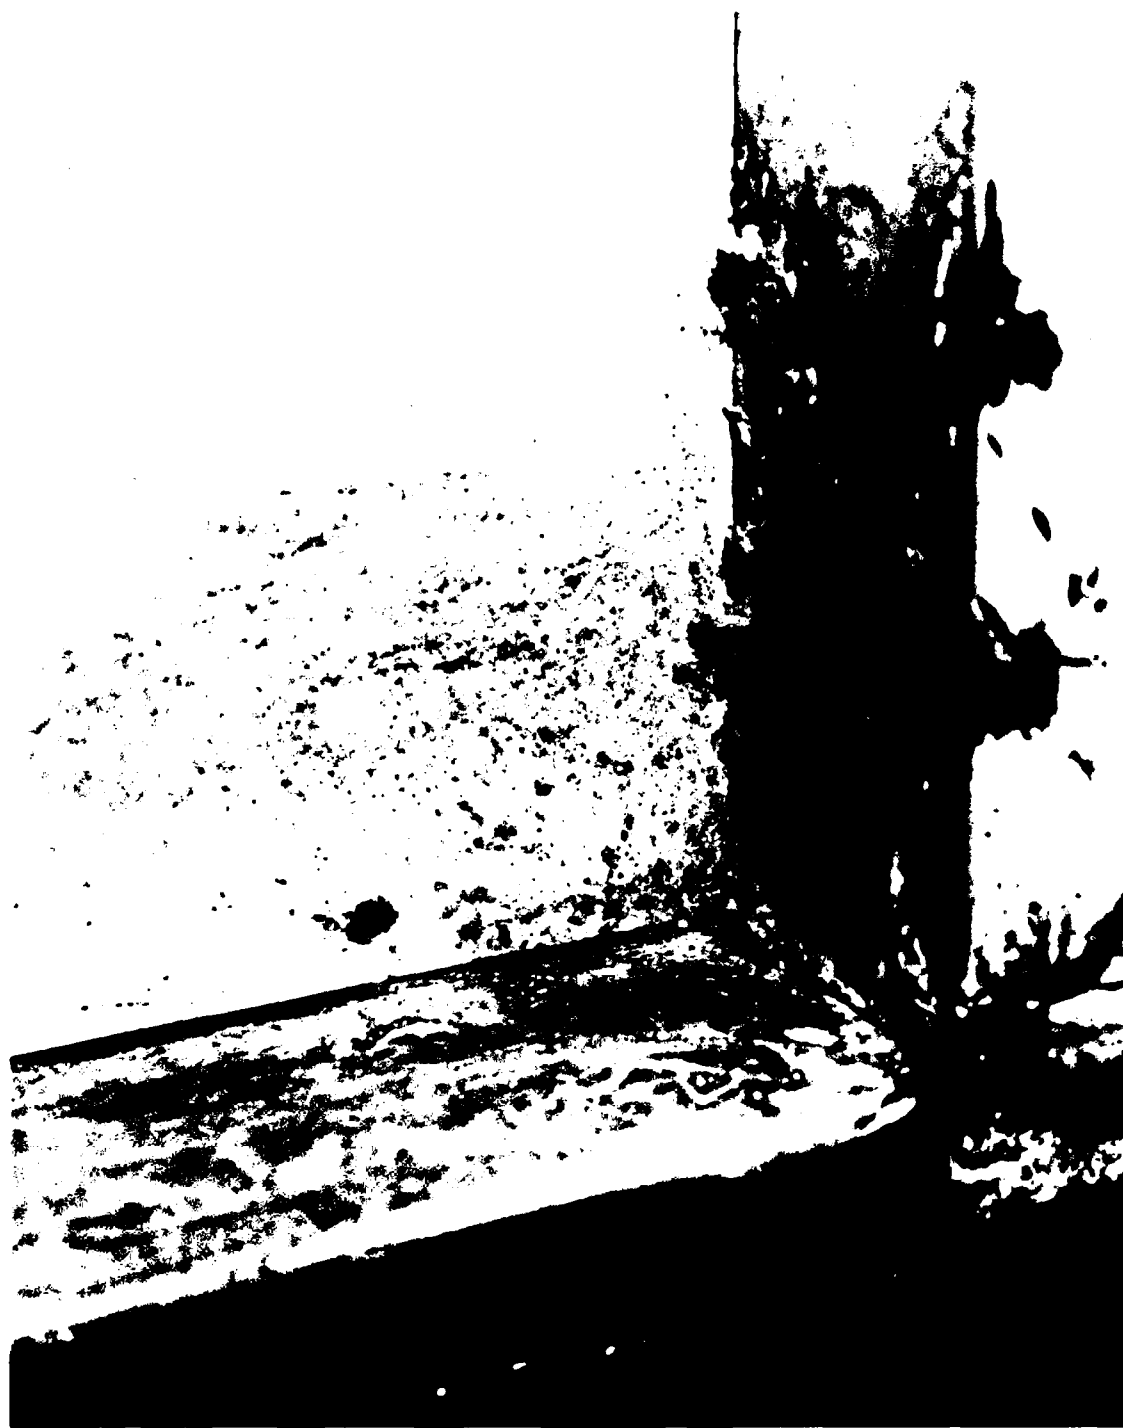
Figure 19. Midspan support showing evidence of water entrapment.

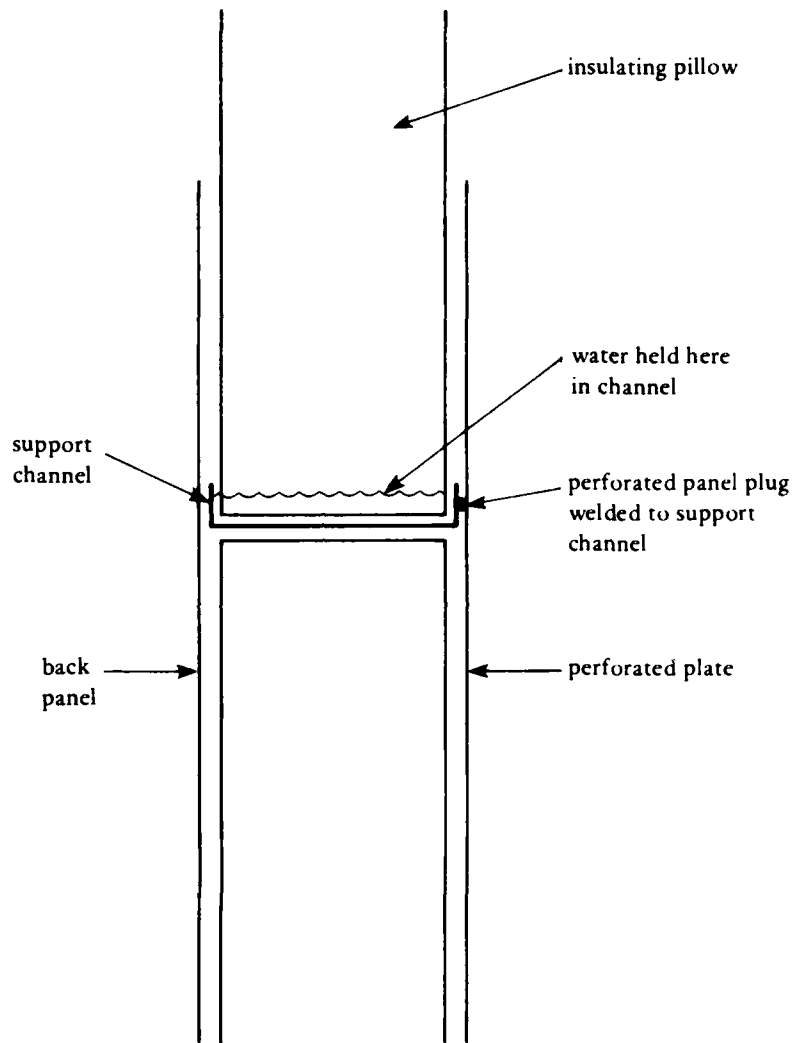
Figure 20. Sketch of midspan support showing water entrapment mechanism.
