## SPILLWAY MODIFICATION GRAPEVINE LAKE, TEXAS

JUNE 1986

FINAL  
FOUNDATION REPORT

GRAPEVINE LAKE  
SPILLWAY MODIFICATION

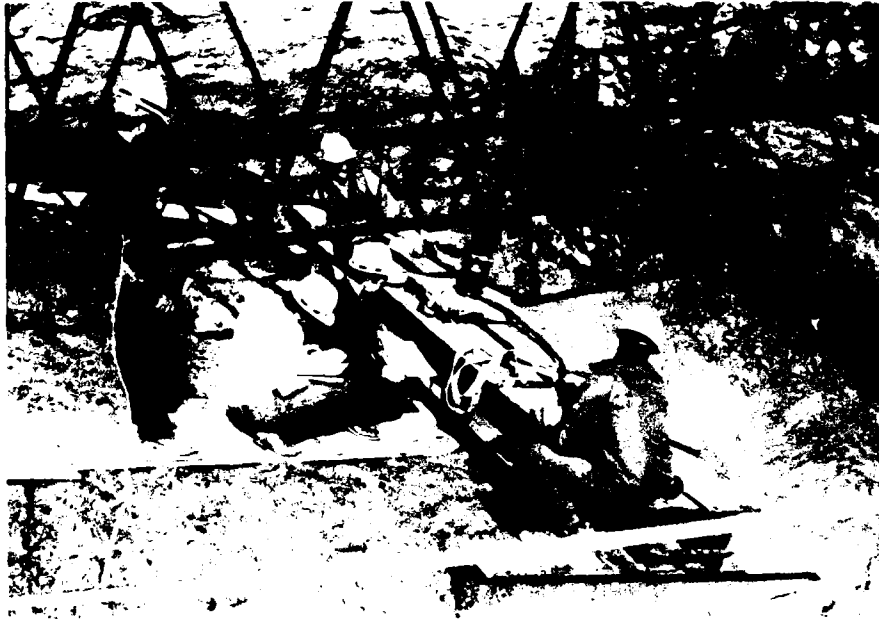
6. Pull-Out Tests. Two rock anchors were installed on February 8, 1984, for the purpose of conducting pull-out tests. Both were installed at design grade near the centerline of the spillway at approximate station 12 + 80, about 50 feet downstream from the end of the existing spillway apron. The pull-out tests were performed by Southwestern Laboratories' personnel. The initial tests conducted on Feb 23-24, 1984, were unsuccessful because of problems with the jack and jack support. The same anchor bars were retested on March 8, 1984, with successful results. The anchors were stressed to 45 tons during which

Fig. 13 - Pull-out test in progress

the maximum deformation observed was 0.551 inch. Figure 13 shows the pull-out tests in progress.

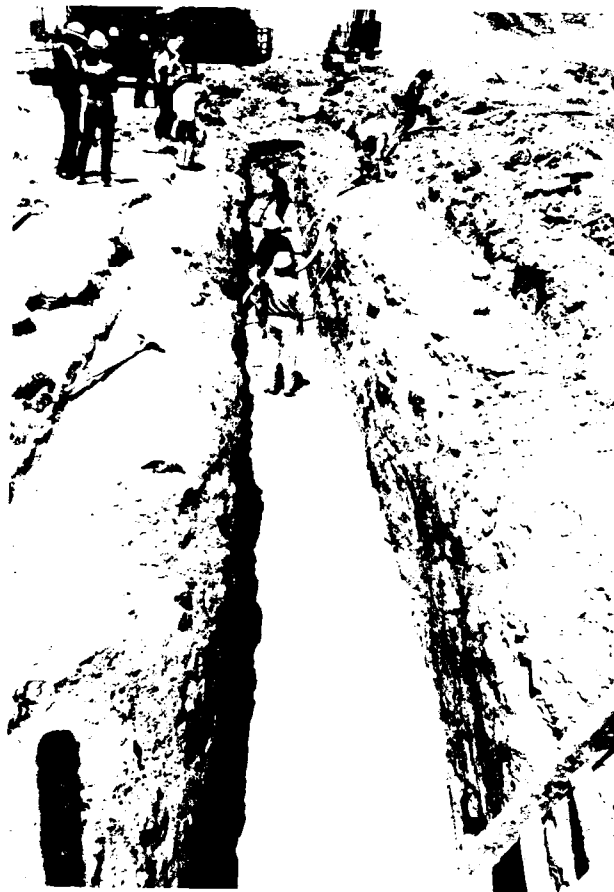
2. Future Considerations. The excavation of a 1 horizontal on 4 vertical slope, as required in the excavation for the spillway end sill, is very difficult to achieve. Normally, when excavating in soft materials where line drilling would not be required, a Contractor will use a backhoe, which will result in a rectangular-shaped ditch, as

Fig. 32 - End sill excavation - 5 April 1985

was the case in this project (see Figure 32). Consideration should be given to designing a rectangular-shaped end sill excavation with a typical bottom width conforming to the width of a typical backhoe bucket.
