TR 86-2

REAL-TIME RADIOGRAPHY INSPECTION  
OF ARAMID (KEVLAR) COMPOSITE  
PASGT HELMETS  
FEASIBILITY STUDY

UNITED STATES DEFENSE LOGISTICS AGENCY  
DEFENSE ELECTRONICS SUPPLY CENTER  
DAYTON, OHIO  
CONTRACT NO. DLA900-86-M-Z929  
JUNE 16, 1986

Oscar Rivera  
Sales Manager - Digital Systems

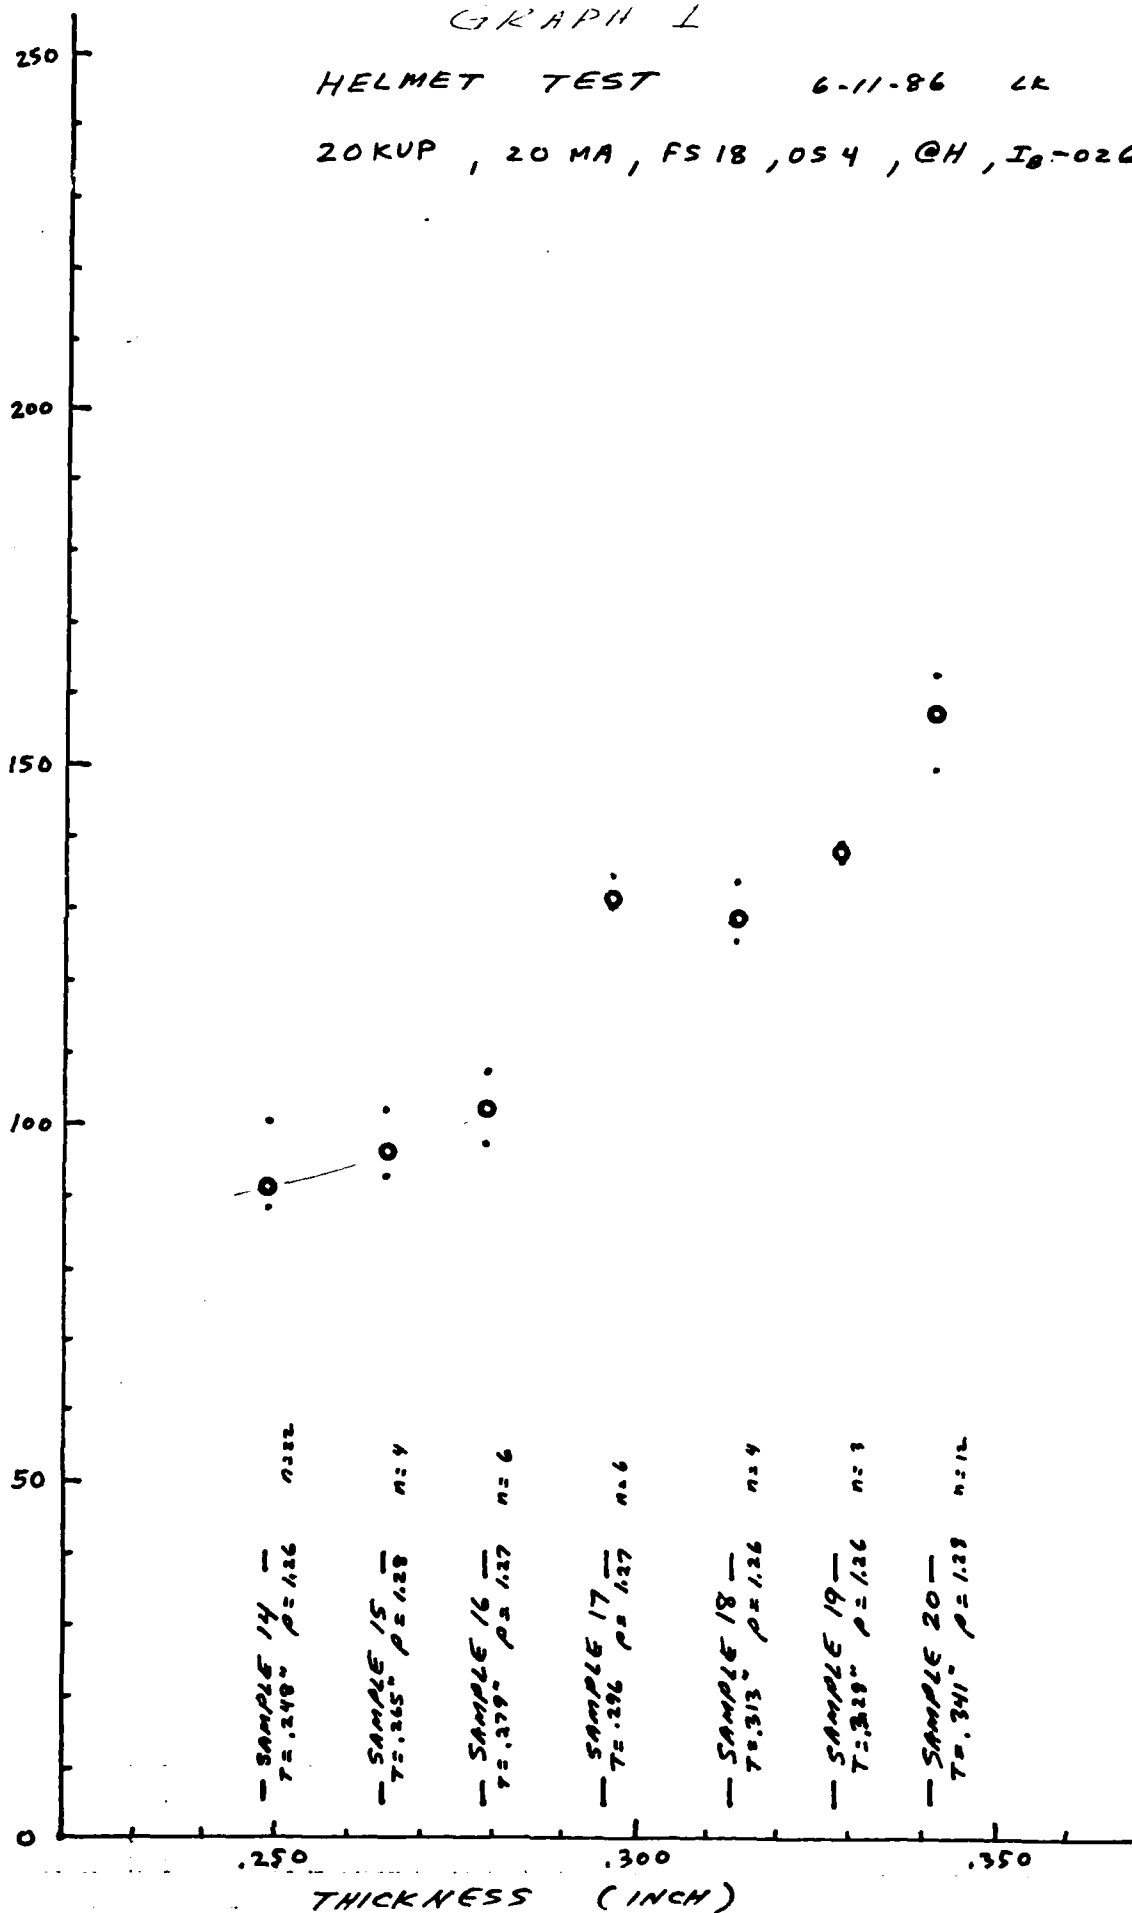
# GRAPH I

The graph shows the change in brightness as a function of thickness. Brightness change is a relative measure of density and/or thickness variation.

All the samples except #17 fit along the smooth curve plotted in graph 1. Sample #17 had not been submitted to a density check at the time it was X-rayed and a brightness measurement made. Since the density check involved immersing the samples in water, and #17 was not, it is believed that is the reason the brightness reading does not fall along the curve.

This procedure established a direct correlation between missing plys and brightness readings.
