TECHNICAL NOTE

MRL-TN-504

GRINDING OF STEEL - A CASE STUDY

G.R. Wilms and R.L. Aghan

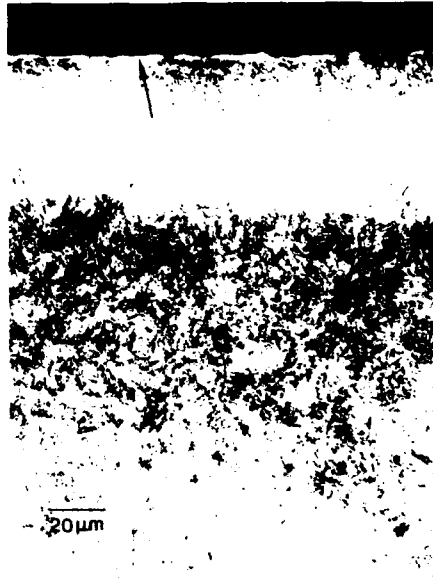
A corresponding section through the ground gear tooth is shown in Fig. 5. There is a substantial white-etching hardened layer together with a deep underlying dark-etching softened layer. There is also evidence of an outermost redeposited layer which is also white-etching. Redeposition has also previously been found to occur in the grinding of mild and high strength steels (2), where it was indicated that the continual reworking of the

FIG. 5 Optical micrograph through surface corresponding to Fig. 3, showing a substantial white-etching layer and a deep underlying dark-etching layer. There is also evidence of an outermost redeposited white-etching layer (arrowed).

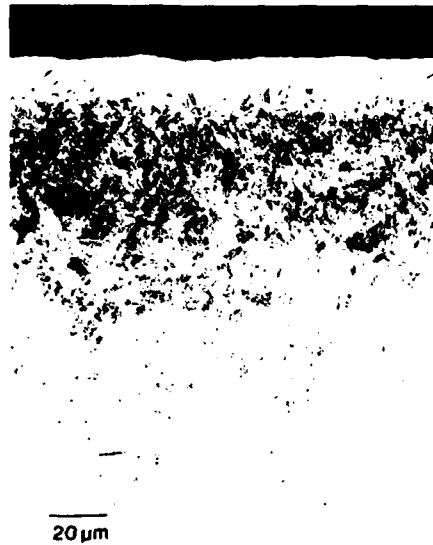
FIG. 7 Optical micrograph through surface corresponding to Fig. 6, showing a white-etching layer and an underlying dark-etching layer (cf. Fig. 5).

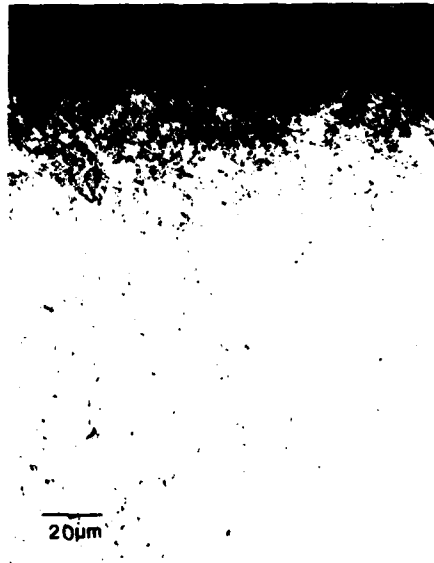
The extent of damage at the lower wheel speed (Fig. 9) indicates that it emanated primarily from the roughing cuts, which would not have been removed by the few finishing passes of $5\ \mu\text{m}$ ($0.0002\ \text{in}$) used in production. The surface grinding studies revealed that, if the roughing cuts were stopped $100\ \mu\text{m}$ ($0.004\ \text{in}$) oversize and the finishing cuts were graded down to $2.5\ \mu\text{m}$ ($0.0001\ \text{in}$), there was then no evidence of any change in the workpiece microstructure, as shown in Fig. 10.

FIG. 9 Optical micrograph through surface corresponding to Fig. 8, showing only a relatively shallow dark-etching layer which should be compared with Fig. 5.

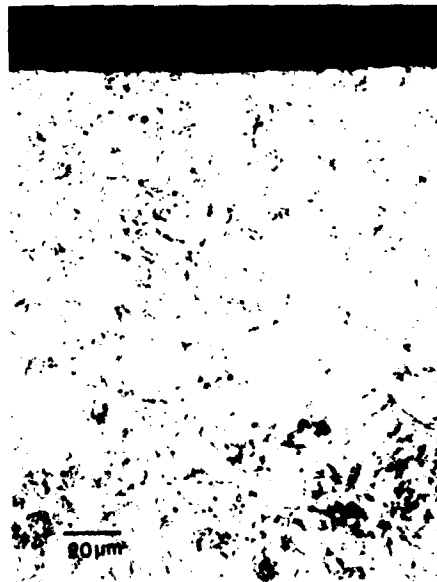
FIG. 10 Optical micrograph through surface after grinding dry at a wheel speed of 18 m/s with graded finishing cuts. There is no detectable change in microstructure.

(i) dressing the wheel after the roughing cuts and taking four cuts of $12.5\ \mu\text{m}$ ($0.0005\ \text{in}$), (ii) taking five cuts of $5\ \mu\text{m}$ ($0.0002\ \text{in}$), and (iii) dressing the wheel and taking ten cuts of $2.5\ \mu\text{m}$ ($0.0001\ \text{in}$).

The surface grinding studies showed that by using a combination of reduced wheel speed and graded finishing cuts extending down to $2.5\ \mu\text{m}$ ($0.0001\ \text{in}$) over a depth of $100\ \mu\text{m}$ ($0.004\ \text{in}$) no changes were apparent in the workpiece microstructure. Applying this procedure in production enabled gears to be ground which did not show any evidence of grinding abuse after the nital-etch test.
