Report No. CG-D-29-86

**THE MAINTENANCE AND OPERATION OF A SMALL  
WIND GENERATOR IN THE MARINE ENVIRONMENT**

WARREN HEERLEIN

U.S. COAST GUARD RESEARCH AND DEVELOPMENT CENTER  
AVERY POINT, GROTON, CONNECTICUT 06340-6096

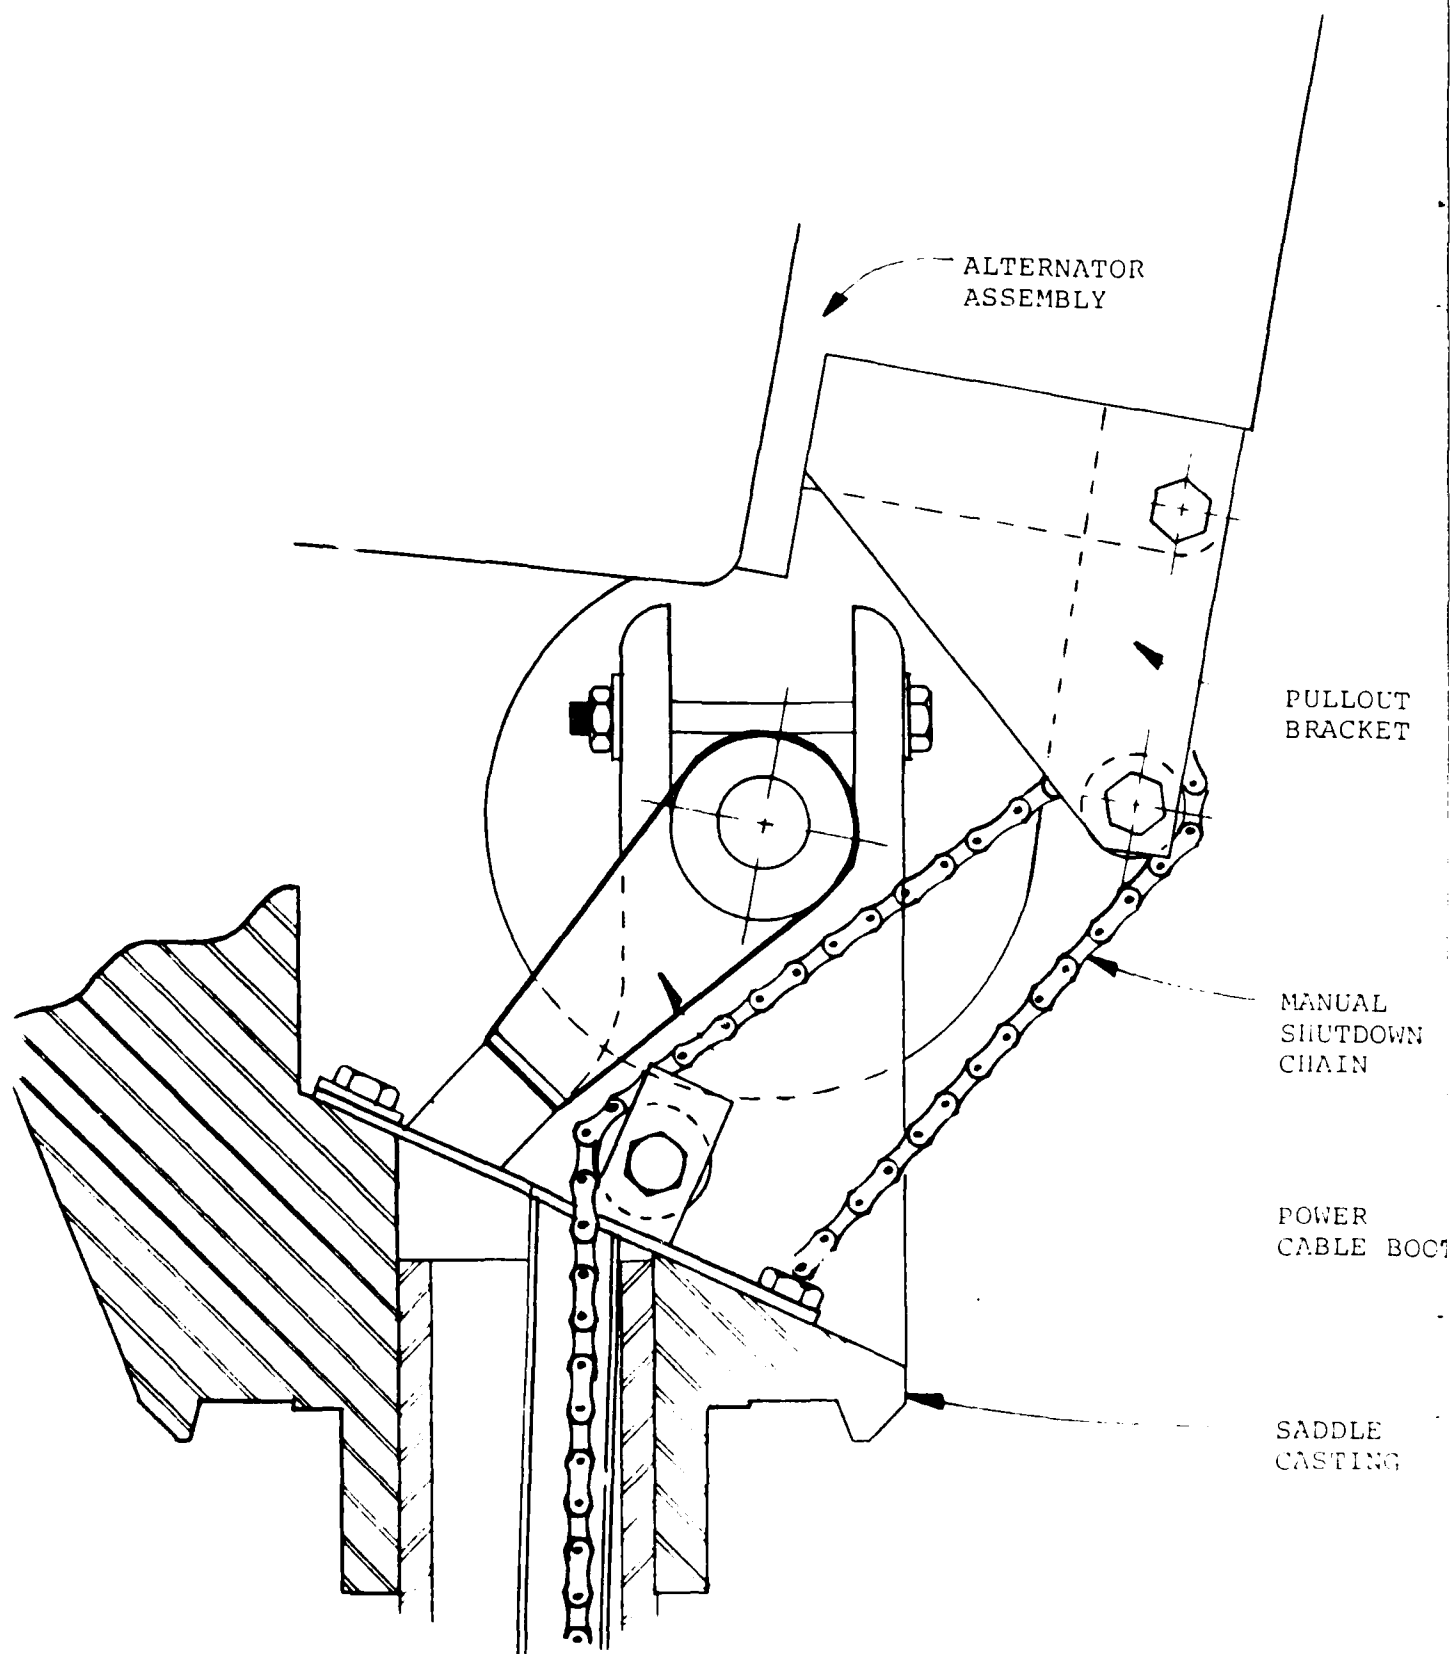
FIGURE 10. MANUAL STOWING ASSEMBLY

The manual stowing assembly was noticed to have evident rusting. APL hand greased the chain but did not replace it with a new chain supplied by North Wind, (see Figure 10).

The manual stowing chain that was observed to be rusting has failed. Repair work is dangerous until the wind machine can be manually feathered. The HR2 continued to produce power while repairs were planned.

The second weakest link in terms of maintenance is the continual failure of the manual stowing mechanism. This device is subject to full marine environmental stresses. Left unused for long periods of time it often fails when it is needed the most. The Coast Guard replaced the North Wind plastic coated wire rope with 1/4-inch stainless steel wire with a 6100 pound rating. Thimbles were employed at all turns. Since this change was made no failures have been experienced.

The manual stowing chain was repaired by USCG personnel.

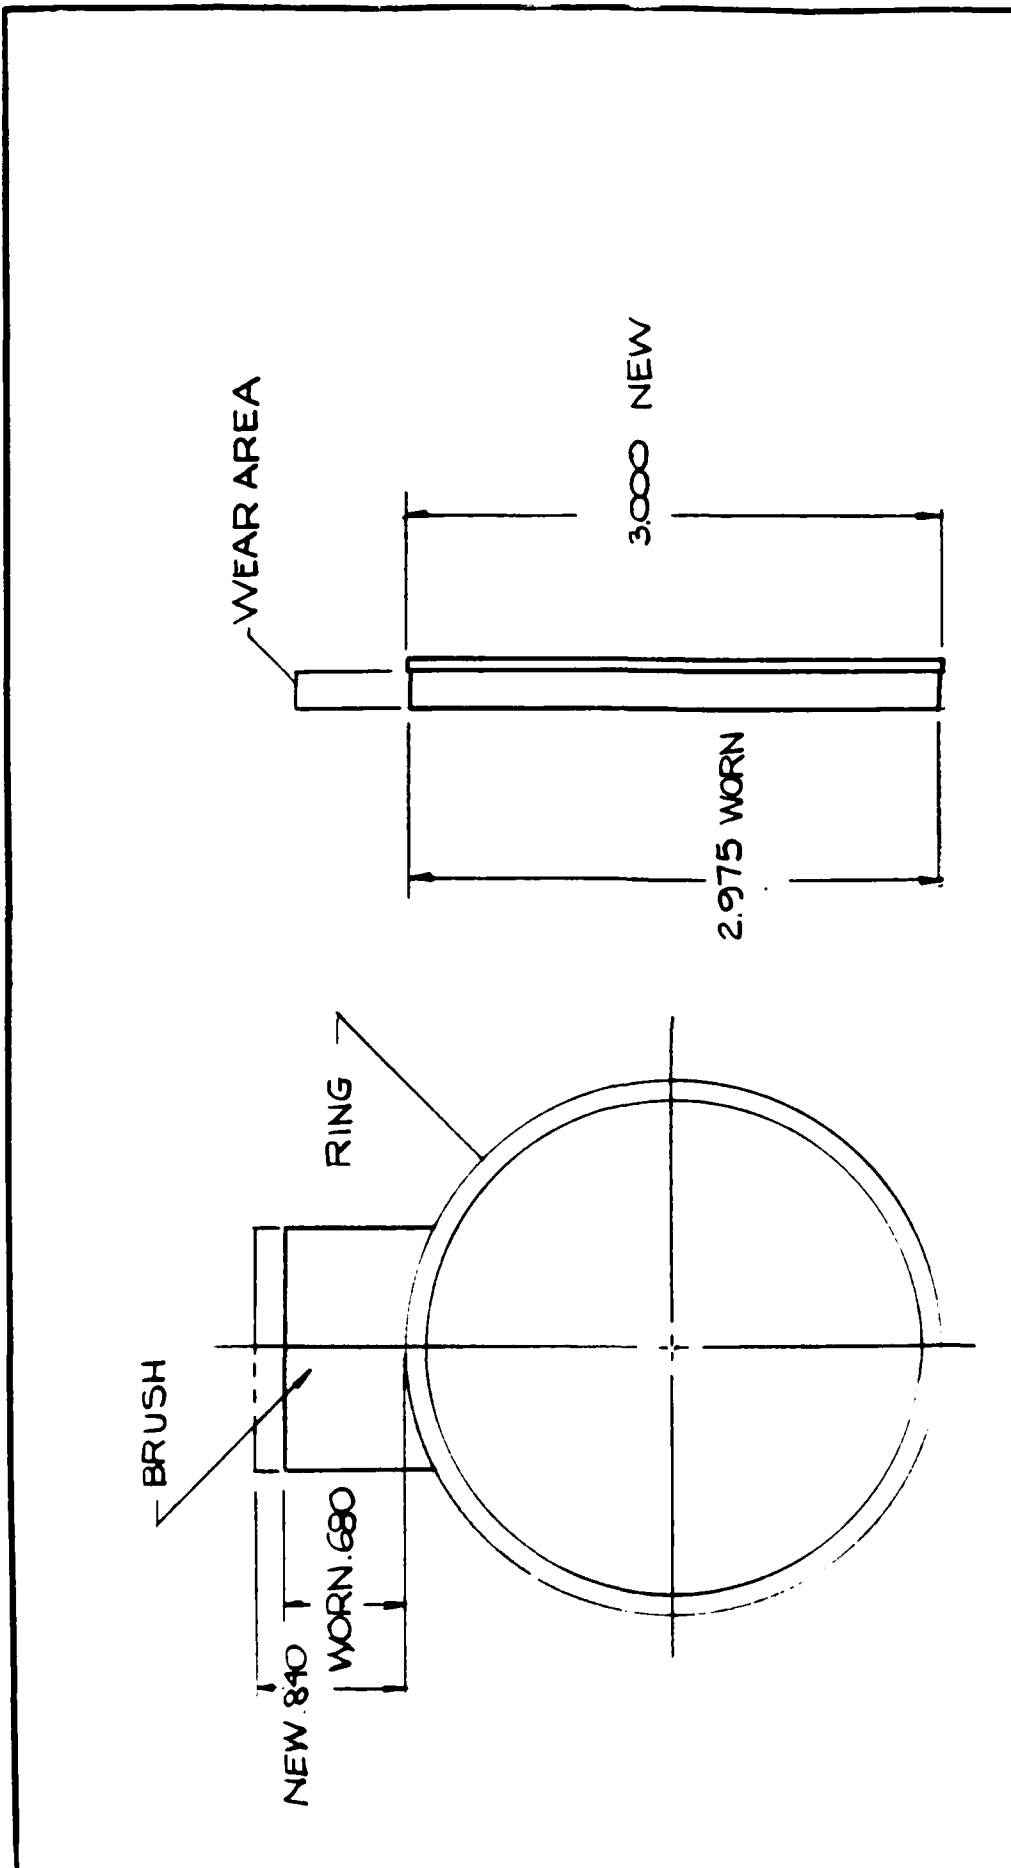
FIGURE 12. HR2 SLIP RING WEAR

From its installation in October 1981 to the time of this report, June 1986, the HR2 experienced four major failures. Two of these failures (RCD, May 1984 and field coil, January 1986) can be traced to the manufacturer's original design. The two other failures (brush/rings September 1982 and May 1984) are of a more serious nature because they reflect on the design limits of the machine. From all observations, the weakest "link" in the HR2's design is the two sets of brushes and rings (field and yaw). The yaw brushes and rings allow the positive, negative, and field current to run down the tower length and then be translated 90 degrees at the tower top. They are not subject to the large number of revolutions that are seen by the field brush and ring assembly on the main shaft, but affected by wind direction only. Based on our data, we conclude that barring catastrophic failure such as was experienced in May 1984 this yaw brush/ring assembly will survive for a full year without service. The field brush reliability for a one year service interval cannot be stated with such certainty. The initial set of brushes put in the machine apparently began to fail after nine months and power output was nil by eleven months. The second set of brushes ran for 16 months with at least two months of no-load (higher RPM) operation. When they were removed for the rebuild in August of 1985, they measured just within specification at 0.680 inches, (see Figure 12). They may survive one year of operation.

Of lesser but still critical importance is the ventilation of the brush/ring enclosures. In all incidents of inspection or maintenance, heavy amounts of carbon debris (dust) could be found within the enclosures. This is a by-product of brush wear and unavoidable. When moisture builds up inside these enclosures and joins with this carbon dust, it is possible short circuits could develop over these unintentional paths. Air and dust vents that ventilate and carry away this moisture and dust have been replaced twice and appear to be susceptible to heavy wear in marine environments. They should be included as an annual maintenance item, and possibly be manufactured from a more corrosion resistant material.
