**PRELIMINARY REPORT NO. 1
DEMOLITION/SALVAGE ANALYSIS
OF
OFFSHORE PLATFORMS
STAGE I AND II**

CONTRACT N62477-82-C-0393

May 1983

The objective of the inspection was to determine the general, above-water, present conditions of the structures, and locate any newly formed major structural hazards that will influence disposal plans, compared to the previous survey taken in December 1980.

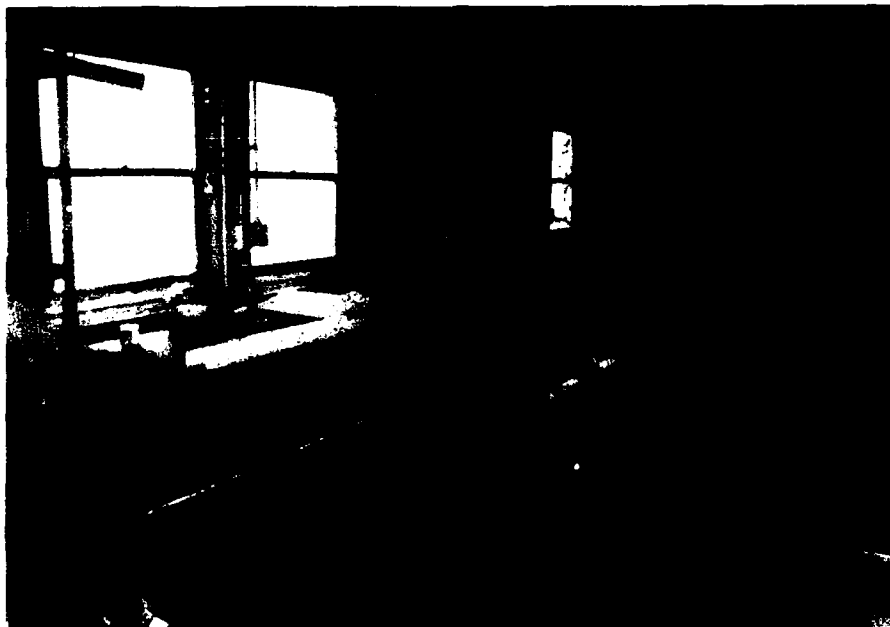
Stage I - Repair Shop
Figure 2.2.8

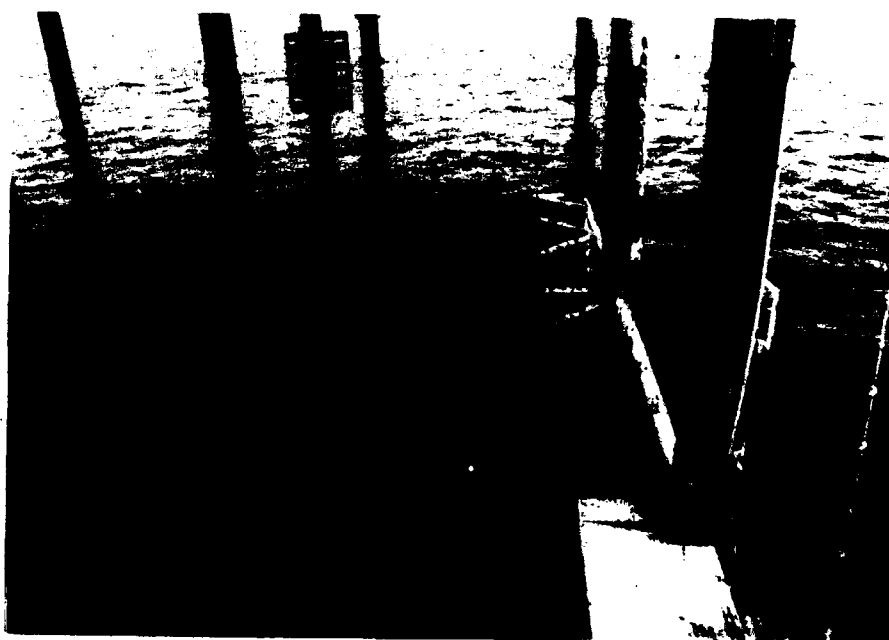
At the El. (+) 10 ft level of the jacket general corrosion is apparent on all steel that is not covered by monel. Where the angle iron supporting the anode cables are bolted to the horizontal jacket members, corrosion is visible. The monel covering appears in good condition except where attempts have been made to weld to it. At these locations, rusting is noticeable. In several areas, grating is missing, washed off by wave action.

Stage I - Top of Jacket Framing Row D on right
Figure 2.2.18

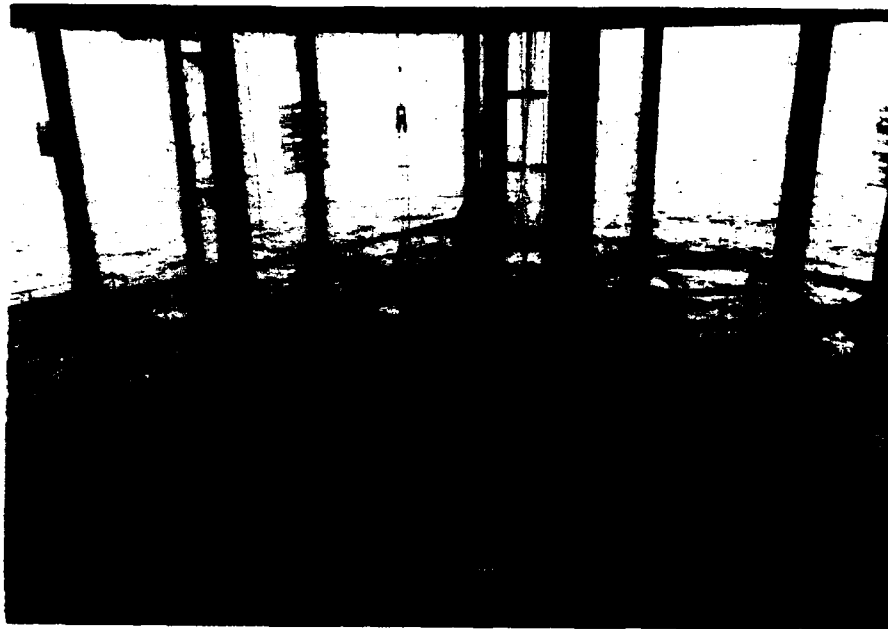
Stage I - Top of Jacket Framing
Figure 2.2.19

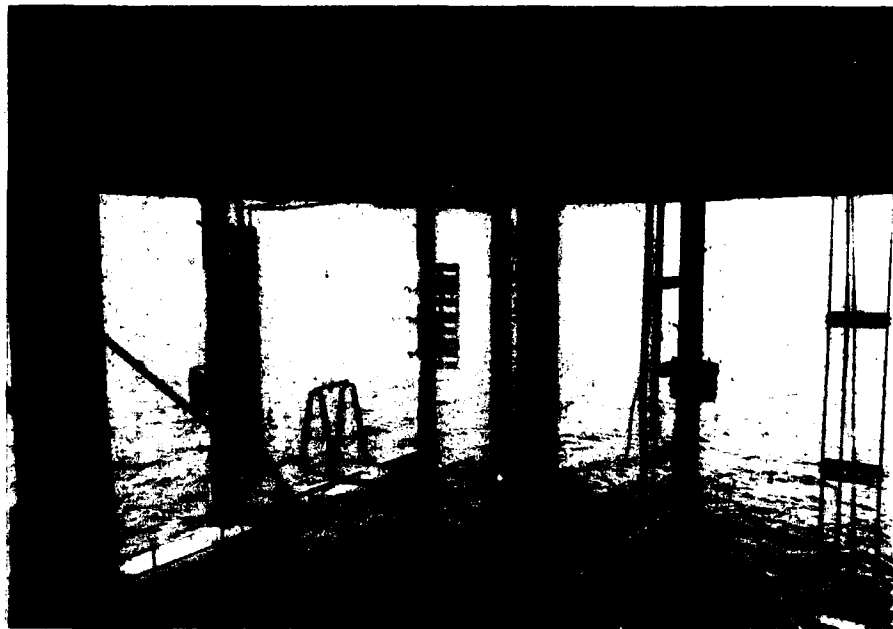
The condition of the top of jacket at El. (+) 12 foot level is poor. All steel not covered by monel shows rusting and pitting. The monel appears in good condition except where attempts have been made to weld to it. At these spots, rusting is visible.

Where the angle iron supporting the anode cables are bolted to the horizontal jacket members, corrosion is visible. In several areas, grating is missing, apparently washed off by wave action.

Stage II - Top of Jacket Framing - Looking towards Leg A3
Figure 2.3.11
