**AERONAUTICAL RESEARCH LABORATORIES**

Structures Technical Memorandum 457

**A REVIEW OF AUSTRALIAN INVESTIGATIONS ON  
AERONAUTICAL FATIGUE DURING THE PERIOD  
APRIL 1985 TO MARCH 1987**

APRIL 1987

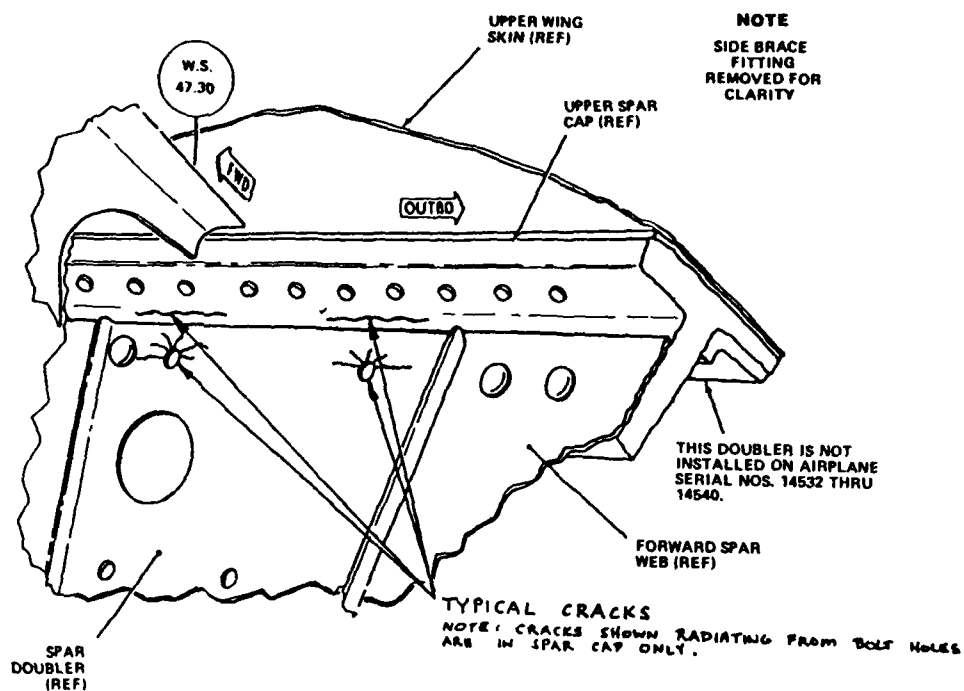
A high proportion of the Australian fleet of these aircraft has experienced cracking in the upper cap of the main wing spar, Fig. 9.8. Cracks of up to 36 mm long have been found, running spanwise in the vertical leg of the extruded T-section. This type of cracking will reduce the compressive stability of the spar cap, thereby increasing the risk of wing collapse under severe positive g manoeuvres or upgusts.

FIG.9.8 GULFSTREAM 112/114 FORWARD UPPER SPAR CAP SHOWING LOCATION OF CRACKING
