DTIC FILE COPY  
MISCELLANEOUS PAPER GL-87-4

# PERIMETER DIKE STABILITY ANALYSES CRANEY ISLAND DISPOSAL AREA, NORFOLK DISTRICT, NORFOLK, VIRGINIA

May 1987  
Final Report

Prepared for US Army Engineer District, Norfolk  
Norfolk, Virginia 23510-1096

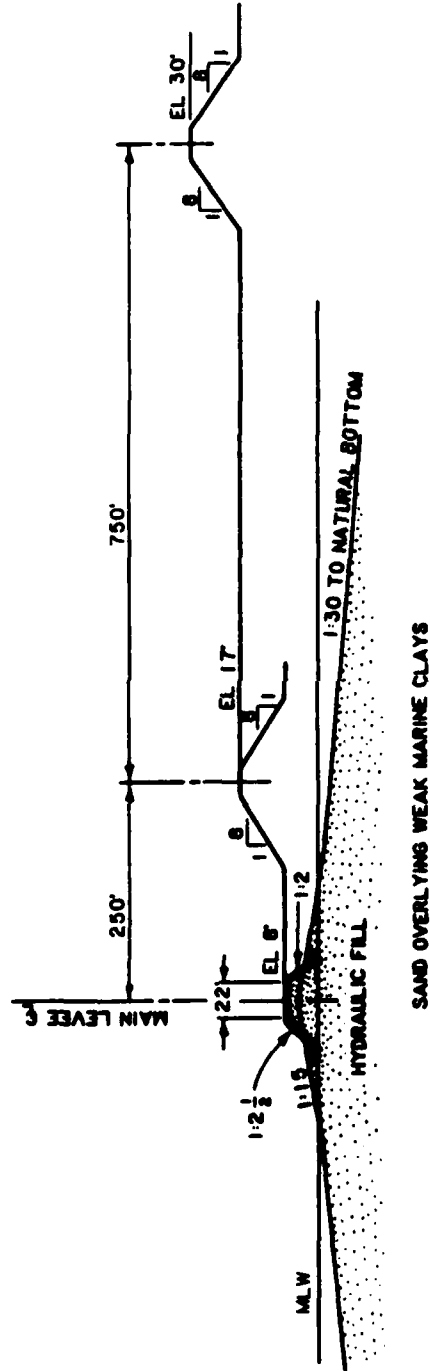
Figure 2. Proposed benched cross-section for west perimeter dike by Norfolk District

17. Because of the continuously wet condition of fine-grained dredged material adjacent to the west perimeter dike it has been virtually impossible to construct a benched dike section without bearing capacity failure. Incremental dike height has historically been achieved by displacing sand fill into the containment area adjacent to the existing perimeter dike. Coarse-grained dredged sand is truck-hauled and end-dumped on the slope, and a dozer pushes the sand up the slope and into the disposal area creating a large mud wave as the weight of the sand displaces the soft fine-grained dredged material.

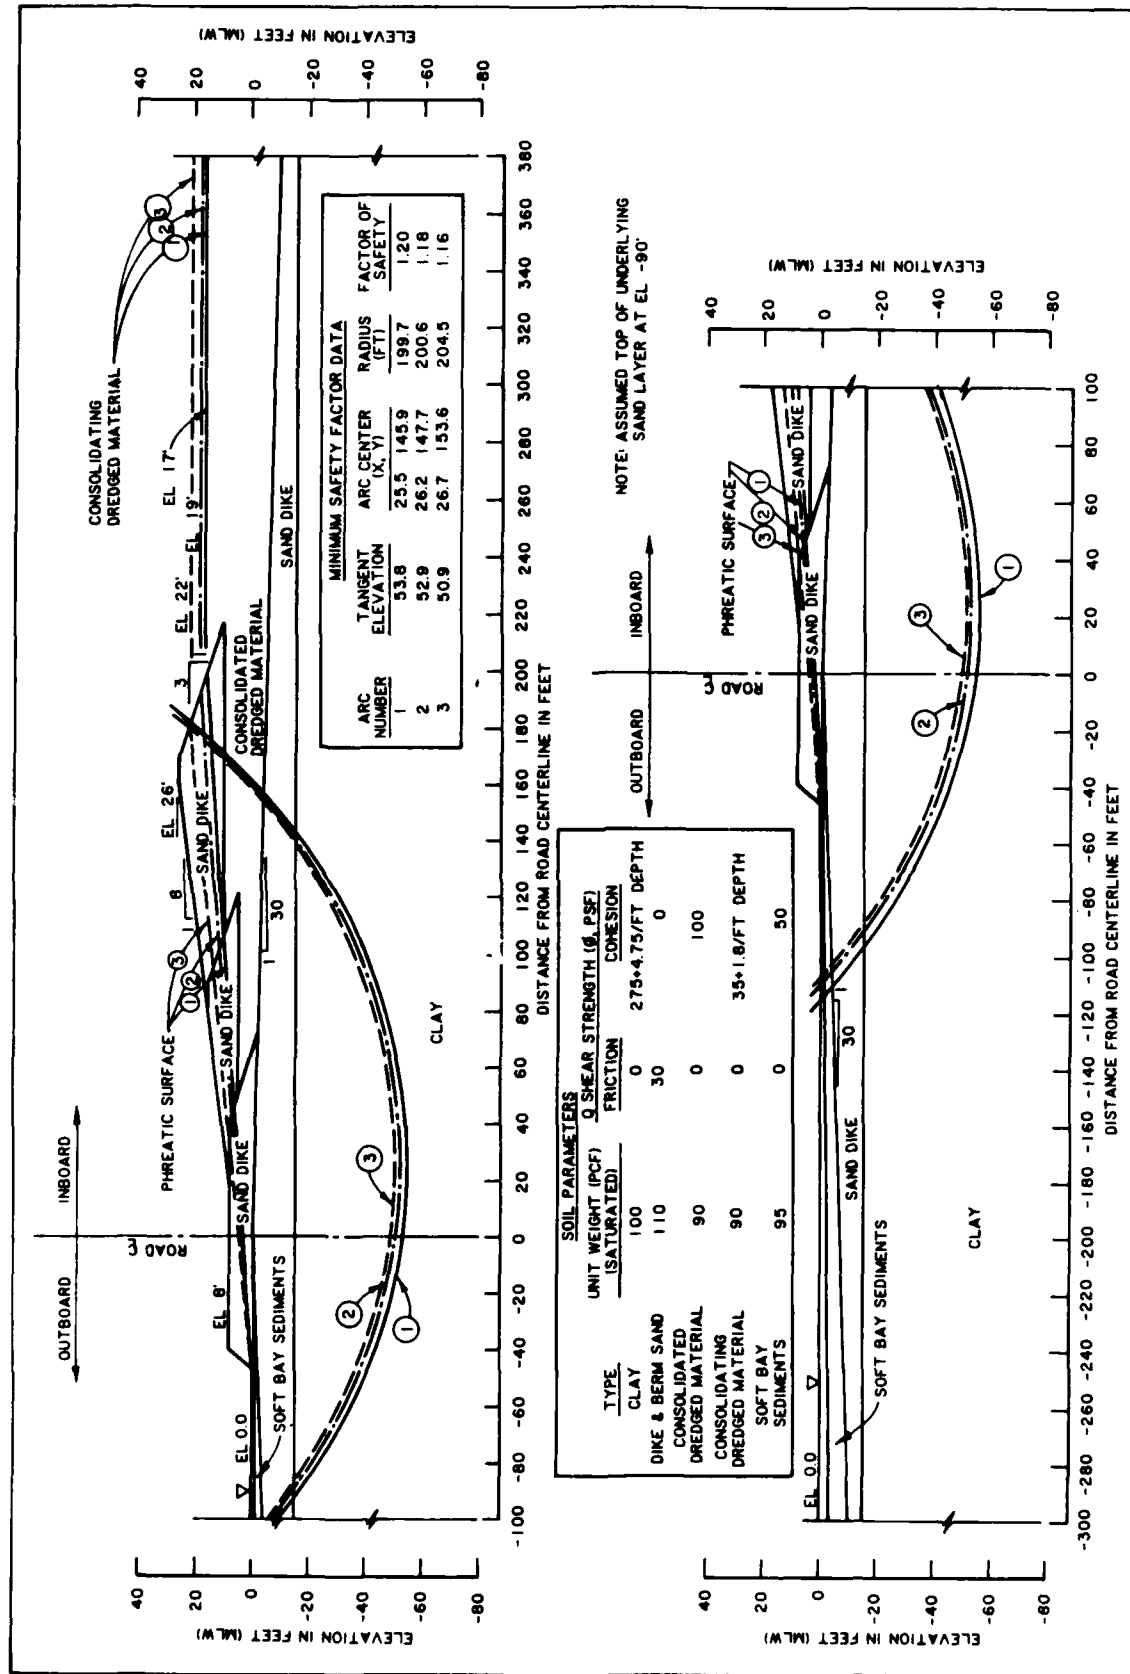
Figure 19. Critical circles for various dredged material elevations using existing west dike configuration

west dike had an average elevation of about +13 ft. The dredged material elevation is presently about +17. The first scenario, investigating the existing conditions, consisted of the dike at el +26 and the dredged material at el +17. The safety factor for this case was 1.20. The next scenarios increased the dredged material to el +19 and +22. The safety factors decreased from 1.20 to 1.16 at the higher dredged material elevation. The results of these analyses are tabulated in Table 2 with the critical circles shown in Figure 19. These safety factors are above 1.0 but below a design value of 1.3. Thus, some of the berms described for the recommended enlarged dike section could be started to increase the safety factor to 1.3.

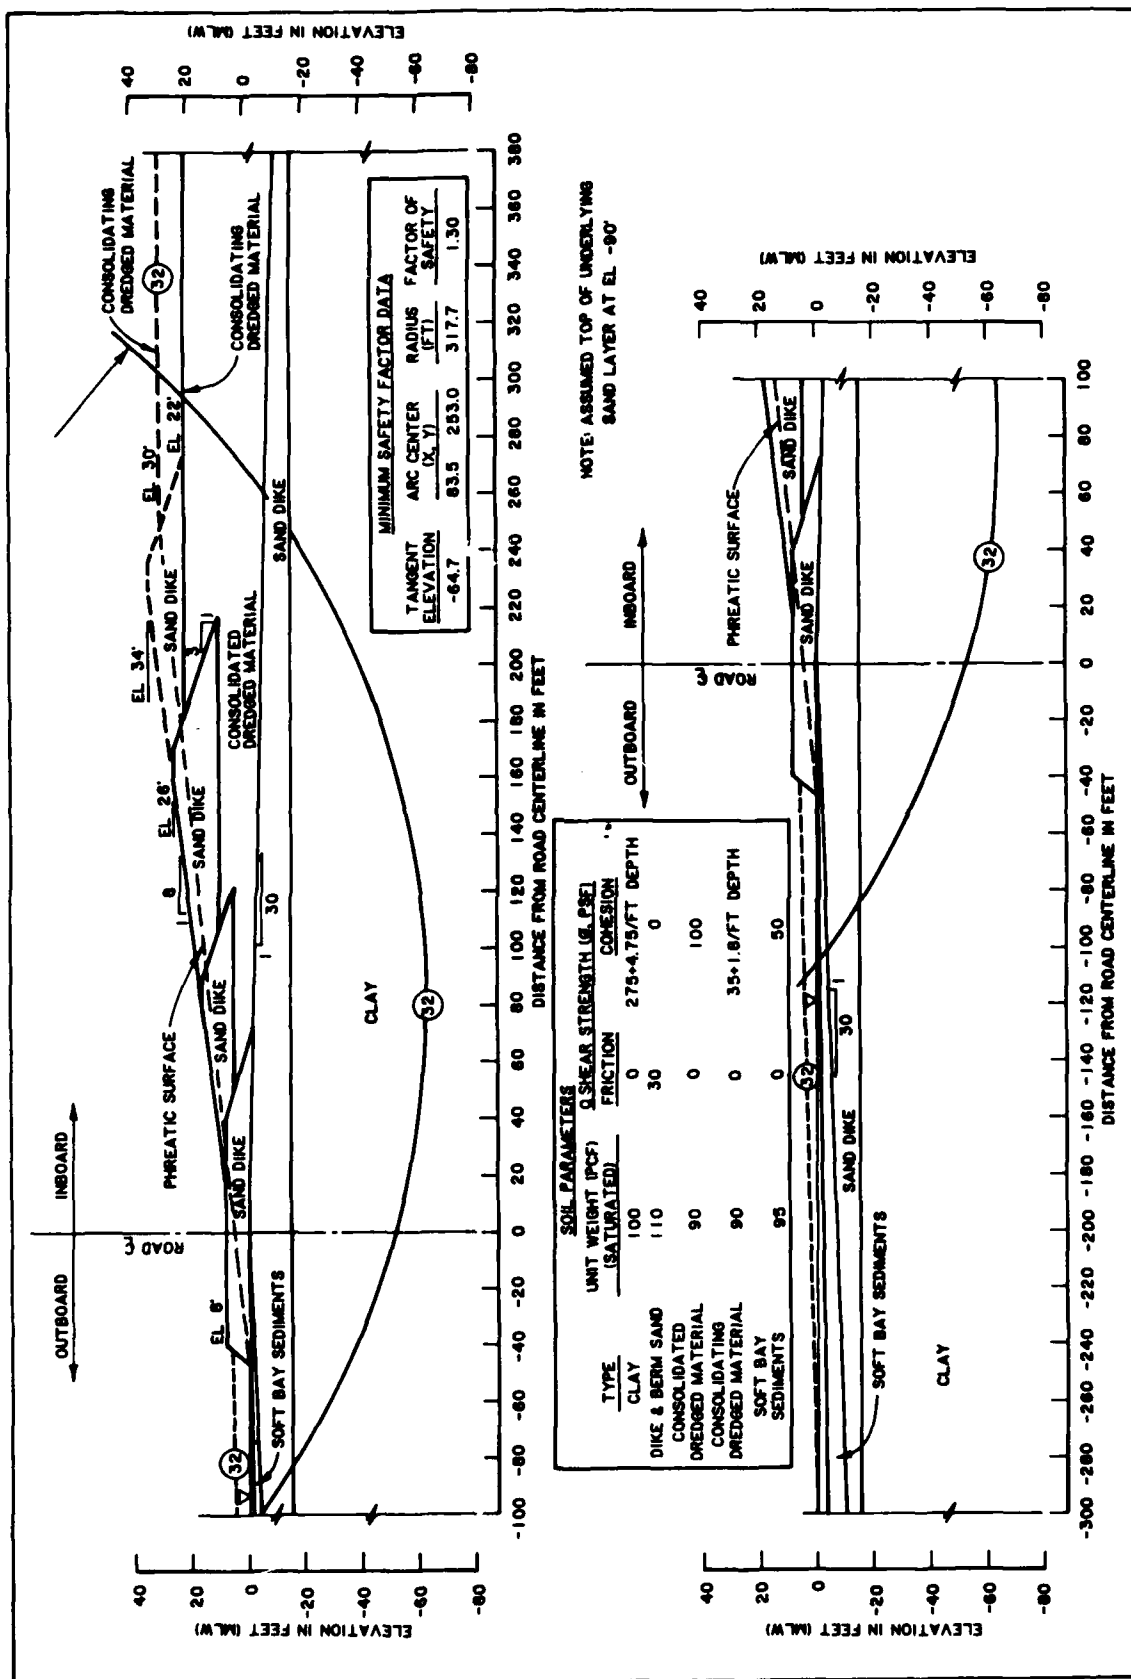
Figure 28. Recommended raised dike cross-section for the west perimeter dike

considered. When combining these three potential solutions it must be noted that there is not a unique solution. The recommended design will be closest to a safety factor of 1.3 and minimize the material in the various berms. The first combination consisted of a water berm 300 ft wide with el +3 to +6 ft and a road berm. The road berm varied from el +16 to el +12. The safety factor for the el +16 berm was 1.34 reducing to 1.29 for the el +12 berm. Notice that the changes in the safety factor calculated individually for each the three solutions can only serve as a guide and can not be added together. Water berms were then combined with a setback distance of 60 ft. The safety factor for a water berm from el +3 to +6 and 300 ft wide was 1.24. When a water berm with el 0 to +3 was considered, the safety factor decreased to 1.19. Because of other constraints such as weirs and reductions in size, setbacks larger than 60 ft were not considered. The optimum design was then a matter of selecting the best water berm and road berm. Four additional combinations were considered. The recommended design consists of a water berm 300 ft wide with el 0 to +7 ft and a road berm to el +10 ft. The safety factor for this combination is 1.30. The results and total volumes for all combinations considered are shown in Table 7. Figure 28 shows the recommended section and the critical circle.

57. It is recommended that a 300-ft-wide water berm be constructed on the west dike starting at el 0 ft and intercepting the existing dike at el +7 ft and a road berm be constructed to el +10 or 12 ft above the existing roadway. This scenario would not require changing the existing slope of 8H:1V. It was concluded that the east, north, and northwest dikes would not require construction of berms if the present setback distances and slopes are maintained.

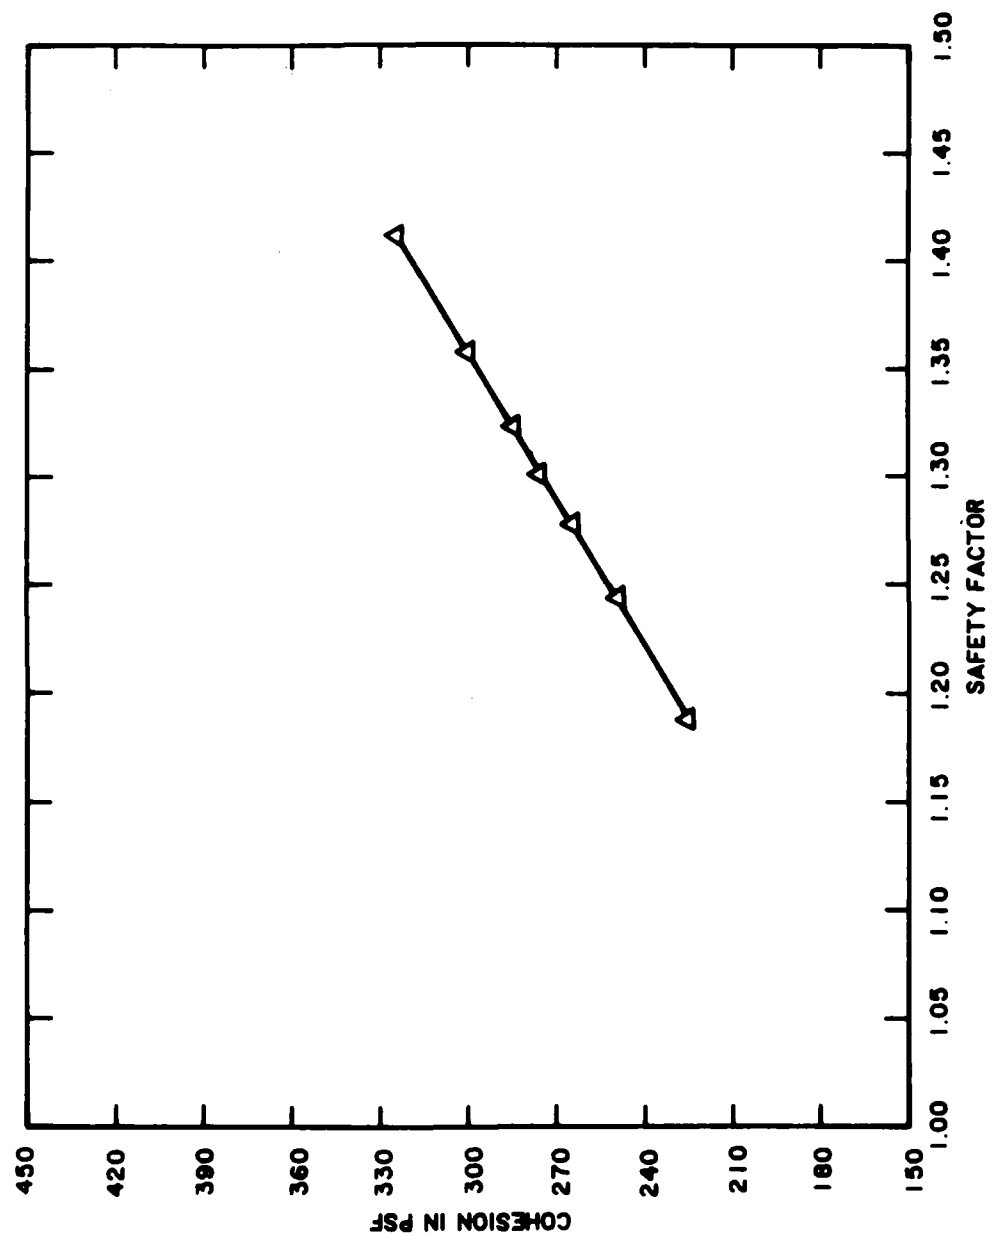
Figure 29. Cohesion of foundation clay under west dike versus safety factor

39. The shear strength of the foundation clay was selected based on numerous tests (see Figure 7). There is a large degree of scatter in the data. To evaluate the sensitivity of the selected shear strength, values plus and minus 10 psf, 25 psf, and 50 psf of the selected cohesion parameter were used in the analysis of the recommended design. The cohesion value is assigned to the profile describing the top of the clay. All analyses used the same rate of increase for the cohesion. Figure 29 illustrates the relationship between cohesion and the safety factor.

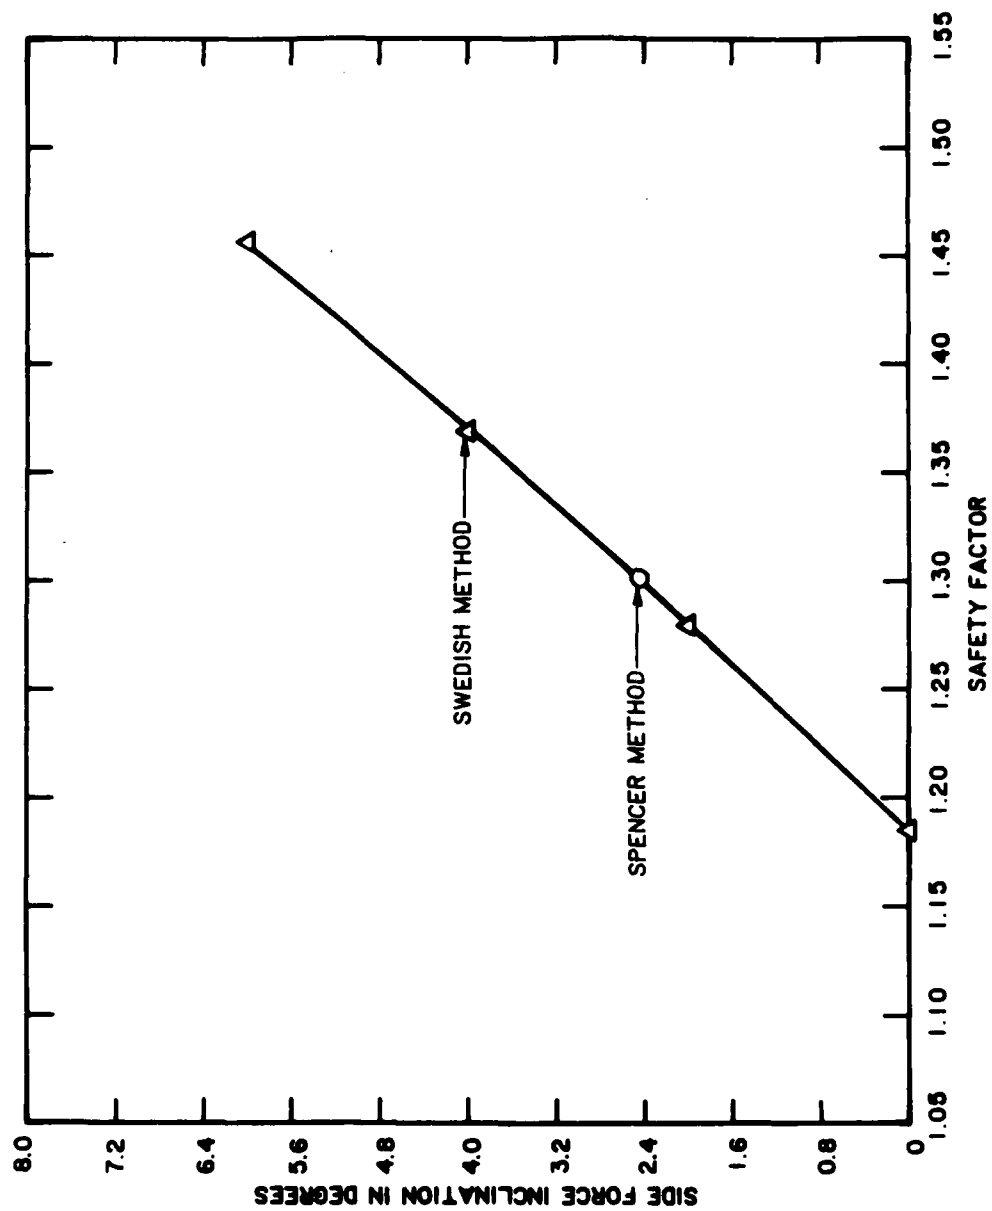
Figure 30. Side force inclination for recommended west dike section versus safety factor

40. The last assumption concerns the side force inclination. For the recommended west dike section, the side force inclination calculated by the Spencer's procedure was nearly horizontal, indicating that the Simplified Bishop procedure would generate about the same results. However, the Modified Swedish force equilibrium procedure with the Corps of Engineers side force assumption of the average outer slope would generate safety factors larger than the rigorous procedure. Spencer's procedure determines the side force inclination that satisfies both moment and force equilibrium. The Modified

Swedish method where different side force inclinations were specified was used to show the influence of the side force inclination. A plot of the results is shown in Figure 30. The side force inclination in the Modified Swedish procedure must be specified by the user. With the surface geometry broken up into many slopes, the proper side force inclination is difficult to determine. Thus, since Spencer's procedure calculates the side force inclination, this method should be used. The side force inclination from Spencer's method can then be used in the Modified Swedish procedure to perform a hand check.

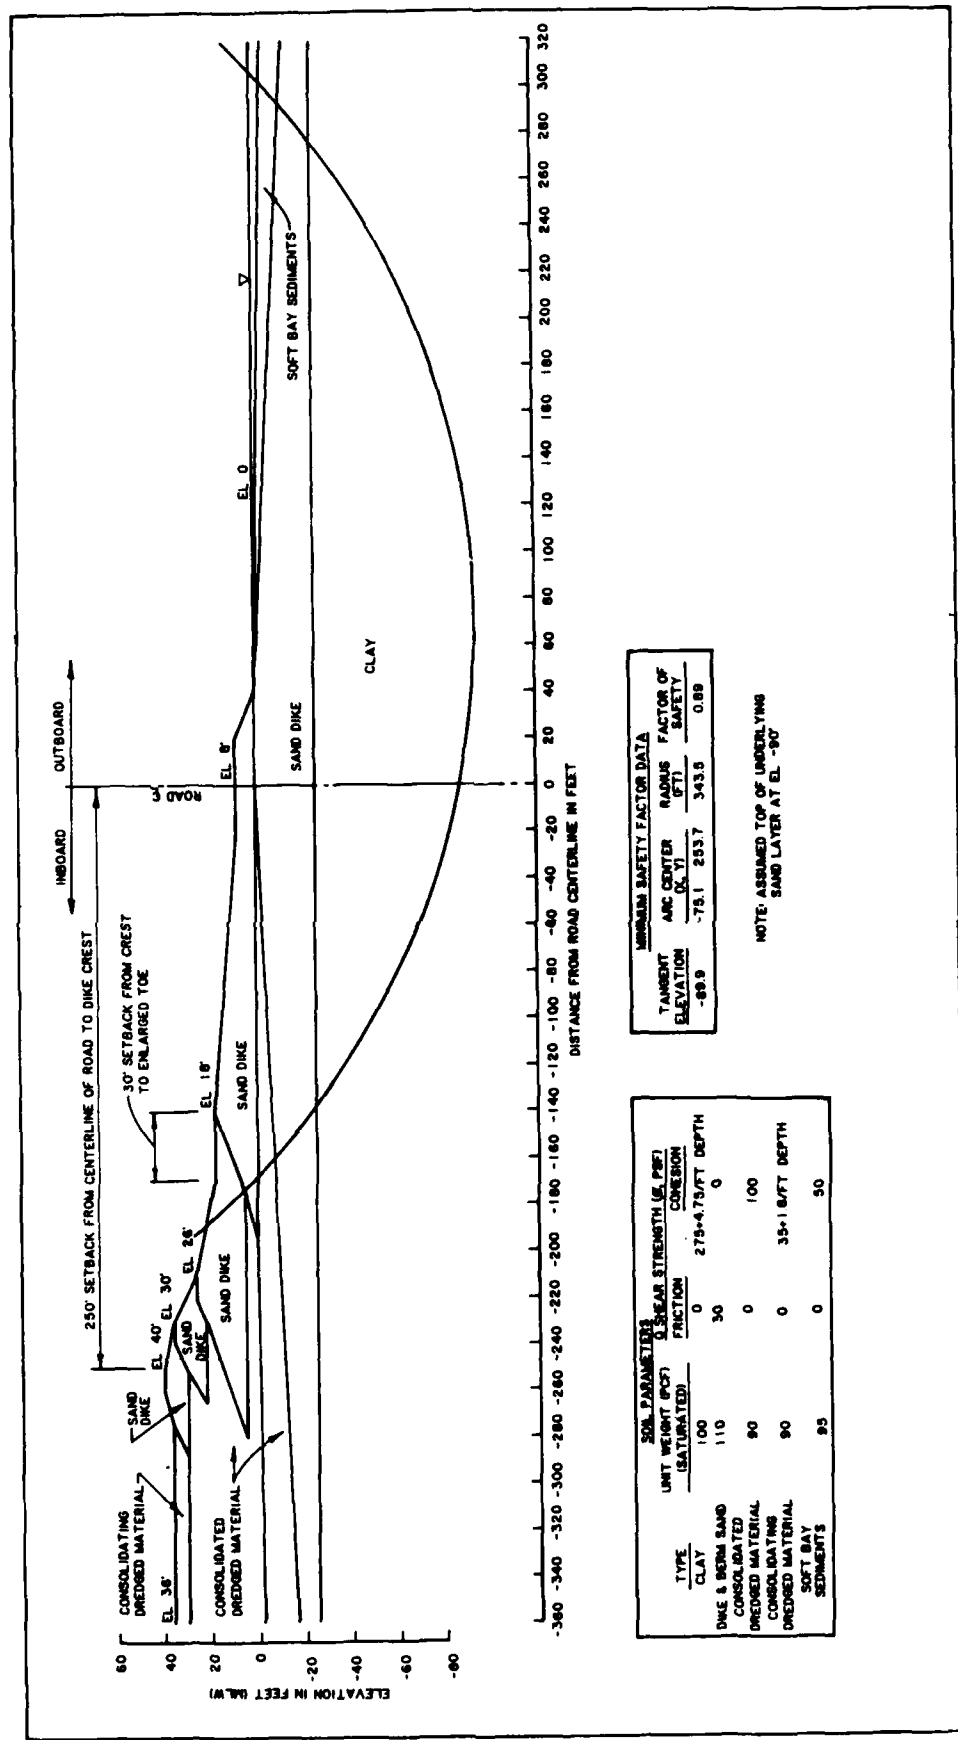
Figure 32. Critical circle for partial setback of raised east dike

42. The practice of reclaiming sandy dredged material by building an outward offset in the perimeter dike has been utilized in the past for this dike section. During an inspection of east dike topographic surveys conducted by the Norfolk District, it was found that a short section of dike about 400 ft long was moved east about 200 ft during dredging activities in early 1985. For the raised dike configuration, this section was analyzed to determine if this practice would cause stability problems. In the analysis it was assumed that the raised dike would begin at the crest of the existing dike and contain no additional setback. The section analyzed consisted of the same foundation cross section as used for sta 80+00. A factor of safety of 0.89 was calculated for this section. This indicates that failure would occur for this configuration. The plot of the critical circle is shown in Figure 32.

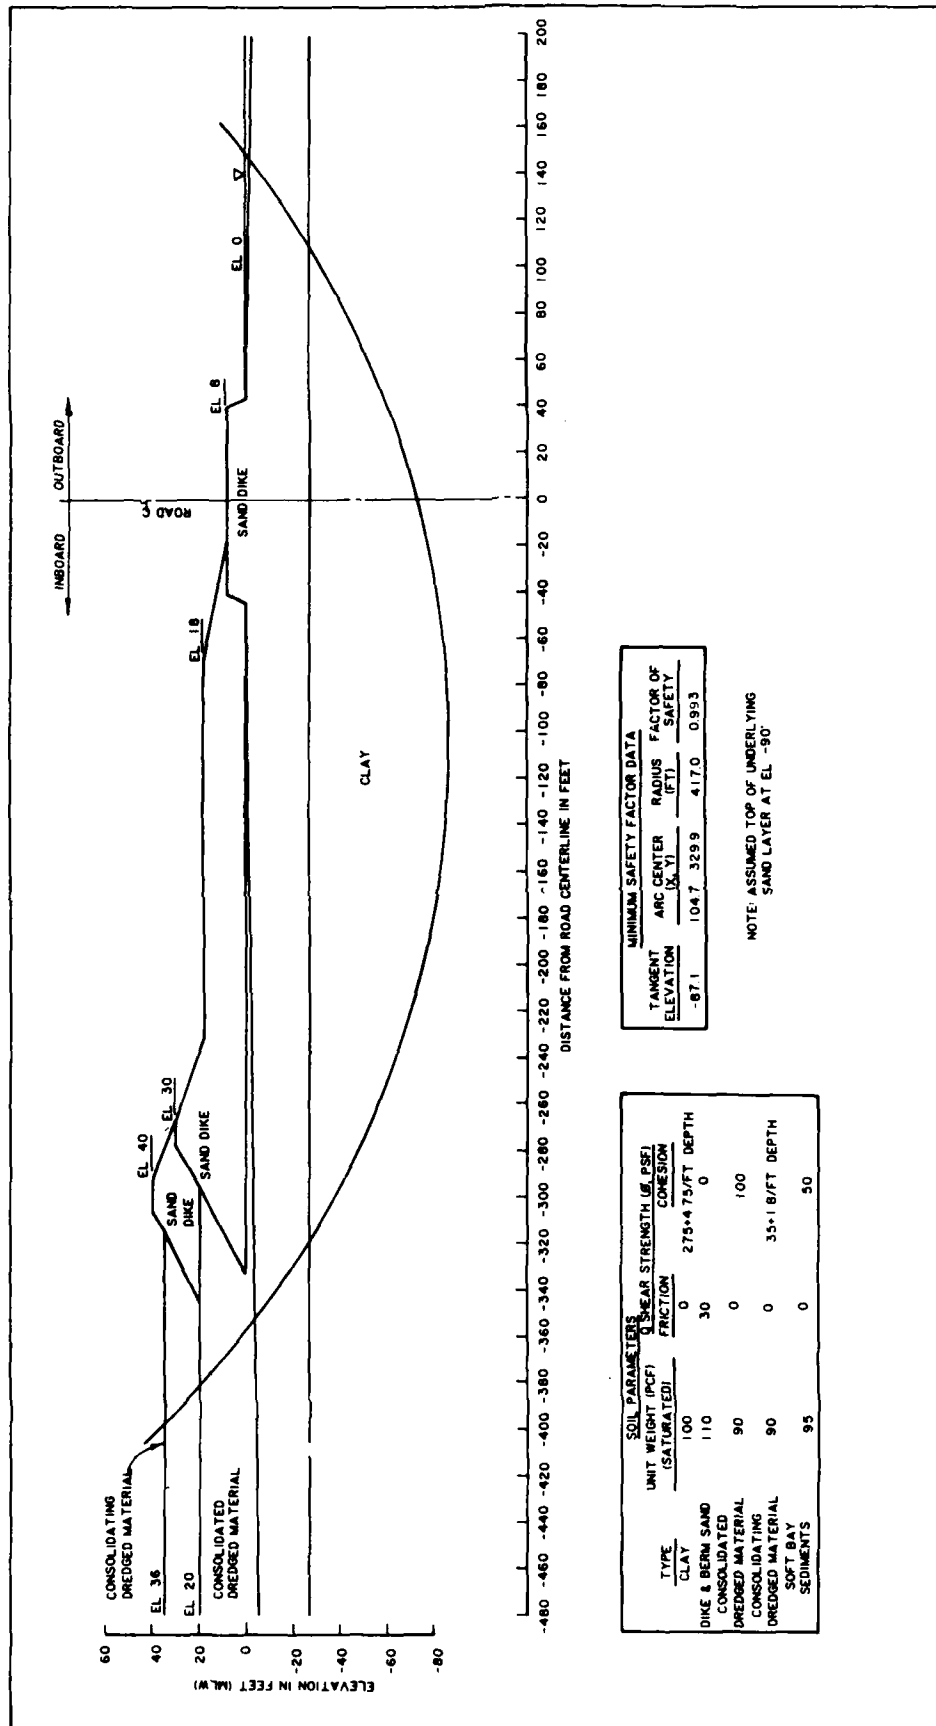
Figure 35. Critical circle for partial setback of raised north dike

case. The same foundation cross section was used in this analysis. The safety factor was calculated to be 0.99. This represents an unsafe condition. Since the full setback dike is barely acceptable, outward offsets should not be allowed along this leg of the perimeter dike unless additional stability berms are provided. The results of this analysis are plotted in Figure 35.
