CONDITION SURVEY OF LOCK NUMBER 8 MONONGAHELA RIVER(U)  
ARMY ENGINEER WATERWAYS EXPERIMENT STATION VICKSBURG MS  
STRUCTURES LAB R L STONE JUN 87 WES/MP/SL-87-4

# CONDITION SURVEY OF LOCK NO. 8, MONONGAHELA RIVER

June 1987

Final Report

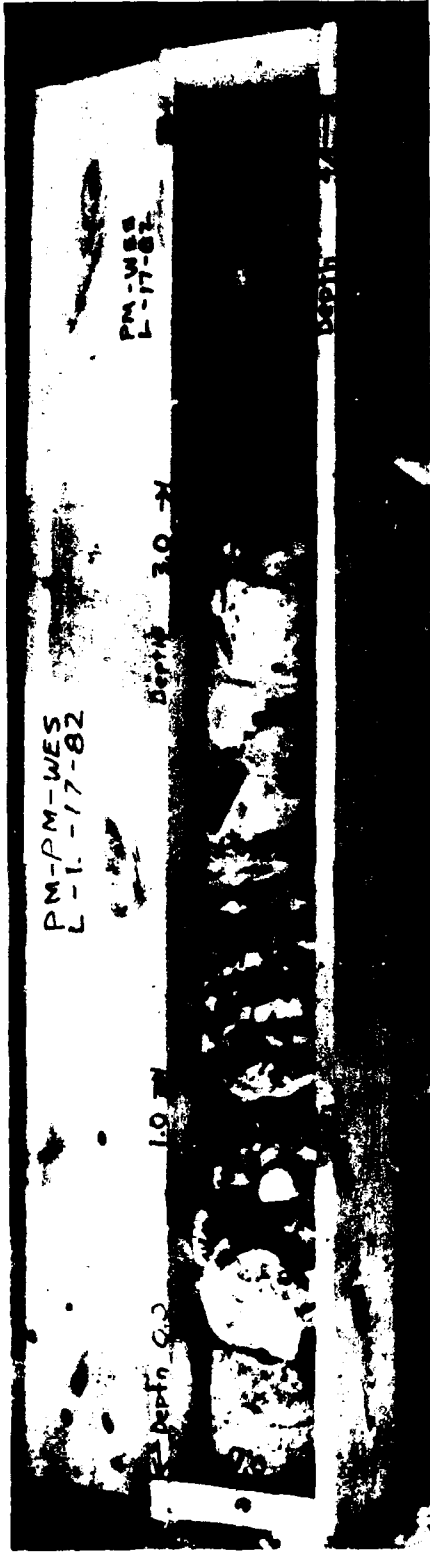
Shotcrete Rubble w/wht subparallel 1.6 ft  
 overlay reaction product cracking

a. Typical vertical concrete core, river lock wall

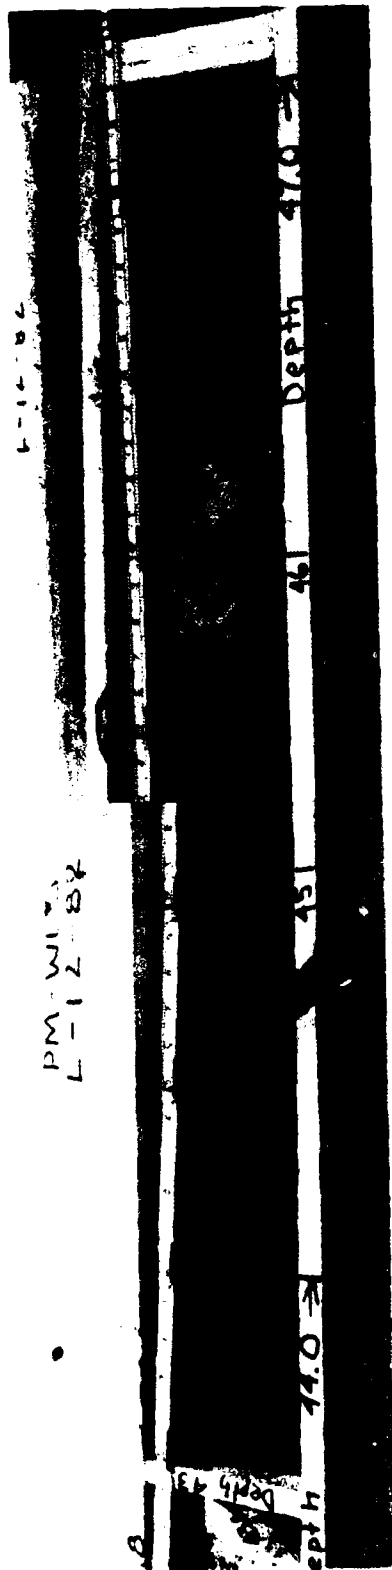
a. Rock from just below river wall, broken during drilling

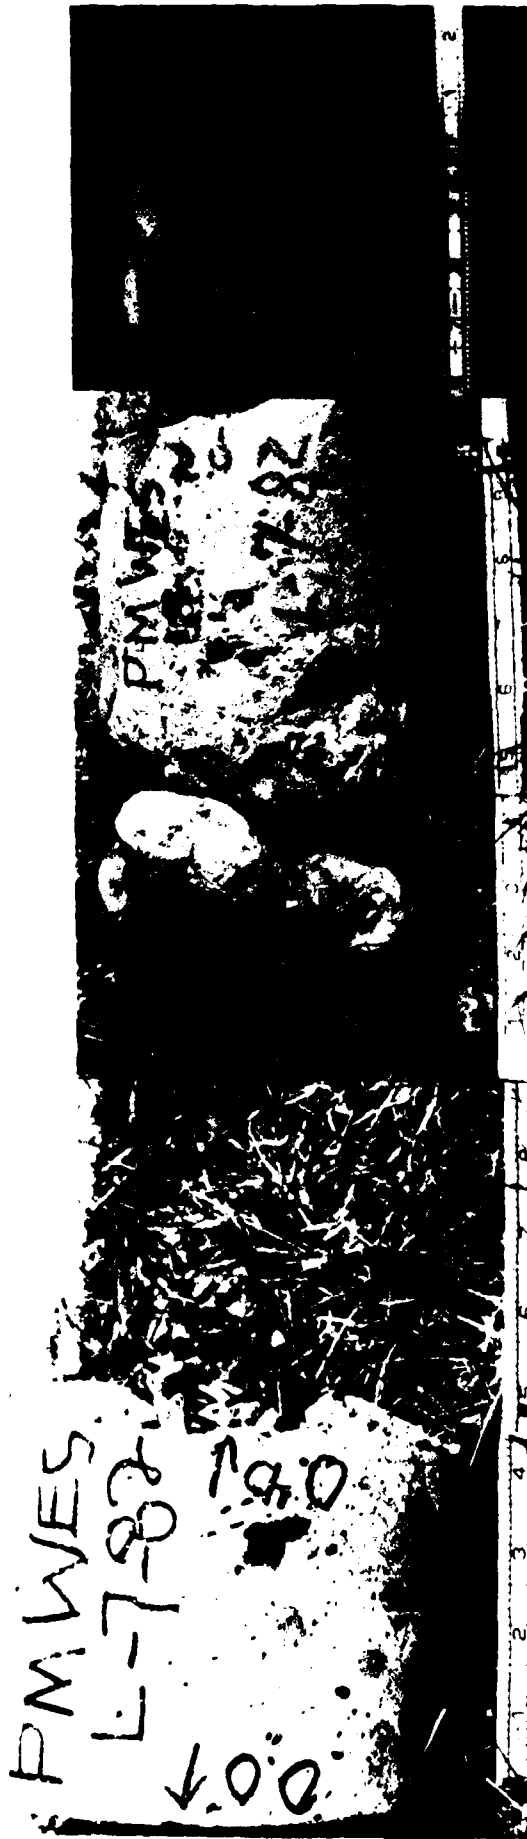
Concrete core, boring L-7-82, overlay concrete, 0.0 to 0.45 ft, missing rubble and cracked concrete to 2.5 ft

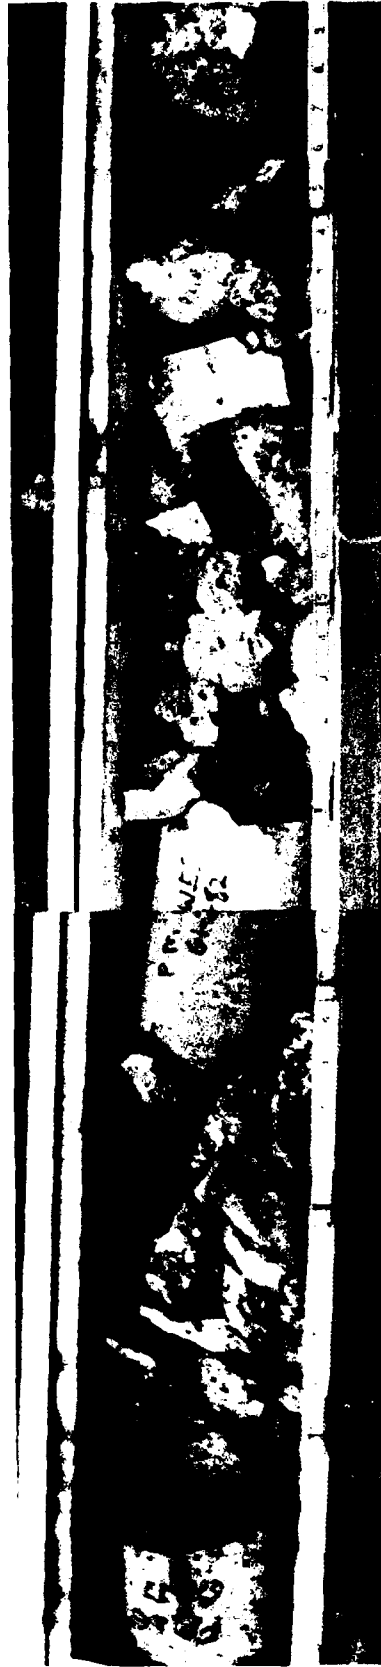
Horizontal boring Gi-2-82, upper miter gate recess, land wall,  
showing broken core to full 3.0-ft depth

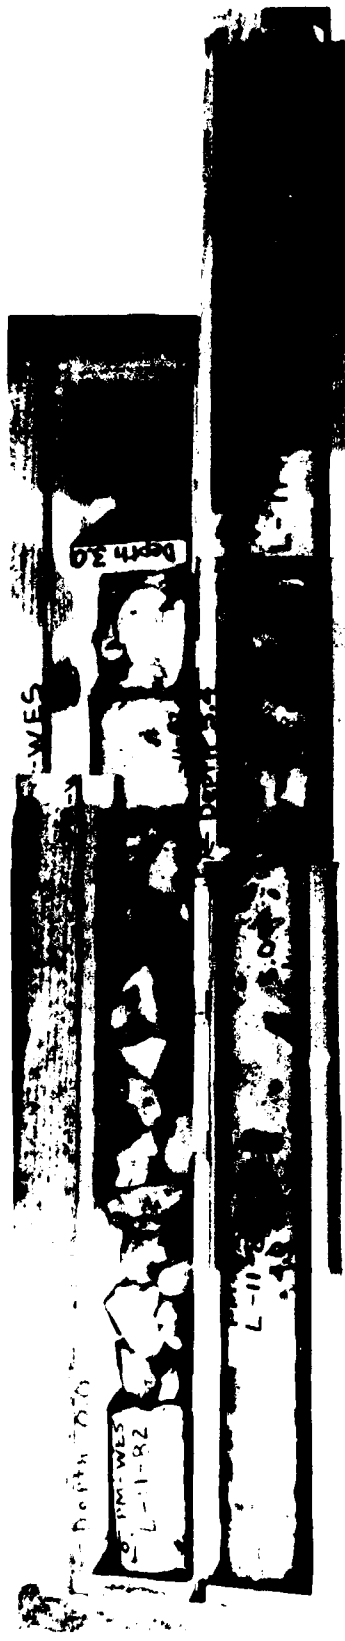
Concrete core L-11-82, vertical boring, upper guard wall; overlay concrete 0.0 to 0.6 ft;  
broken core interval 0.6 to 3.0 ft

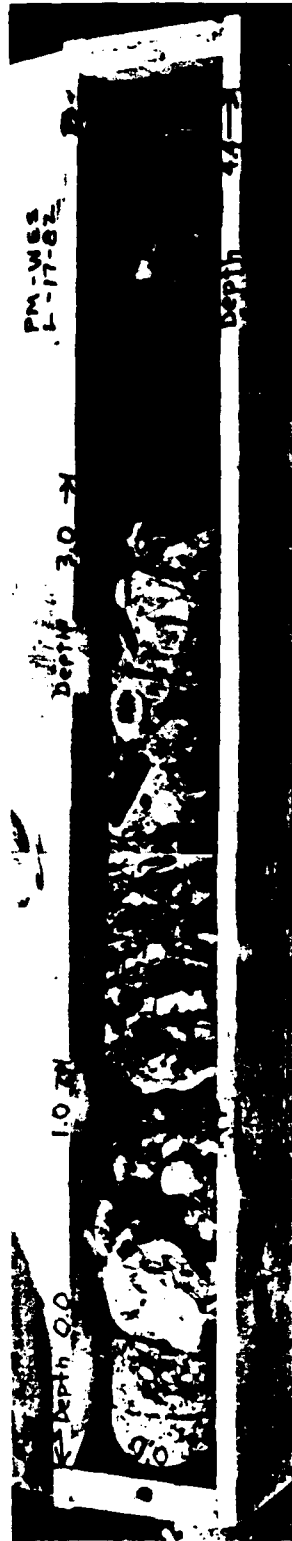
Concrete core L-17-82, vertical boring, lower guard wall; overlay concrete 0.0 to 0.5 ft;  
broken and cracked concrete to 1.6 ft

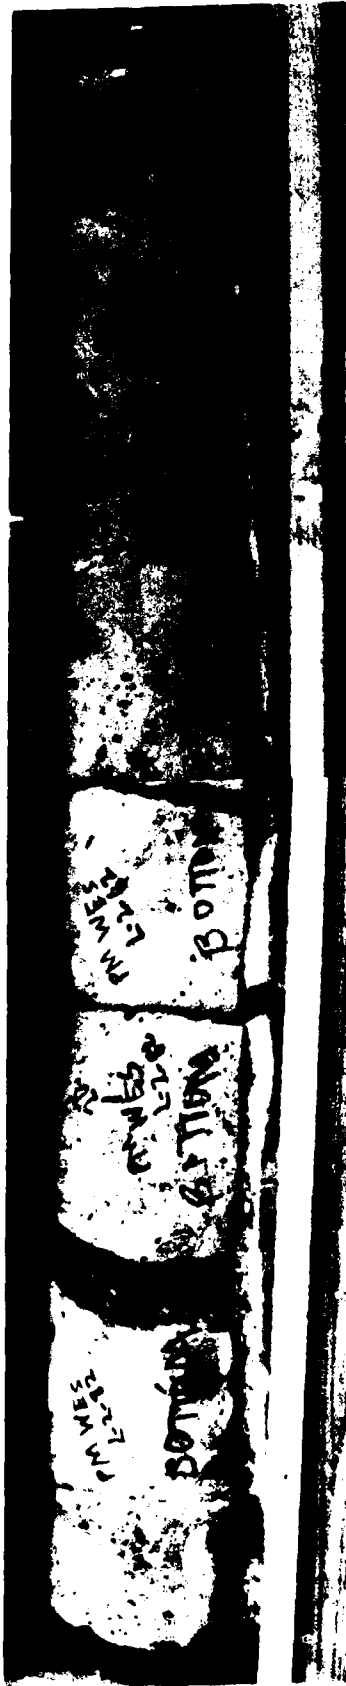
Concrete core, boring L-2-82, low horizontal boring showing frost damage from 0.0 to 0.5 ft. Vertical construction joint. Note white alkali-silica gel on joint and cracks

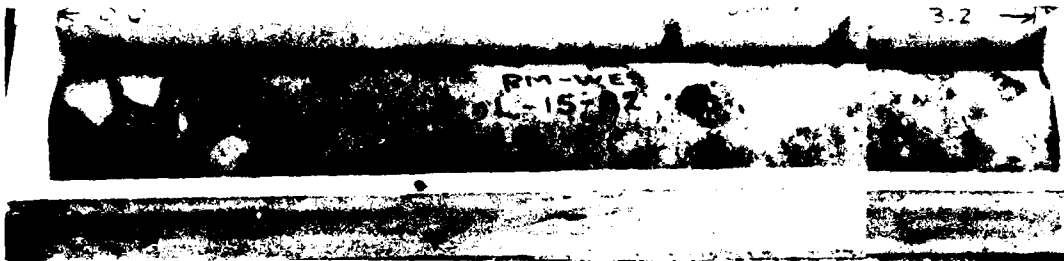
Concrete core, boring L-15-82, high horizontal boring, river lock wall.  
Note cracking to 0.9 ft

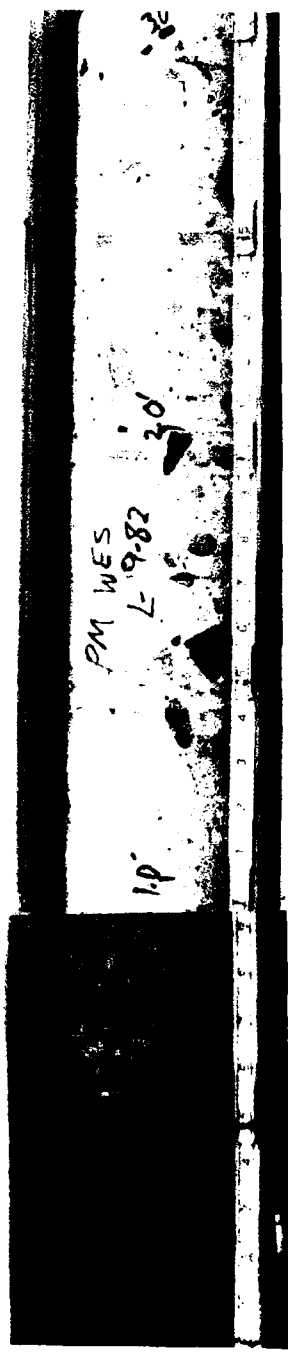
Shotcrete Cracked

Concrete core, boring L-9-82, low horizontal boring, river lock wall

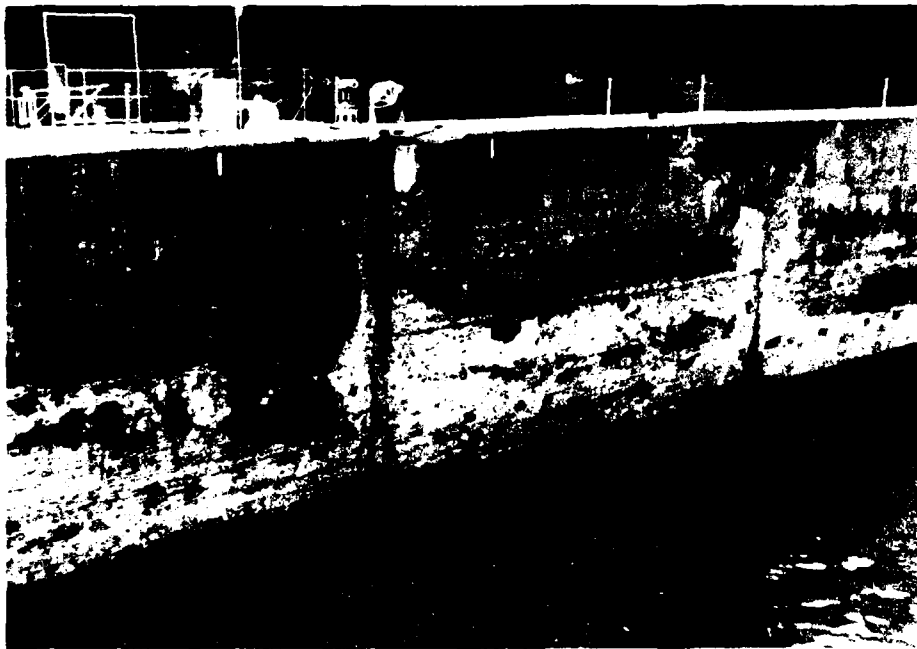
Photo 8. Lower guide wall showing shotcrete removal, construction joint spalls, and scaling, looking downstream from lower guard wall
