**DEPARTMENT OF DEFENCE
DEFENCE SCIENCE AND TECHNOLOGY ORGANISATION
MATERIALS RESEARCH LABORATORIES
MELBOURNE, VICTORIA**

MRL-R-1060

**AN EXAMINATION OF COATING FAILURE ON WING PIVOT FITTINGS
OF F111 AIRCRAFT**

L.V. Wake

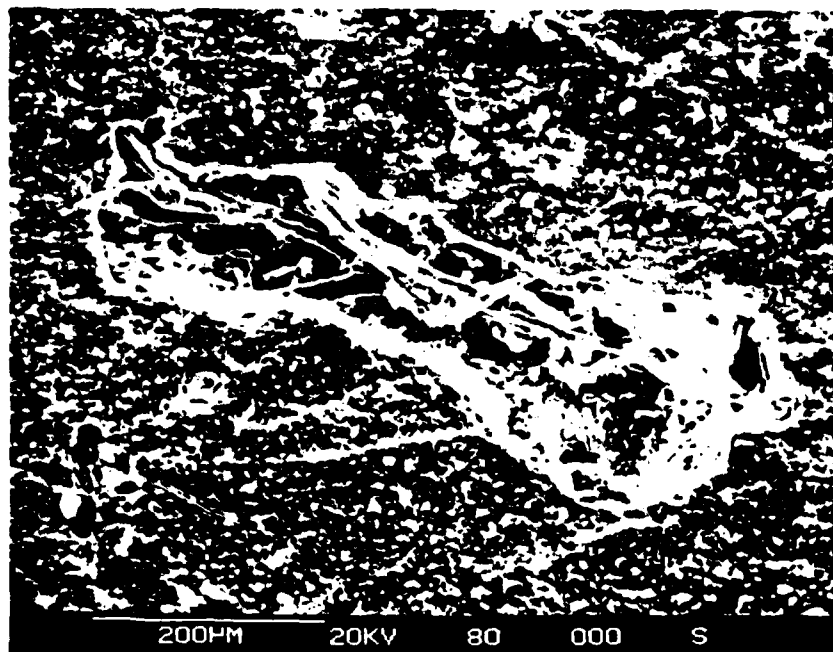
FIG. 7 Paint failure of PR 1560 topcoat around an organic fibre inclusion. Aircraft A8-135 aft fuel tank. Lower surface of paint.

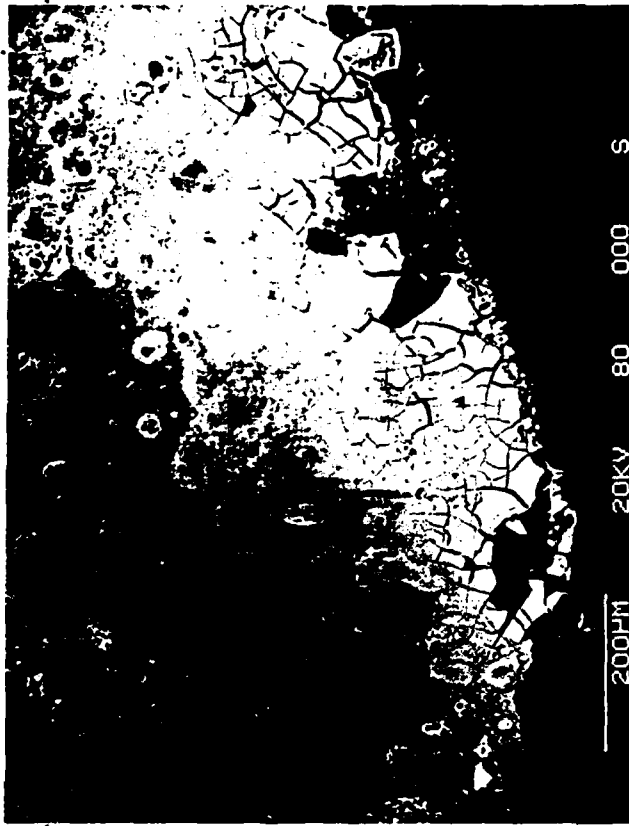
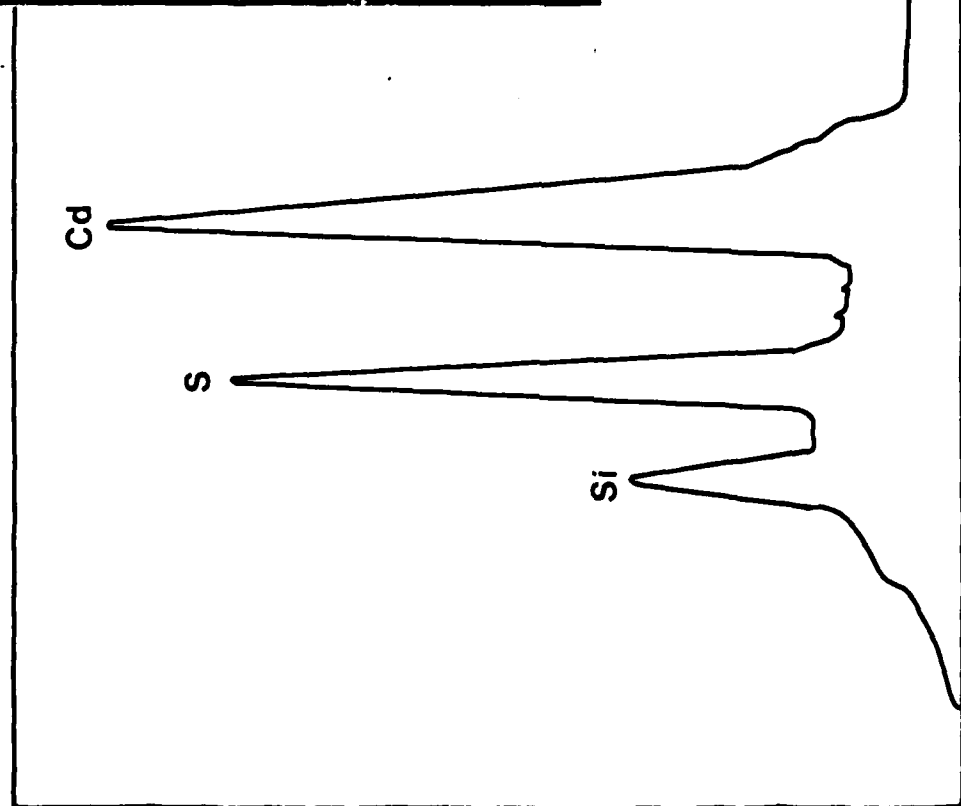
A further problem causing coating failure on the pivot fittings was breakdown of the original vapor deposited cadmium. This failure occurred on one of the upper stiffeners on aircraft A8-114. The cadmium had reacted with a sulphur material, presumably the sulphur present in Brisbane fuel, and the product had detached removing the overlying original PR1563 polyurethane paint with it. The cadmium/sulphur reaction product was relatively thick along one edge of the failure (Fig. 8). (A similar failure occurred under paint and sealant in a wing tank as a result of breakdown of the vapour deposited cadmium. In this case the reaction product was a cadmium/phosphorus compound (Fig. 9)).

Fig 8. Cadmium/sulphur reaction product. The thickness of the product is much heavier adjacent to one side of failed paint flake. (Silicone peak from filler in coating). Aircraft A8-140.

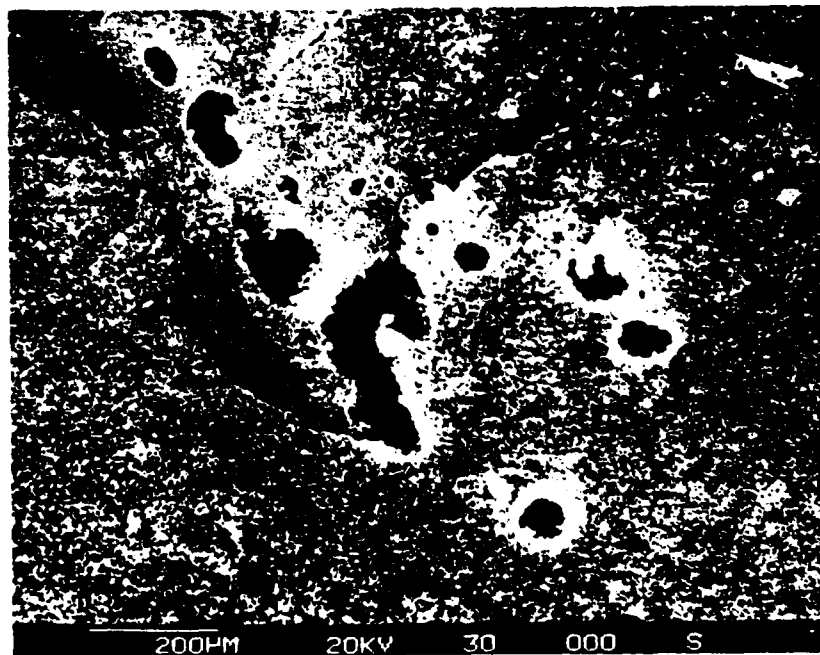
Following priming of the inspection areas, it is apparent that these and all other surfaces inside the wing tanks, the wing carry-thru box and other fuel tanks were resprayed with the replacement topcoat to provide a uniform coating appearance. This practice has been confirmed by the relevant Service personnel. Widespread adhesive paint failures have occurred with this repair scheme, resulting in detachment of the oversprayed polyurethane topcoat from the original fuel resistant topcoat away from the inspection areas of the pivot fittings (Figs. 4 and 5). The condition of the failed topcoat from the blistered areas shows evidence of binder breakdown (Figs. 10 and 11).

FIG. 11 Advanced paint failure of PR 1563 topcoat. Paint from Aircraft A8-140. Lower surface of paint flake.
