| REPORT DOCUMENTATION PAGE | | READ INSTRUCTIONS<br>BEFORE COMPLETING FORM |
|---|---|---|
| 4. TITLE (and Subtitle)<br>MULTIPLE-PURPOSE PROJECT; LITTLE BLUE RIVER BASIN;<br>LITTLE BLUE RIVER, MO; LONGVIEW LAKE, OPERATION AND<br>MAINTENANCE MANUAL; APPENDIX IV, VOLUMES ONE & TWO<br>CONSTRUCTION FOUNDATION REPORT | | 5. TYPE OF REPORT & PERIOD COVERED<br>12 Sep 79 to 16 Oct 82 |

**LONGVIEW LAKE**

**CONSTRUCTION FOUNDATION REPORT**

APPENDIX IV  
CONSTRUCTION FOUNDATION REPORT  
VOLUME ONE

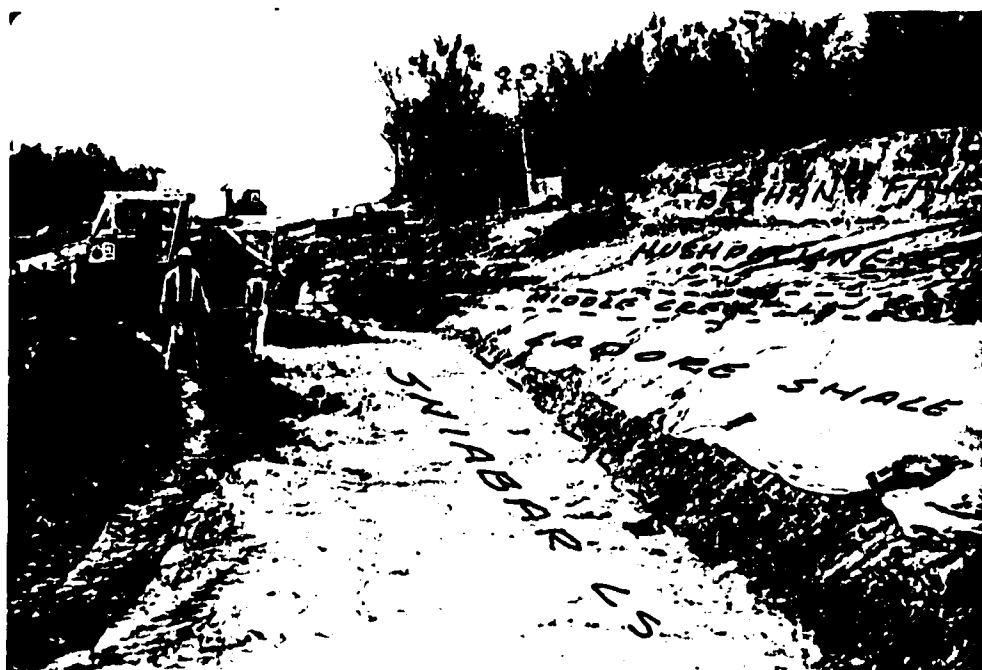
135. Longview Lake, 2 Oct 81, Neg. No. 1132.  
Station 100+75. Look downstream slickensides in  
Ladore shale.
