CONDITION SURVEY AND PAVER IMPLEMENTATION EIELSON AIR FORCE BASE, ALASKA

by
Ross A Bentsen
Geotechnical Laboratory

July 1987
Final Report

Prepared for: DEPARTMENT OF THE AIR FORCE
Eielson Air Force Base, Alaska 99702

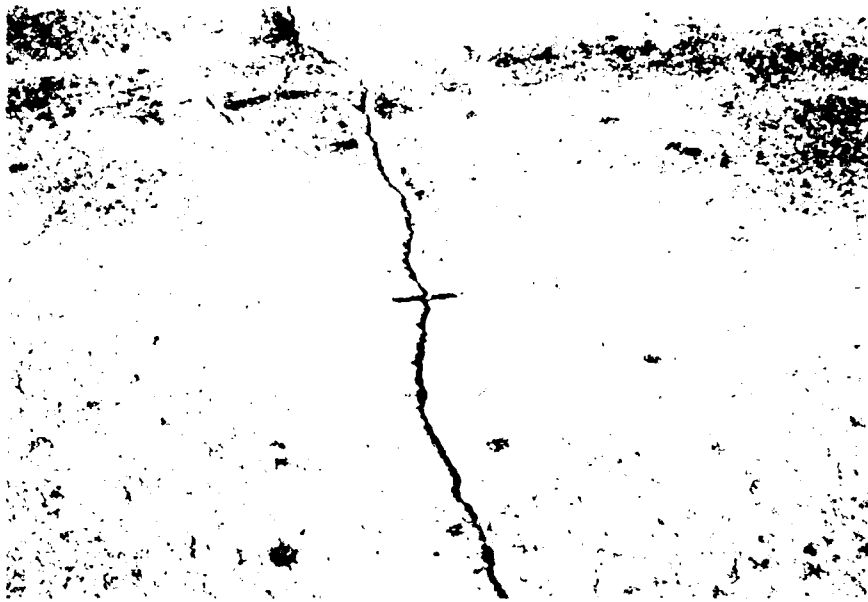
Photo 13. Typical unsealed, low-severity cracking, main taxiway (T13A)

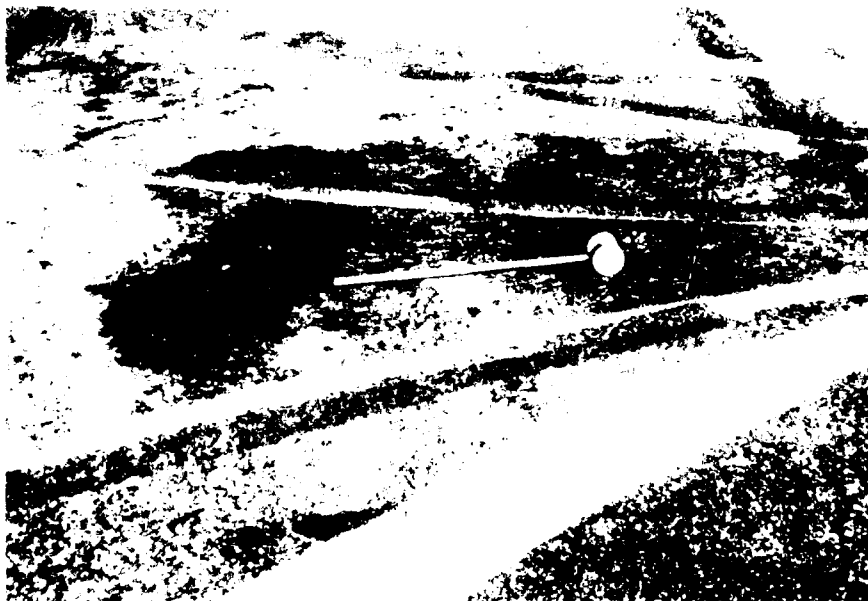
Photo 14. Bleeding, main taxiway (T13A)

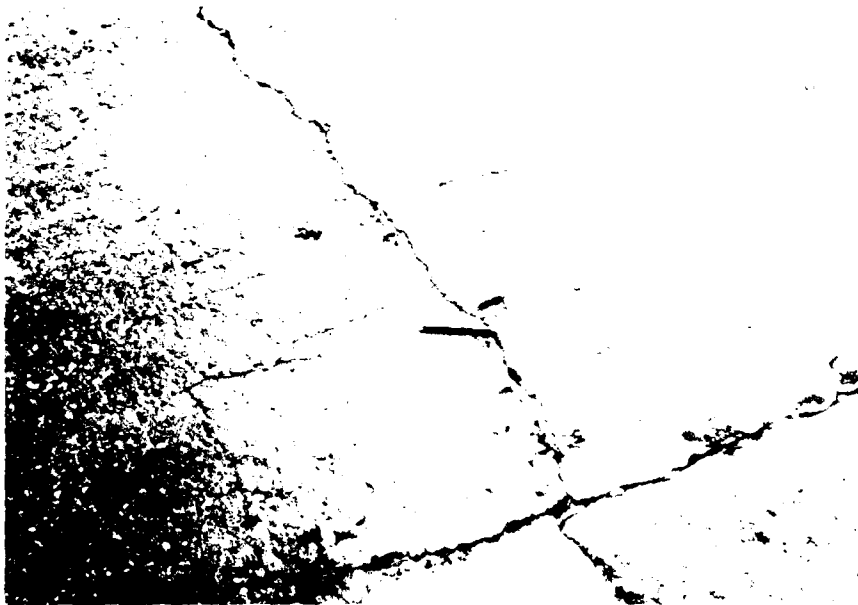
Photo 16. Low-severity cracking and general condition of asphalt surface, Taxiway 4 (T17C)

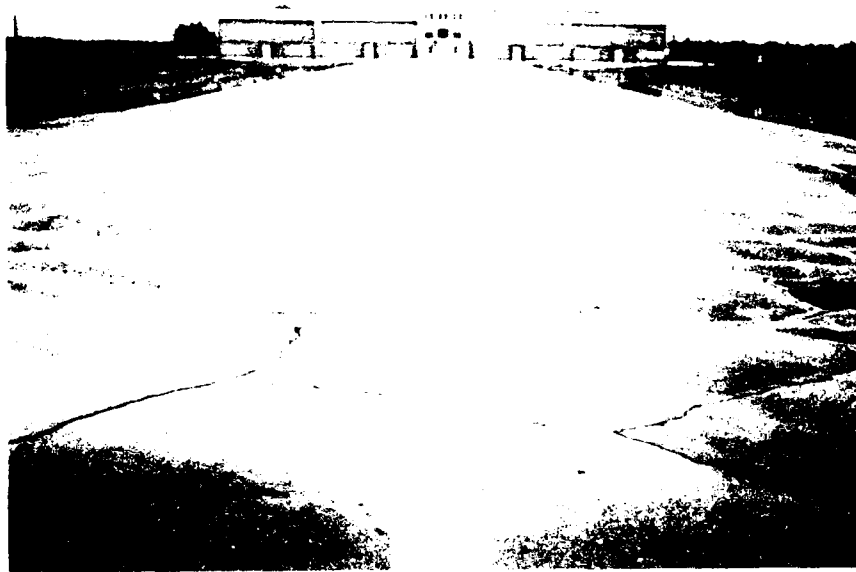
Photo 17. General view of surface cracking, alert area access taxiway (T22A)

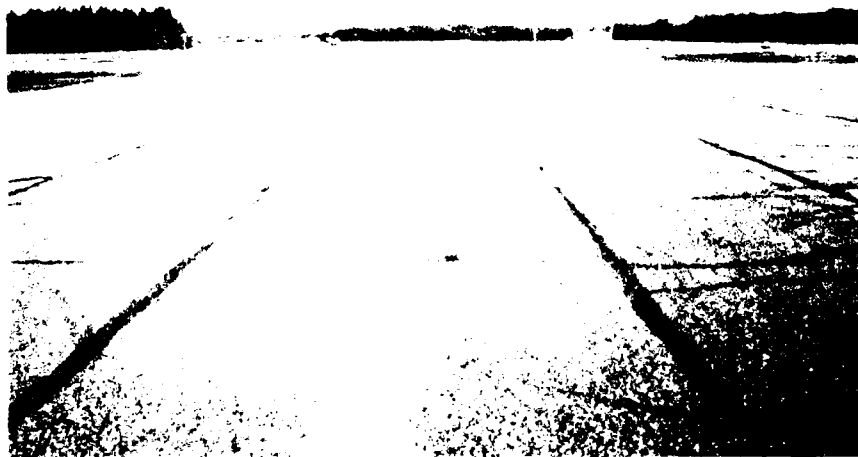
Photo 18. General view of loop taxiway (T23A) showing typical cracking

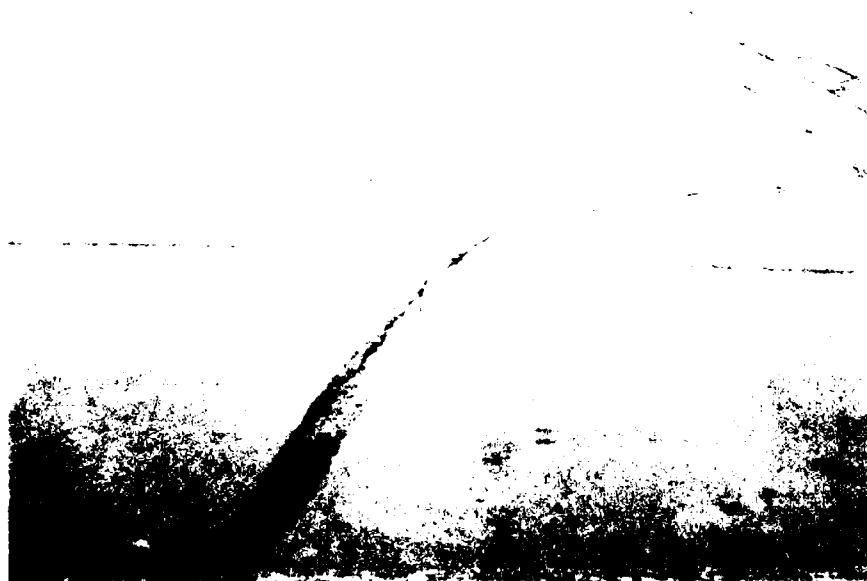
Photo 20. Typical shattered slab, Nose Docks 1 and 2
Apron (A1B)

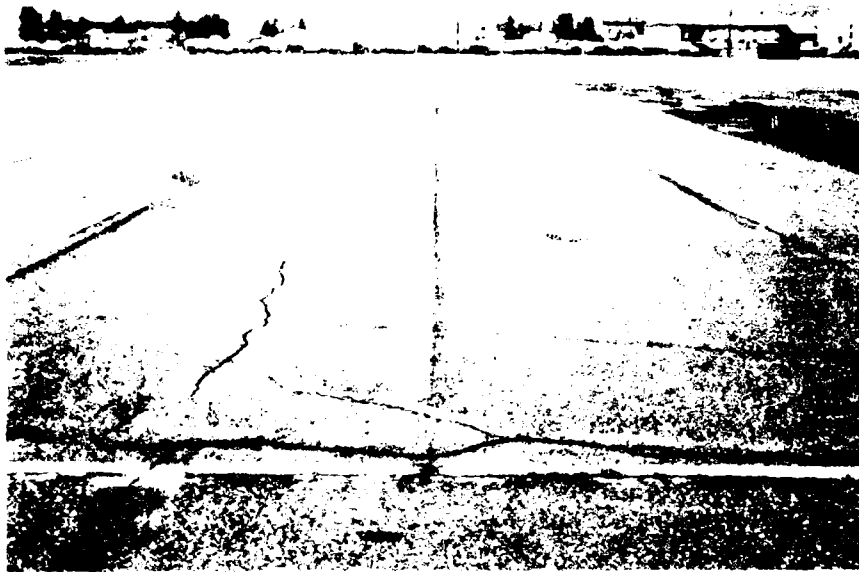
Photo 21. Overall view of tar-rubber overlay, SAC apron (A2P) (Note the weathering in the rightmost paving lane)

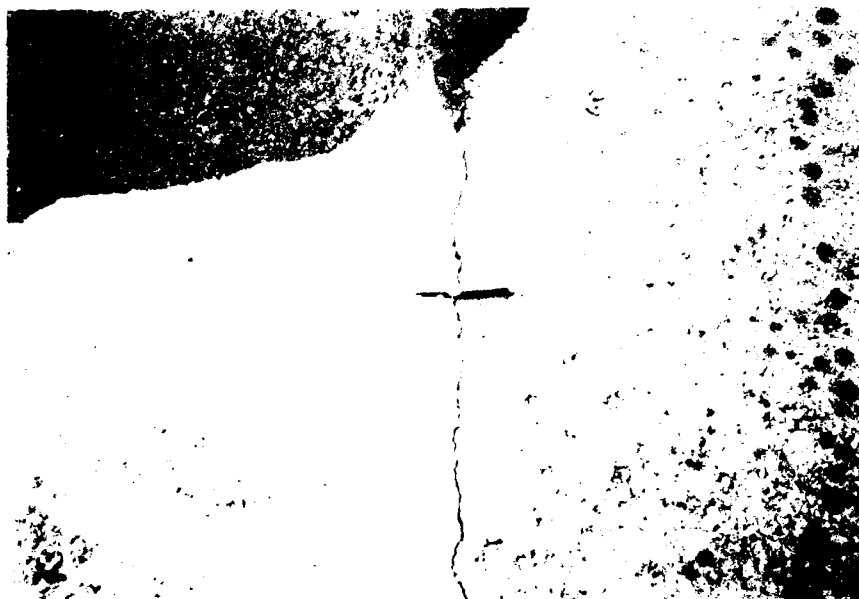
Photo 22. Low-severity cracking in recent AC overlay, C-135 apron (A6B)

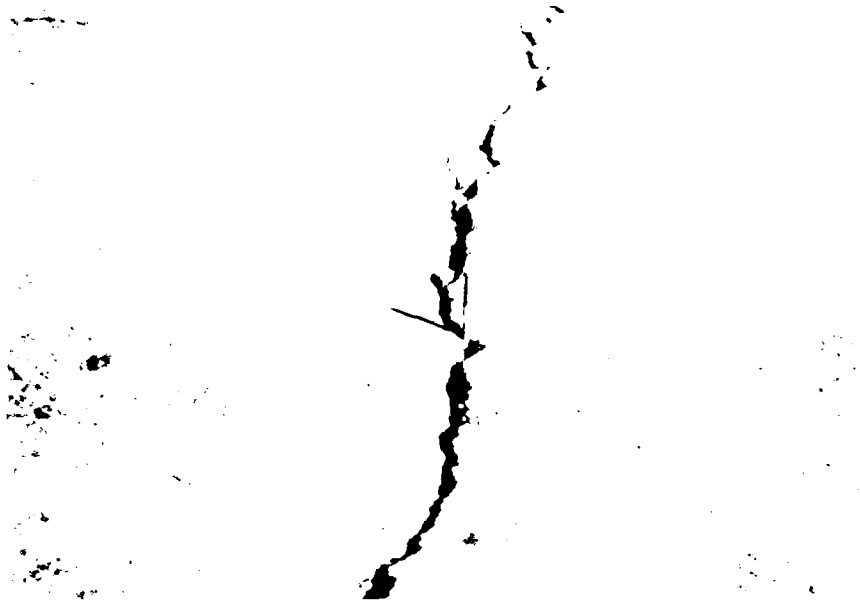
Photo 23. Typical unsealed, high-severity cracking,
C-135 apron

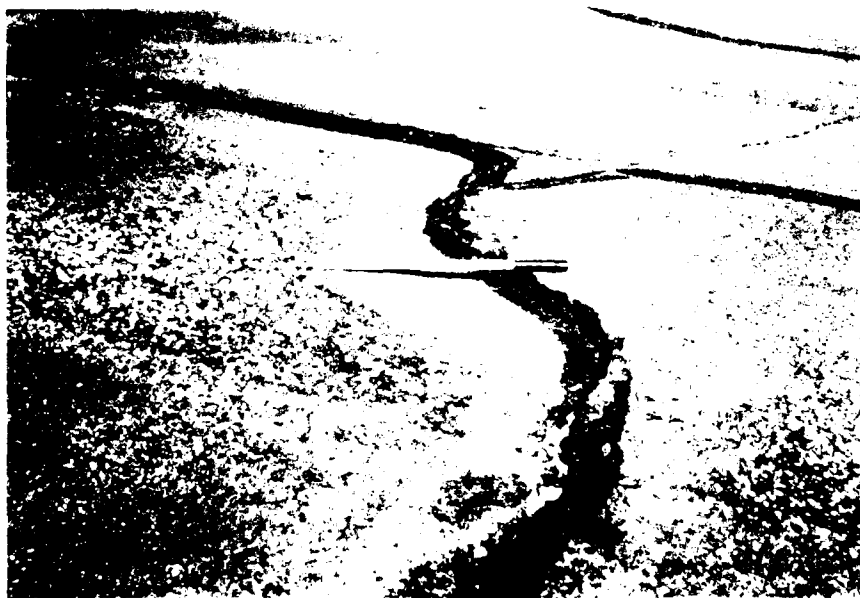
Photo 24. Faulted high-severity crack, C-135 apron

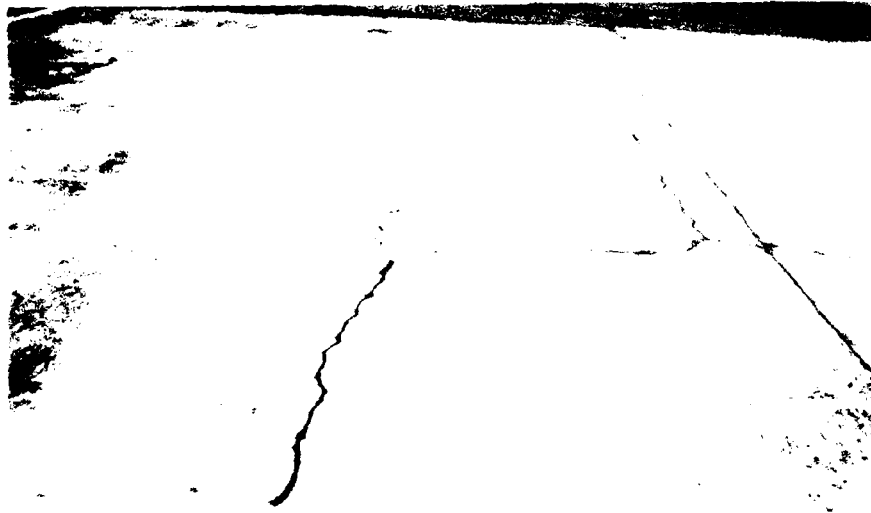
Photo 26. Sealed low-severity cracking in original PCC pavement, C-135 parking pads (A7E)

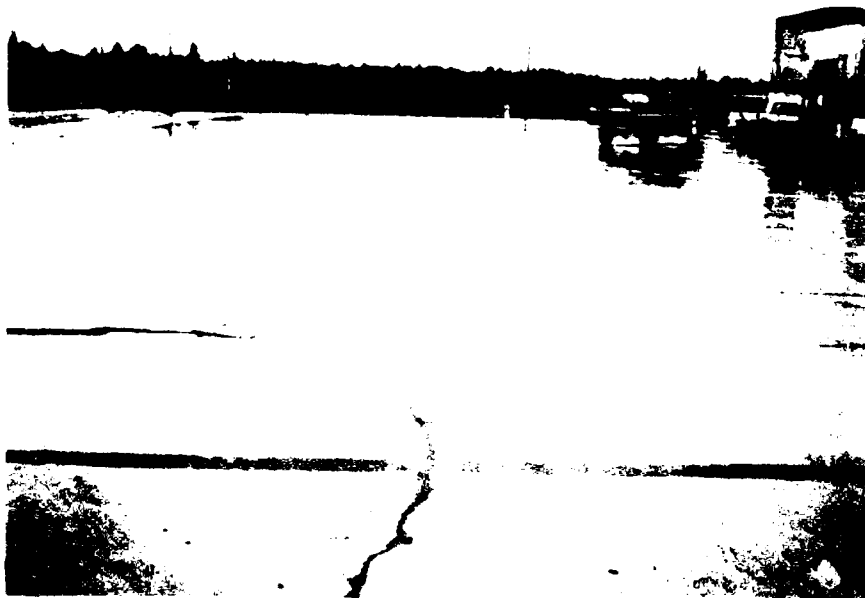
Photo 31. Low-severity shattered slab, alert area apron.
(A13B)

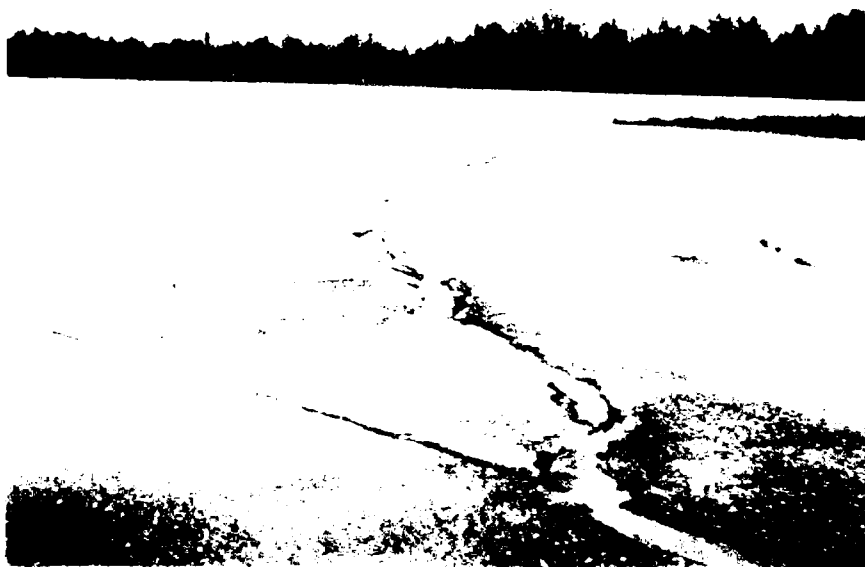
Photo 32. High-severity cracking and depression, reflective
film apron. (A13B)
