ROYAL AIRCRAFT ESTABLISHMENT

Technical Memorandum Materials/Structures 1074

**MEASUREMENTS OF THE OUT-OF-PLANE DISPLACEMENT OF AN AXIALLY LOADED  
CRACKED METAL SHEET WITH A CFRP REPAIR PATCH**

R. M. J. Kemp

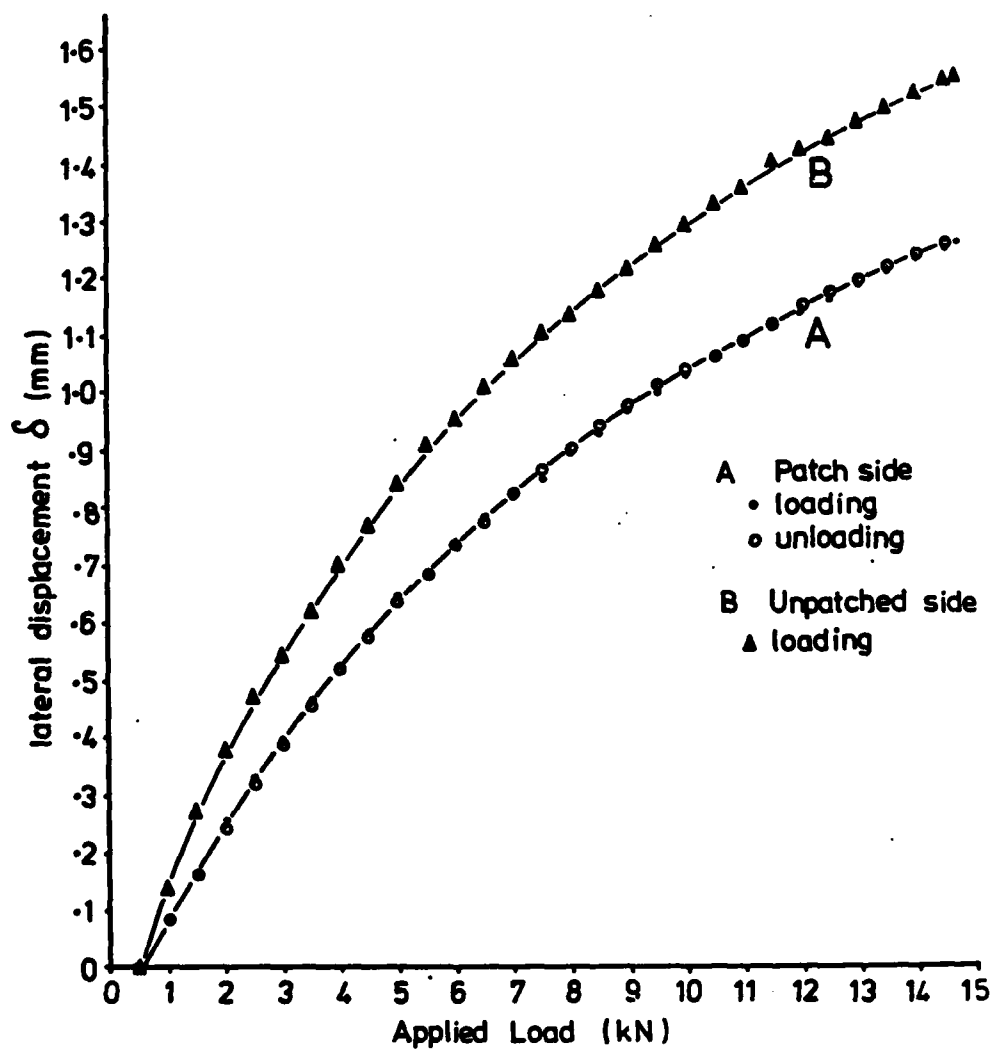
A comparison of displacement measurements at the centre of the patched and unpatched sides of the panel is shown in Fig 5. The crack length was  $2a = 94$  mm and the differences between loading and unloading on displacement were negligible (curve A). A considerable disparity was, however, observed between measurements taken on the two sides of the panel. At maximum load, the unpatched side of the panel was displaced by 1.55 mm compared to 1.25 mm measured on the patch surface. This disparity will be discussed later.

A disparity was observed in one situation as shown in Fig 5 between the displacements measured on the patched side of the panel and the unpatched side. The crack length was  $2a = 94$  mm, and the difference in displacement on opposite sides of the panel at the centre of the crack was 0.3 mm, suggesting that the panel was separating from the patch, or that some void was being created. An ultrasonic C-scan image was taken of the unloaded panel immediately after application of the patch for a crack length of  $2a = 75$  mm, and this was compared with a C-scan taken of the unloaded panel for a crack length of  $2a = 94$  mm, as shown in Fig 13a&b.

Fig 5 Displacement measurements at the centre ( $x = 0, y = 0$ ) of a panel with a crack length of  $2a = 94$  mm (loading and unloading)  
A patch side and B unpatched side

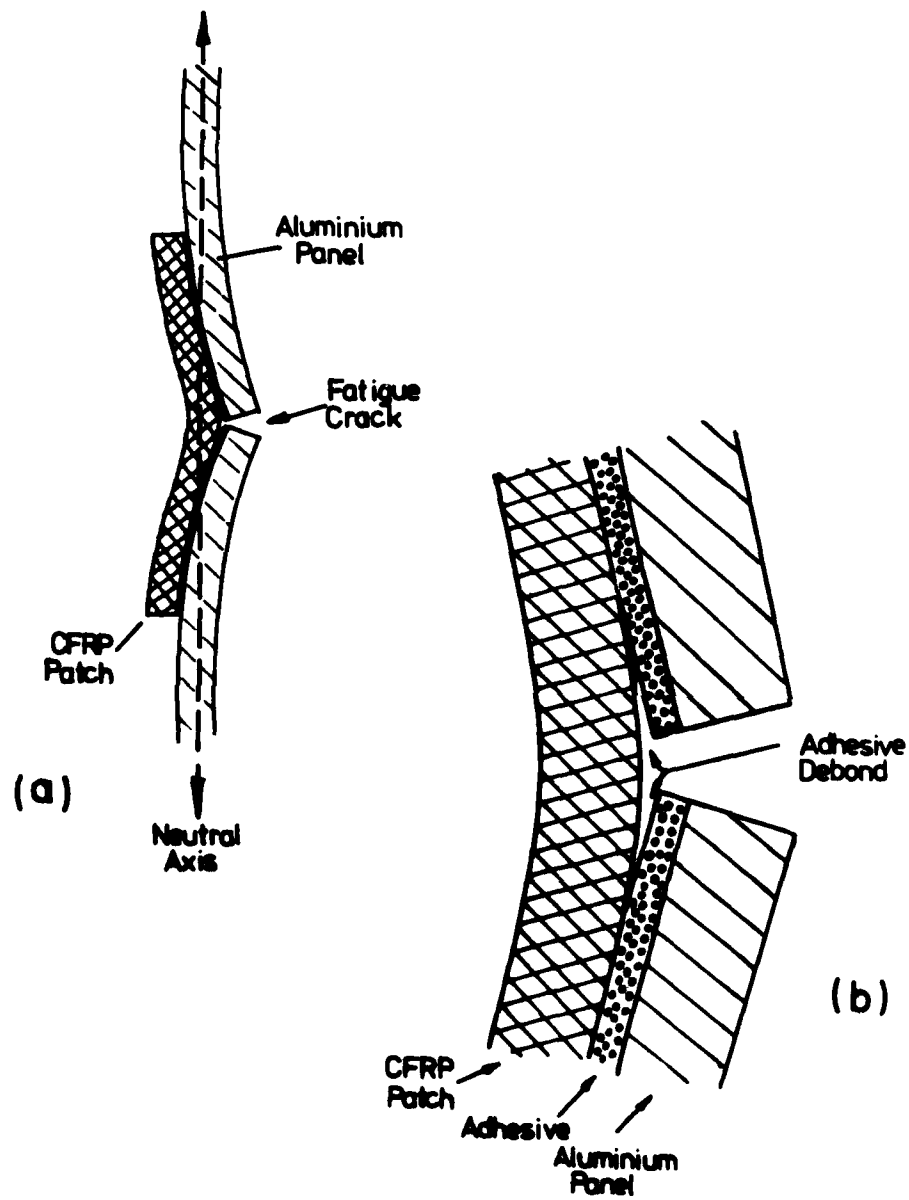
At the longer crack length an extensive debond region was observed along the line of the crack, strongly suggesting that the displacement disparity of 0.3 mm was caused by the debond region opening under load. It is thought that the panel is pulling away from the patch along the crack line and if so, then this 'splaying' of the crack edges is akin to the buckling observed in an unpatched centre-cracked sheet highly loaded in tension. Since it is known that high shear stresses exist in the adhesive between the patch and panel along the line of the crack<sup>4</sup>, then the additional stresses in the adhesive due to the buckling condition are thought to be contributory to the formation of an adhesive debond by increasing interfacial stresses. A comparison of the load-displacement curves for two crack length values as shown in Fig 4 indicates that the presence of a debond region also affects the magnitude of patch displacement under load. The higher overall displacement at high loads for the longer crack would be expected as a result of both the reduced stiffness of the aluminium panel with a longer crack and the reduced constraint on panel displacement

because of the increase in debond area. The 'crossover' effect at low loads may be explained by the presence of the debond at the longer crack length; since the debond occurs where adhesive shear stresses and hence load transfer to the patch are greatest, removal of this region would be expected to result in reduced load transfer to the patch at low loads, hence little displacement. It is seen, therefore, that load transfer to the patch is synonymous with displacement and *vice versa*. If no load transfer occurred, no displacement would be observed. At low axial load, in particular, the out-of-plane displacement is a sensitive function of load transfer to the patch - the more effective the transfer of load, the greater the displacement.

Fig 12 Illustrations of out-of-plane displacement showing  
 (a) offset due to modification of neutral axis and  
 (b) effect of debond on panel displacement
