MISCELLANEOUS PAPER GL-87-29

CONDITION SURVEY AND PAVER IMPLEMENTATION MACDILL AIR FORCE BASE, FLORIDA

November 1987

Final Report

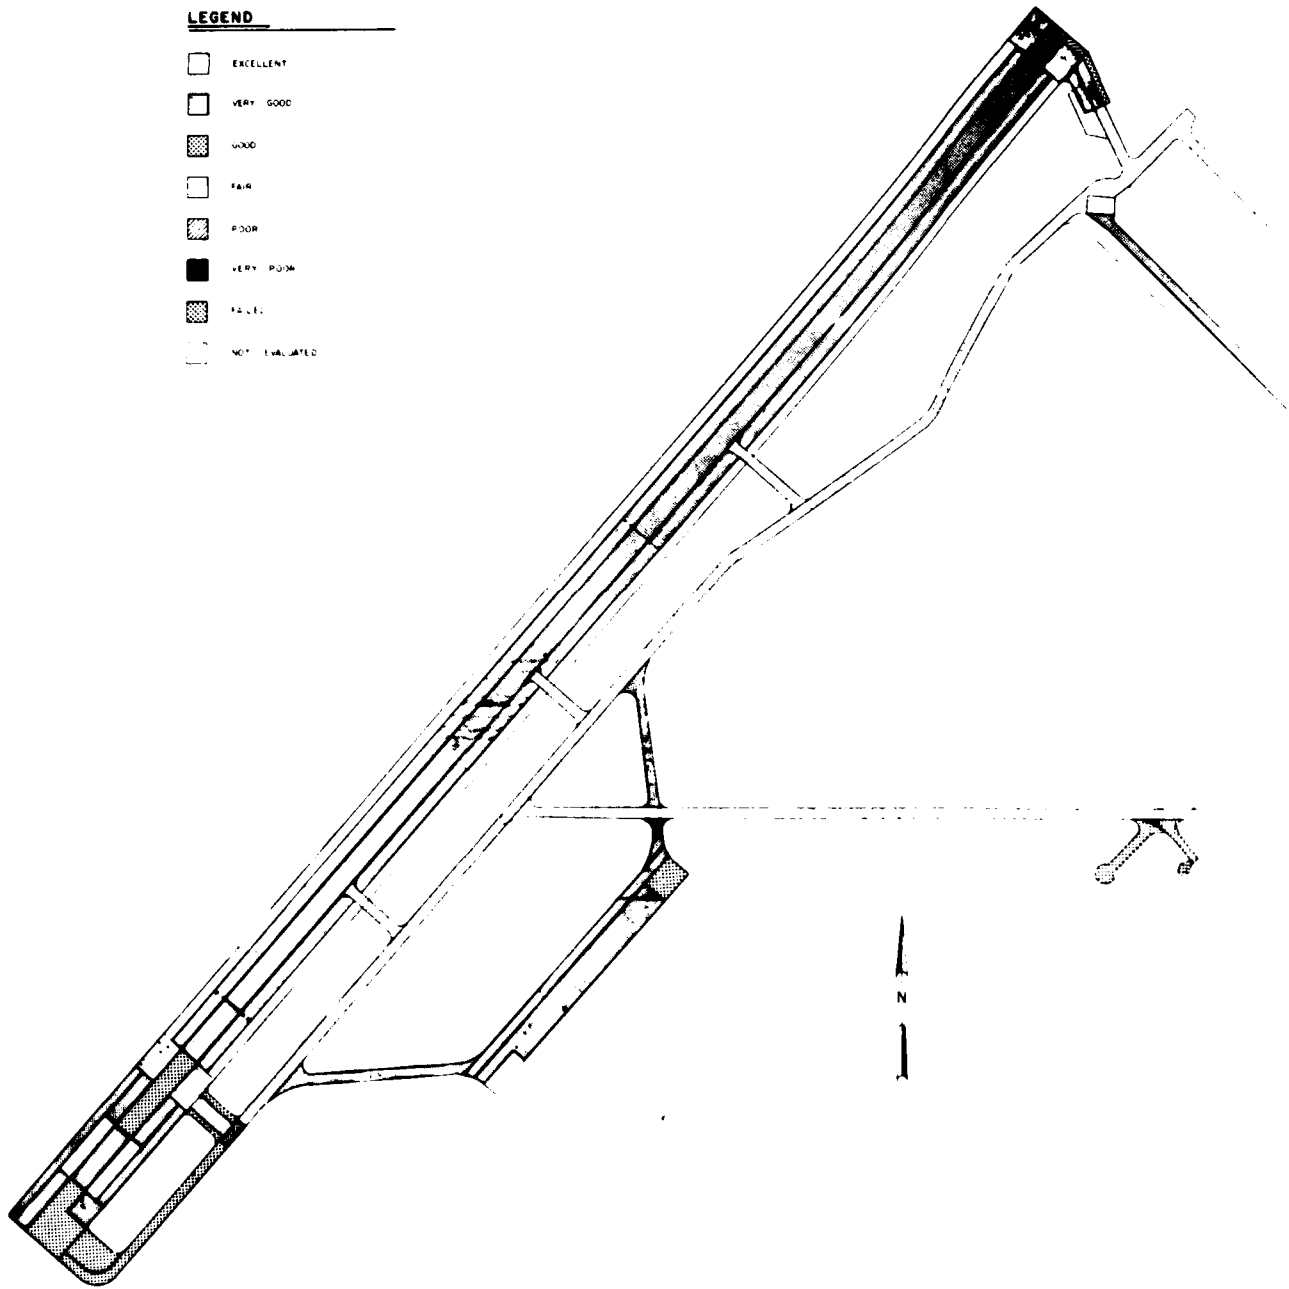
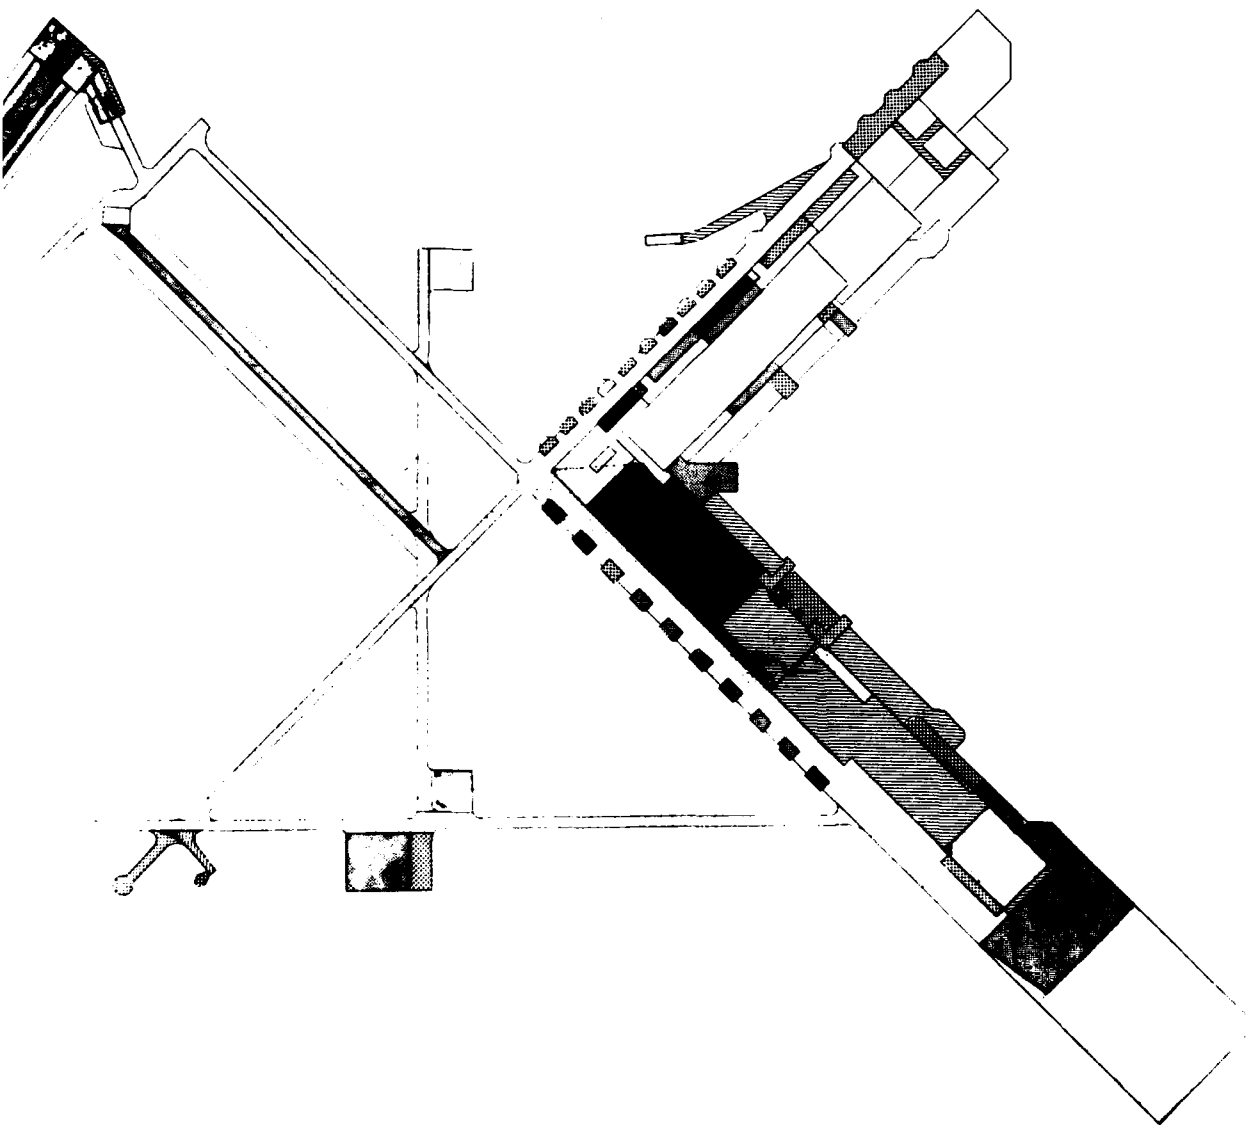
Figure 53. Pavement condit:

12. The majority of the pavement features at MacDill AFB are rated from fair to excellent condition with some features rated poor to failed. Figure 53 illustrates the condition ratings of the features at MacDill AFB, and Table 2 describes the more prominent distresses observed in the features. Photos 1 through 19 show various distresses that were observed on the airfield pavements.

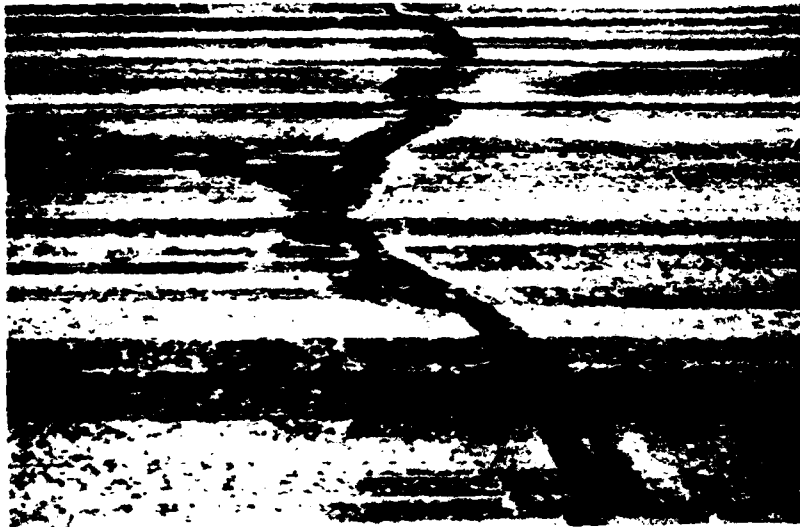
Photo 1. Medium severity cracking in PCC,
Runway 4-22 (R3B)

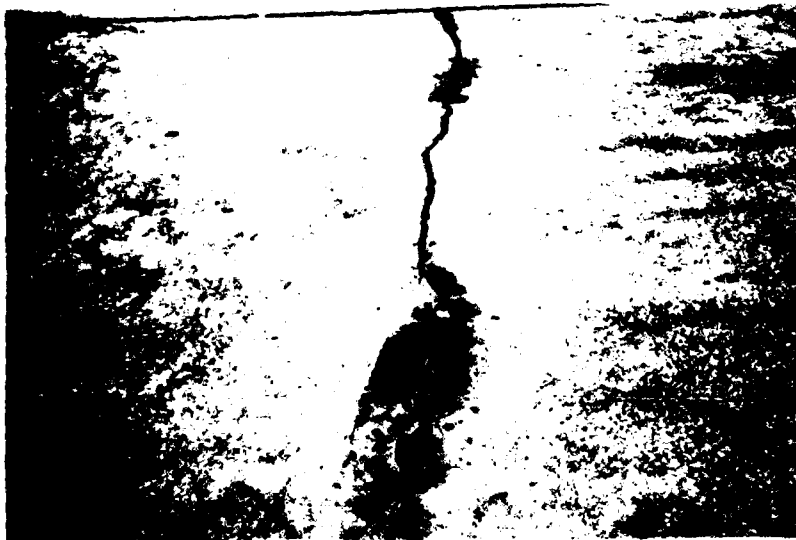
Photo 2. Sealed, low severity crack, Runway 4-22
(R5B)

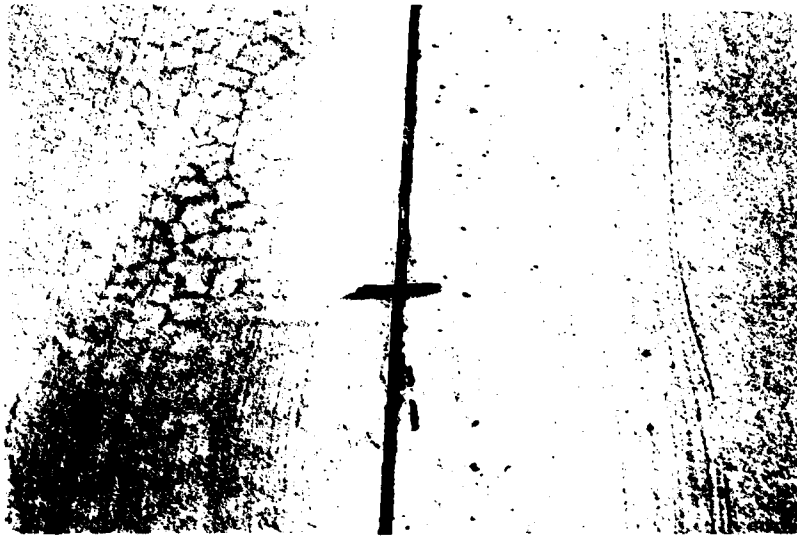
Photo 3. Typical joint seal damage, allowing incompressibles into the joint, Runway 4-22

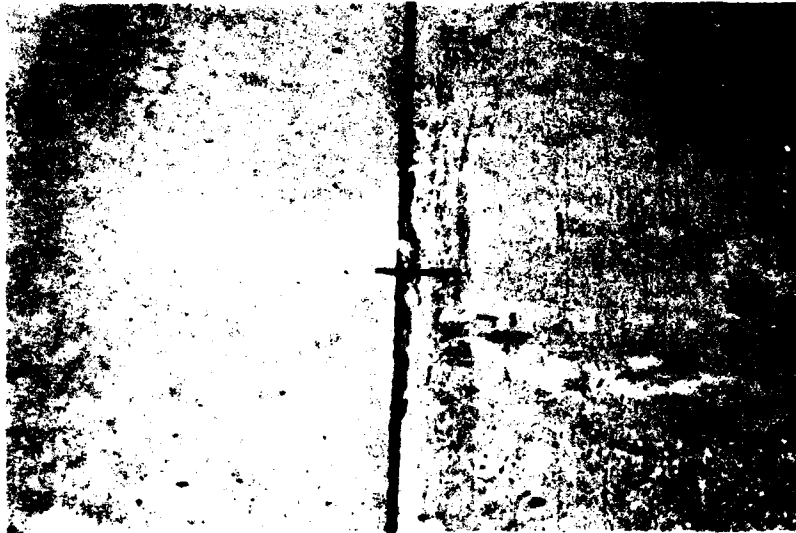
Photo 11. Typical low severity joint spall, Apron L

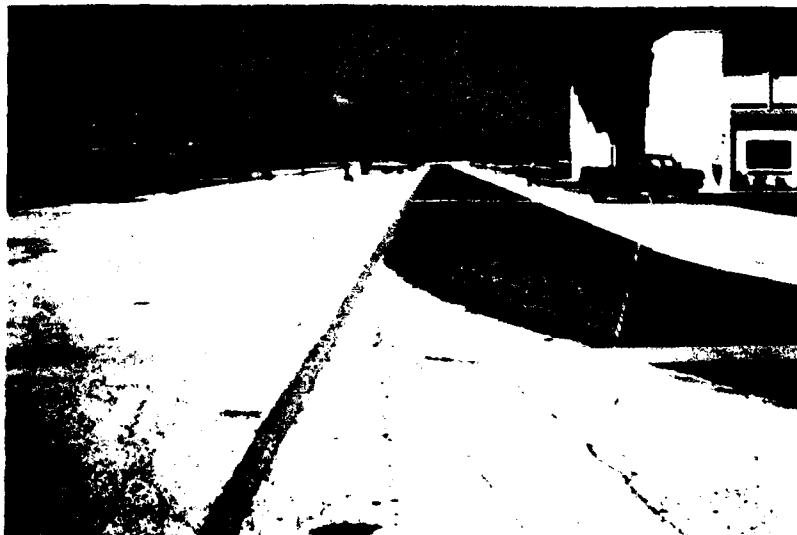
Photo 14. Shoulder pavement being used for apron,
aircraft fuel cell repair and corrosion control
apron (Note airplanes to left of picture)

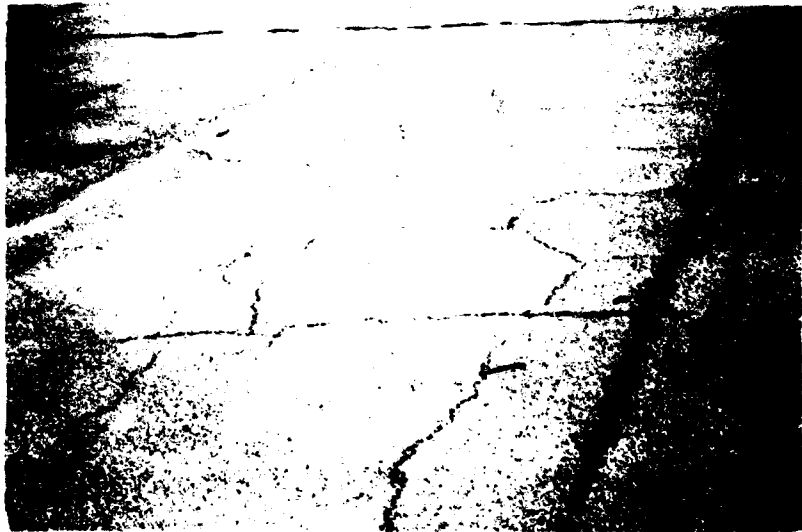
Photo 19. High severity joint reflection cracking
and medium severity block cracking, south ramp
