*Aircraft Materials Technical Memorandum 396*

#### CRACK DISTRIBUTION AND GROWTH RATES FOR CRITICAL FASTENER HOLES IN MIRAGE WING RH79 (J)

S. BOWLES

SEPTEMBER 1987

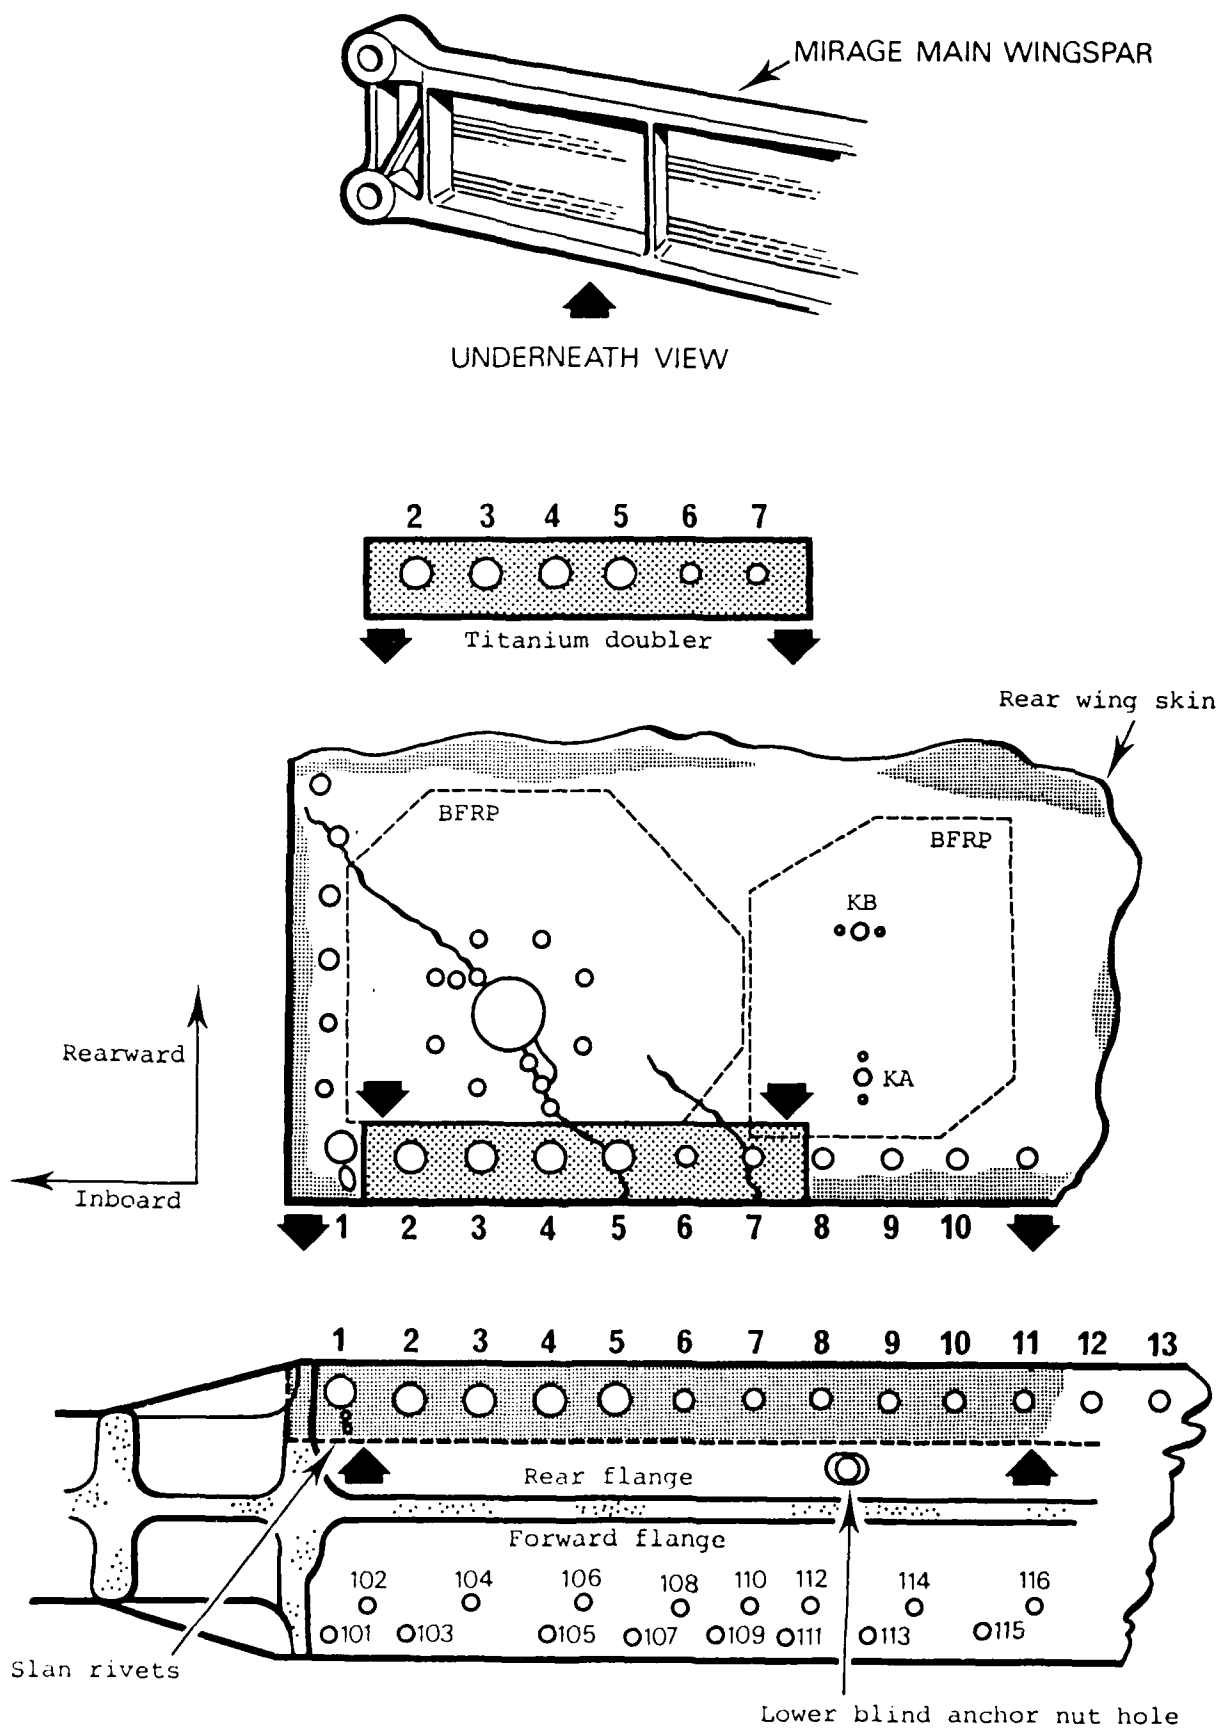
FIG. 1 LOCATION OF FASTENER HOLES IN THE MIRAGE WING-SPAR (LOWER FLANGE) AND THE ATTACHED REARWARD WING-SKIN.

The largest crack observed in the rearward spar flange holes was 2.18 mm deep (in hole 10), while the largest crack observed in the forward spar flange holes was only 0.27 mm deep (in hole 104.)

Overall, this fractographic information shows that the pattern of crack distribution is much as expected, with the largest cracks occurring on the rearward flange; the greatest cracking activity occurred in the SLAN rivet holes [2]. Holes 1 to 4 remained crack-free; this indicates that the bushes installed during refurbishment were effective since from past experience holes in these positions are normally critical crack initiation sites. For the remaining rearward flange holes inspected, cracking activity was more prominent in the holes towards the outboard end of the spar: holes 10, 11, 12, 13 and the blind-anchor-nut hole. This may result from a load redistribution due to either the large cracks found growing in the rearward wing-skin or the boron-fibre reinforced patches on the wing skin (see Figure 1). The most active crack in the forward flange occurred in fastener hole 104, which seems to carry the main load from the forward fairing.

BORON FIBRE REINFORCED PATCHES (BFRP) AND A TITANIUM DOUBLER USED IN SKIN REPAIR ARE SHOWN. MAJOR SKIN CRACKS ARE ALSO SHOWN.

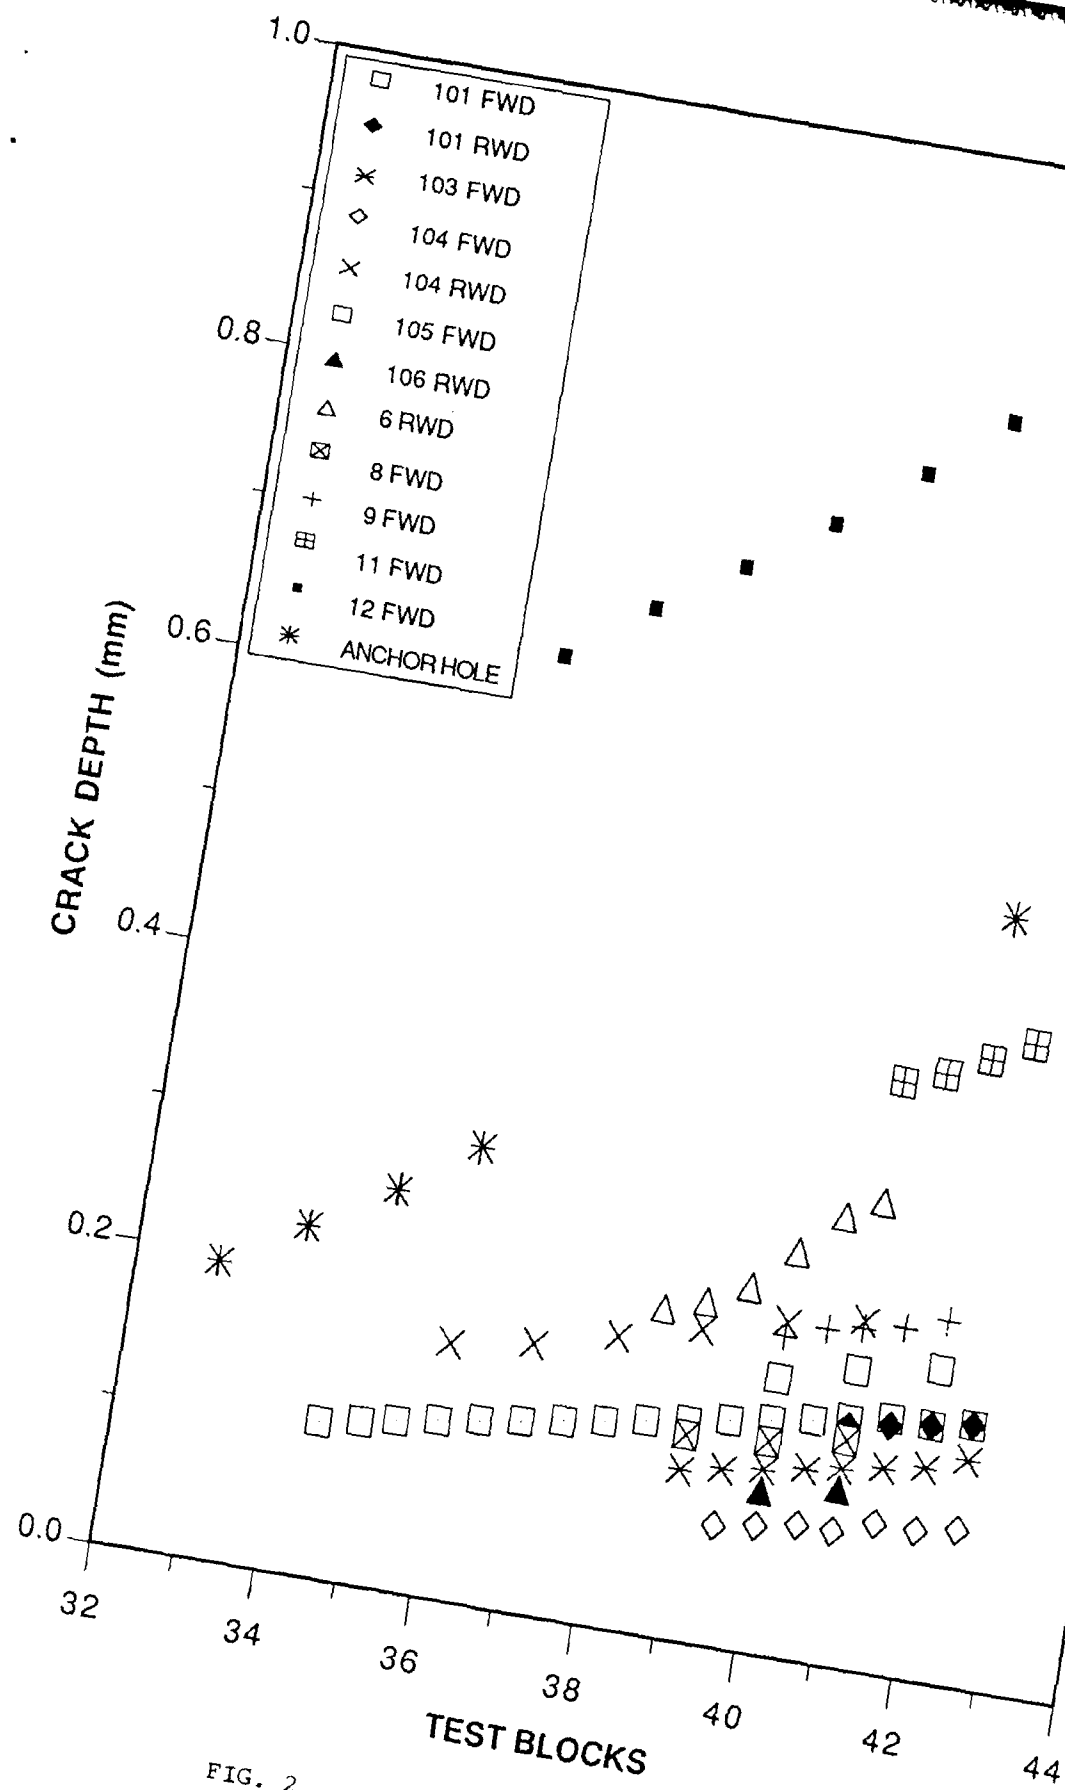
FIG. 2

Crack growth curves for cracks in holes 6, 8, 9, 11, 12, blind-anchor-nut hole, 101, 103, 104, 105 and 106 are presented in Figure 2. Unfortunately many of the crack faces, including those of the crack in hole 10, were severely fretted and crack growth data could not be obtained.

CRACK GROWTH CURVES FOR MIRAGE  
WING RH79.
