DEPARTMENT OF DEFENCE  
DEFENCE SCIENCE AND TECHNOLOGY ORGANISATION  
MATERIALS RESEARCH LABORATORIES

MRL-TN-522

A DEFECT INVESTIGATION OF THUNDERFLASH MK N5 (NAVY)

C Commonwealth of Australia  
SEPTEMBER 1987

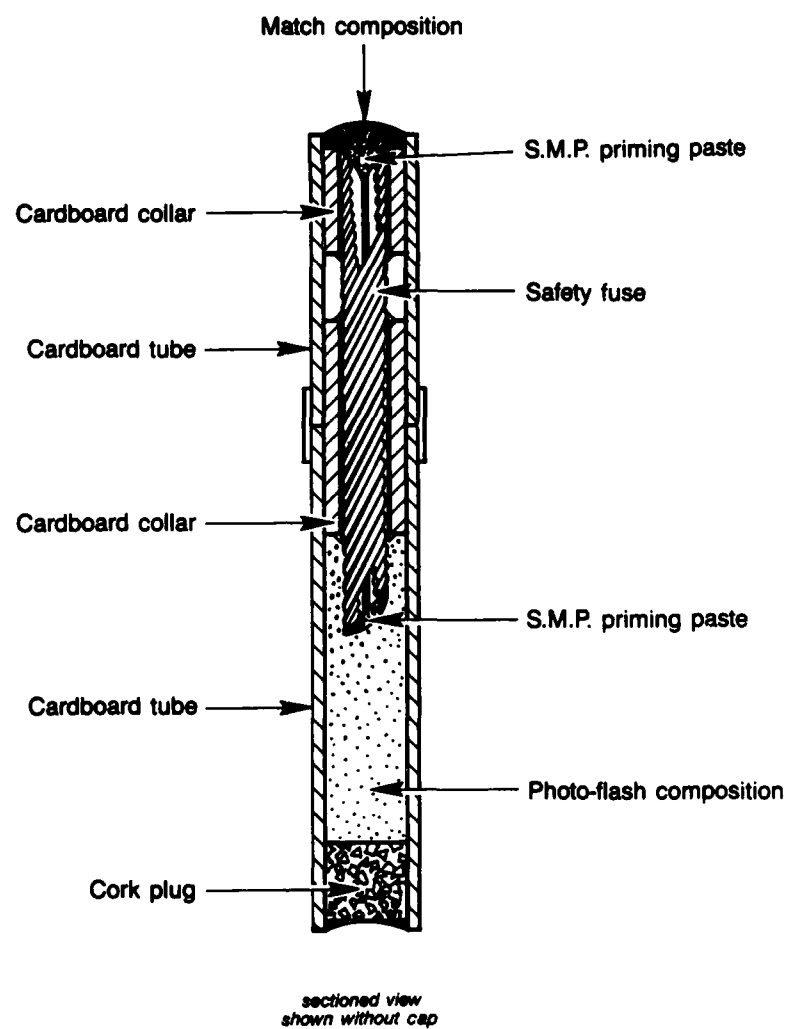
The Thunderflash, Small Mk N5 (Fig.1) consists of a cylindrical cardboard tube, closed at one end by a cork plug. The cylinder is filled with the photoflash composition SR 801B which was developed in 1944 at the Royal Armament Research and Development Establishment, RARDE, Fort Halstead, UK. The composition contains 57% magnesium powder grade 4, 37% potassium perchlorate and 6% graphite. The devices are ignited by striking a match composition, located at the top of the cylinder. A length of safety fuse provides an interval which enables the device to be safely hand deployed. After a specified time, the fuse ignites the photoflash filling resulting in a loud explosion and a high intensity flash of light. The outer surface of the cardboard cylinder is weatherproofed with a coating of shellac and is fitted with an identification label. A protective rubber cap which covers the match composition is removed before use (Fig.2).

FIGURE 1 Thunderflash, Small Mk N5.

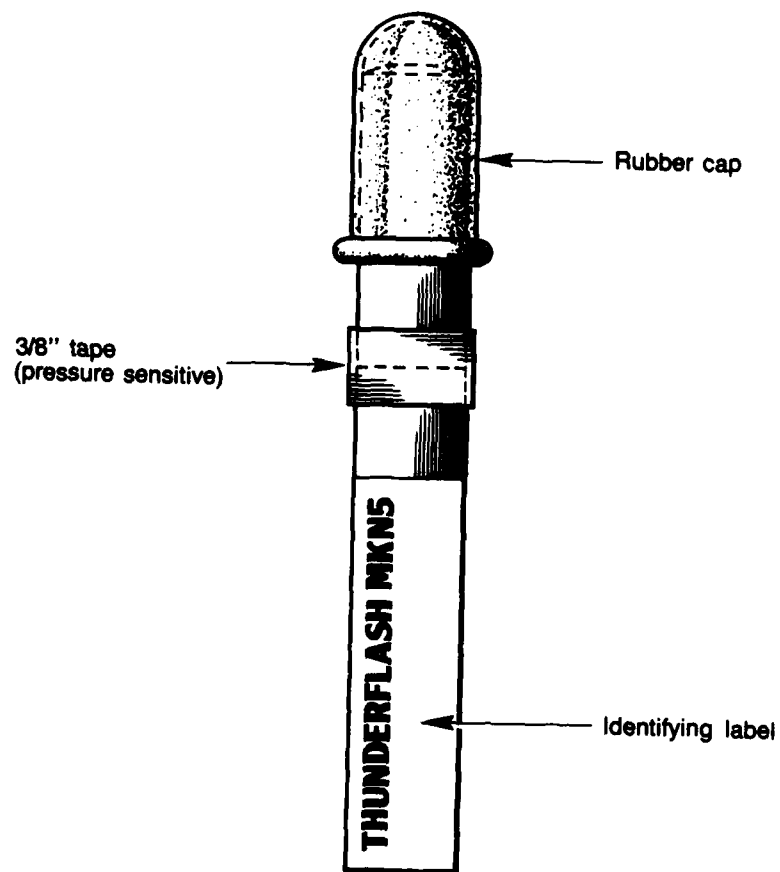
FIGURE 2 Thunderflash, Small Mk N5.

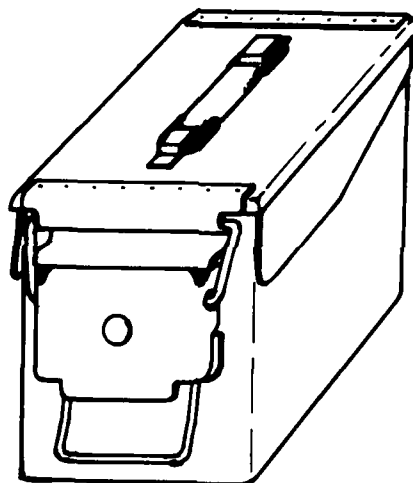
Ten Thunderflash devices with one striker are supplied wrapped in waxed paper and sealed in a polythene envelope. Ten of these packages are stored in an M2A1 ammunition box which incorporates a rubber seal in the lid

(Fig.3). The free space in the box is packed with waxed paper to protect the contents against rough handling.

Swelling due to internal pressure was observed in a number of M2A1 boxes each containing one hundred Thunderflash devices. Reports from the Naval Quality Assurance Representative (NQAR), Newington indicated that some of these boxes had been opened within the last twelve months yet, at the time of this initial inspection, no swelling was observed. It has been determined that the internal pressure required to swell the M2A1 boxes to the degree observed could be as high as 100 kPa [2], therefore ammunition boxes that exhibited deformation due to internal pressure were considered unsafe for transport. A number of Thunderflash devices from these boxes were repackaged and forwarded to MRL for examination. Samples of the photoflash composition were taken from devices under manufacturing Lots, 5 MY 3/72, 4 MY 3/72, 33 MY 3/79, 3 MY 6/82 and analysed for free magnesium content. The results are listed in Table 1.

FIGURE 3 M2A1 Ammunition box

MRL have examined the pyrotechnic filling from a number of Thunderflash, Small Mk N5 devices. The examination indicates a depletion of the free magnesium content in the filling caused by a reaction between the magnesium and moisture. A consequence of this reaction is the liberation of hydrogen gas. The volume of gas evolved is sufficient to generate a high pressure in sealed ammunition boxes. It is recommended on the basis of this investigation that the Thunderflash devices stored in boxes that exhibit swelling be destroyed.
