# CONDITION SURVEY AND PAVER IMPLEMENTATION MACDILL AUXILIARY FIELD NO. 1 (AVON PARK RANGE), FLORIDA

Final Report

Prepared for DEPARTMENT OF THE AIR FORCE  
MacDill Air Force Base, Florida 33608

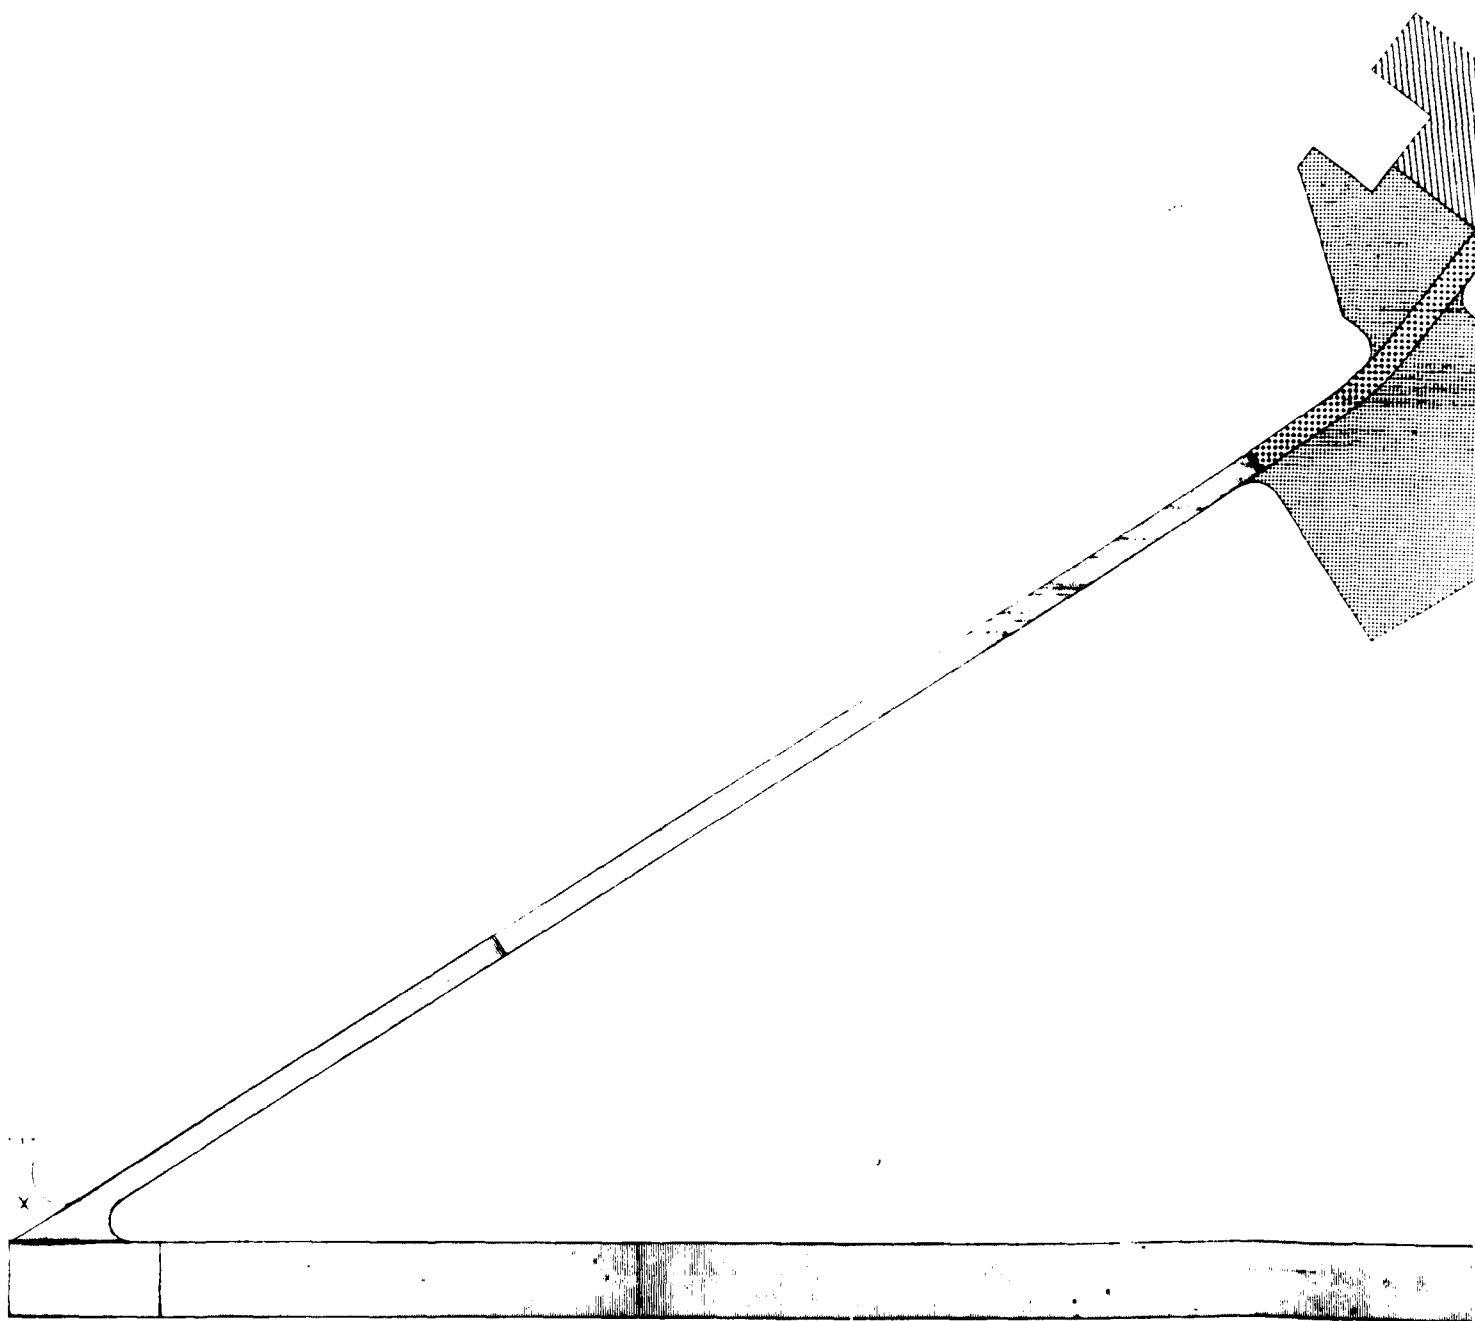
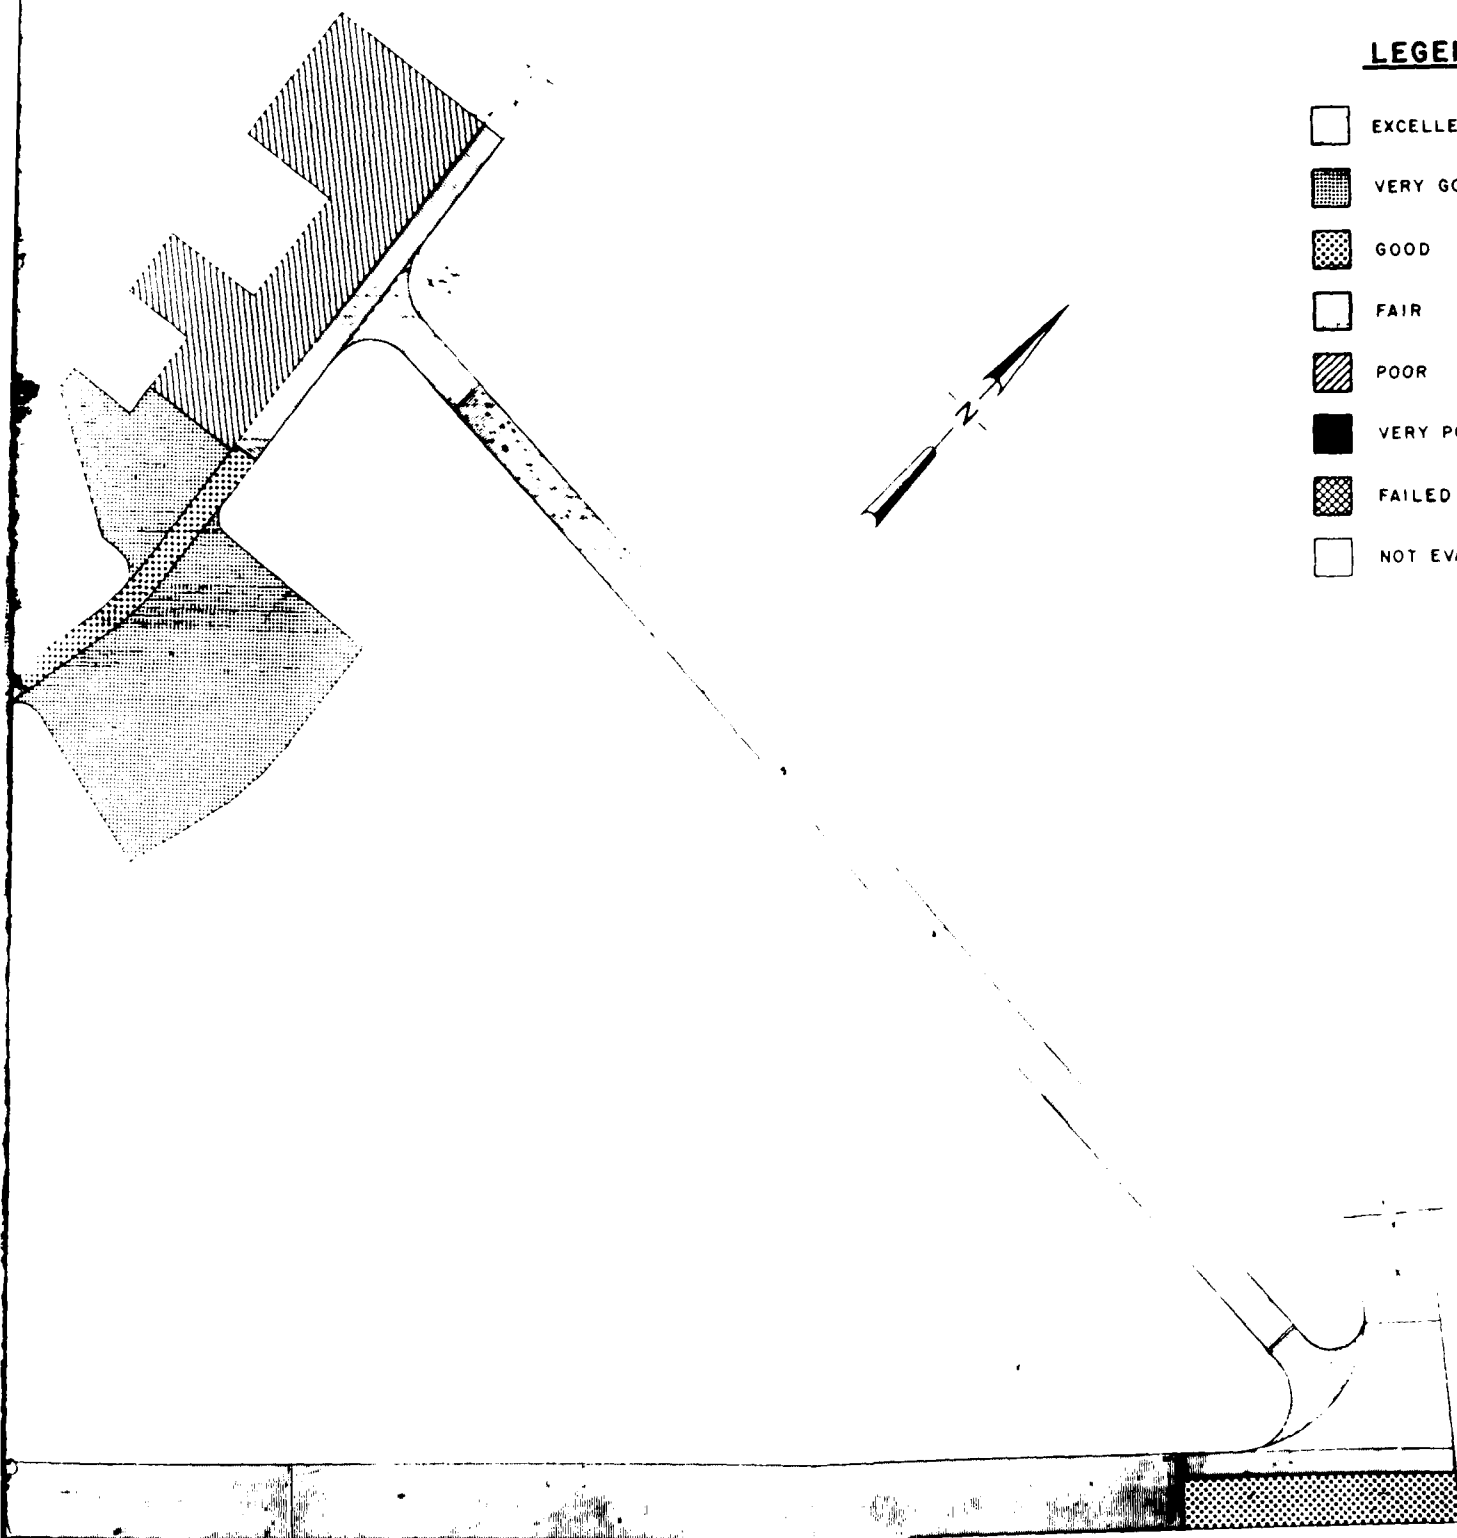
Figure 14. Pavement condition r

12. The majority of the pavement features at Avon Park Range are rated from fair to very good condition with one feature rated poor. Figure 14 illustrates the condition ratings of the features at Avon Park Range, and Table 1 describes the more prominent distresses observed in the features. Photos 1 through 7 show various distresses that were observed on the airfield pavements.

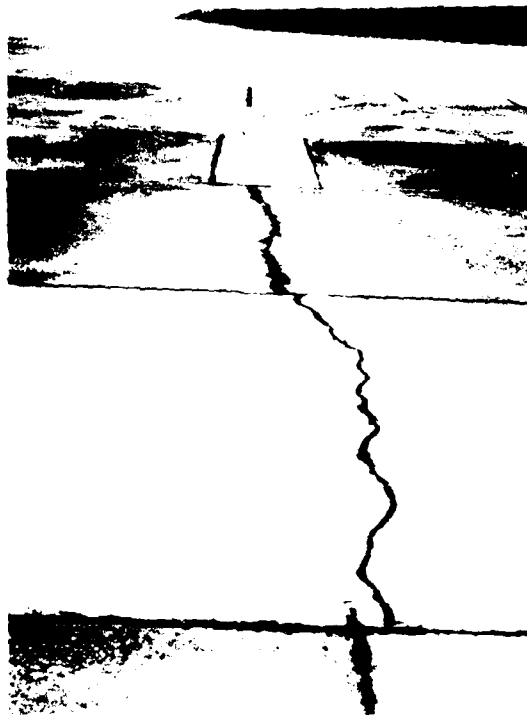
Photo 1. Typical cracking and  
patching in PCC, Runway 5-23

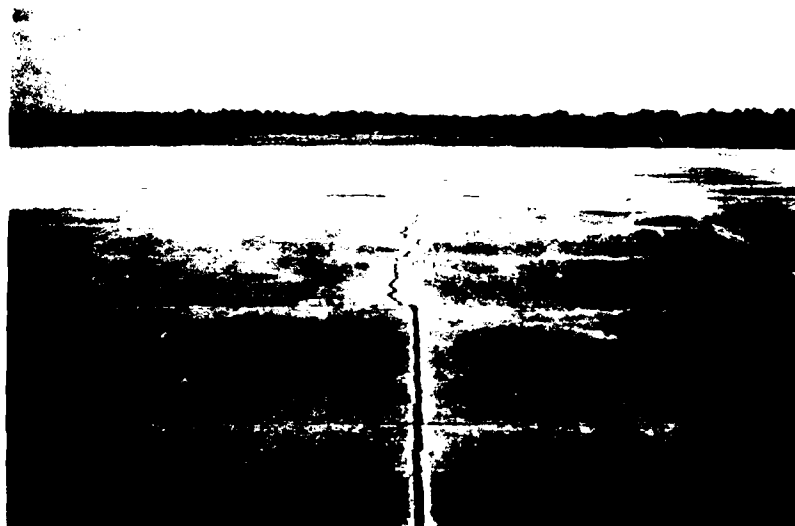
Photo 5. View of cracking caused by uncut joint,  
Apron E

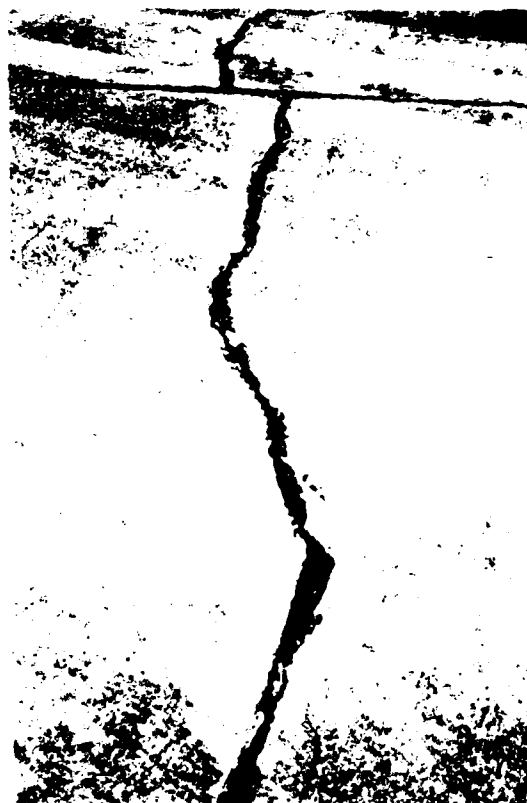
Photo 6. Close-up of old sealant,  
allowing incompressibles to enter  
the crack, Apron E
